Bisbee Restoration Museum
37 Main St.
Bisbee, AZ 85603

Site Location
Cover Sheet

Sidewalk Site Condition Photographs

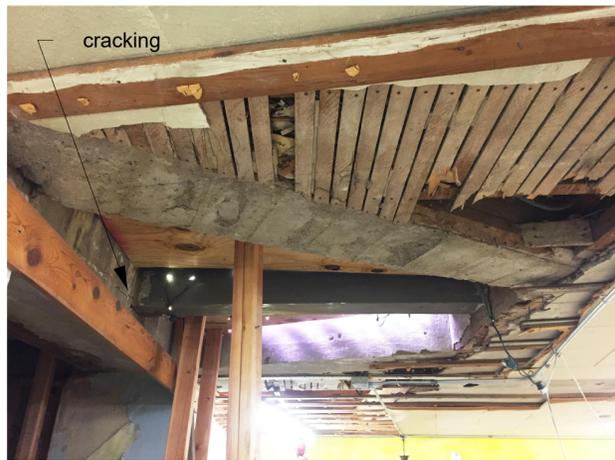
1 Steel (?) beams wrapped in concrete under door entry area. Center beam is wood, and has expanded, cracking the concrete beams it ties into on the south. The two glass sidewalk panels these beams hold are still in perfect condition, do not need replacement or repair. The wood connection point of center beam needs support from underneath or a supplemental beam, column, or shear wall placed next to or under in case of future failure.

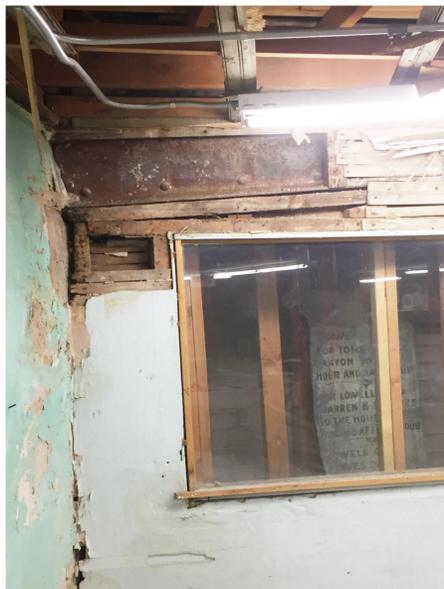
2 Riveted composite beam under south facade. Two C channels 3x10" & 5x10" back-to-back. See Section S2-4. On partial inspection this beam does not look overly corroded, but needs thorough inspection during sidewalk construction.

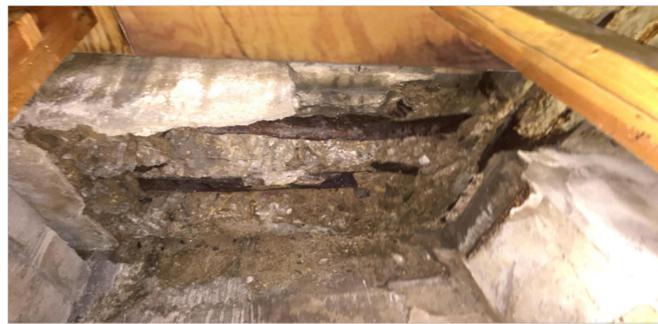
3 Heavily deteriorated concrete beam above, with rusted steel beam on the right. Rebar shown exposed is approximately size #10 square bar (typ). All four sidewalk beams are in a similar condition as this.

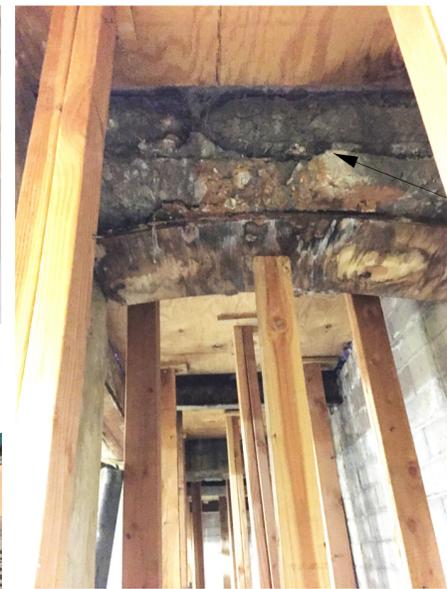
missing C-Channel

4 Heavily deteriorated concrete beam above, with rusted steel beam on the left. Without the wood shoring underneath, the underside of the beam would likely spawl-off. Facing the camera on the side of the beam is the indentation of a steel C-channel that was imbedded into the concrete, but has since completely rusted away.

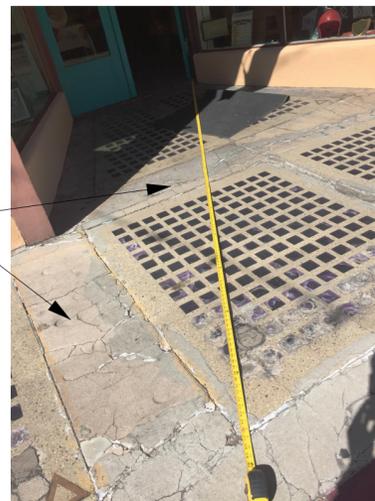
7 The concrete beams as seen from above, cracking in the top surface shows sagging and failure more visible below. The beams have been resurfaced in the past, hiding structural decay.

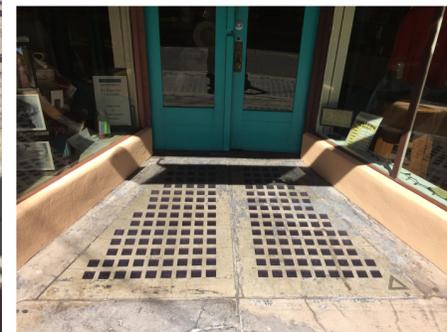
8 These two glass and concrete panels are in good condition and do not need replacement or repair. The wood center beam below does need additional support.

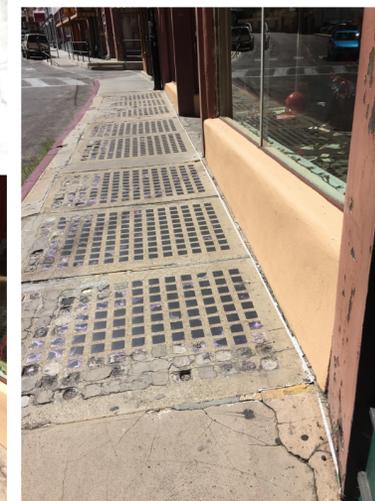
9 Broken and missing glass blocks have occurred directly over the newer CMU retaining wall which was placed underneath along the south (left) and east (bottom) side.

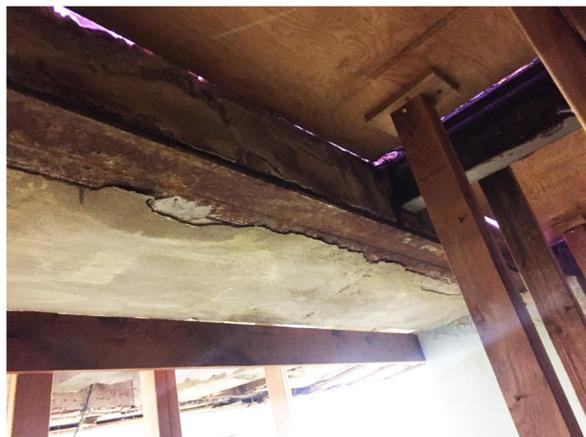
5 Riveted composite beam under south facade. Two C channels 3x10" & 5x10" back-to-back. See Section S2-4. On partial inspection this beam does not look overly corroded, but needs thorough inspection during sidewalk construction.

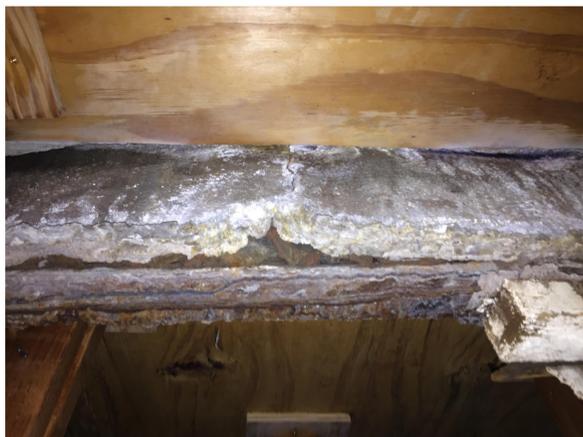
6 3"x6" I beam heavily rusted through with inset concrete actively spalling off. This is typical of all of the steel beams under the sidewalk.

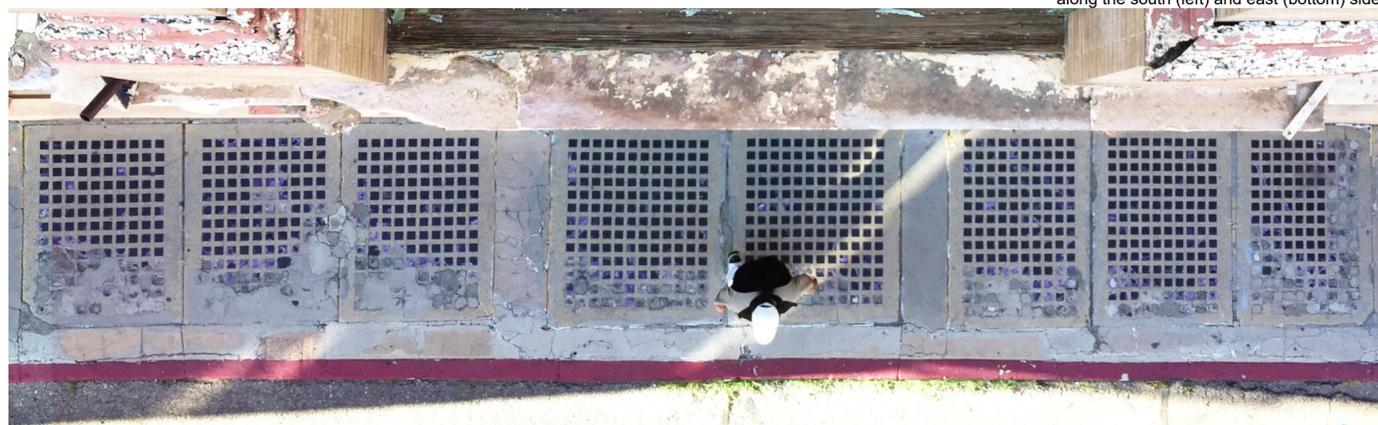
10 Broken and missing glass blocks have occurred directly over the newer CMU retaining wall which was placed underneath along the south (bottom) and east (right) side. The weight and vibration of the live-loads pressing the glass against the CMU wall underneath might have caused the glass blocks to break. Replacement sidewalk panels should avoid having the weight incorrectly placed on the glass blocks, and instead along the edges of the concrete panels as originally designed by the architect.

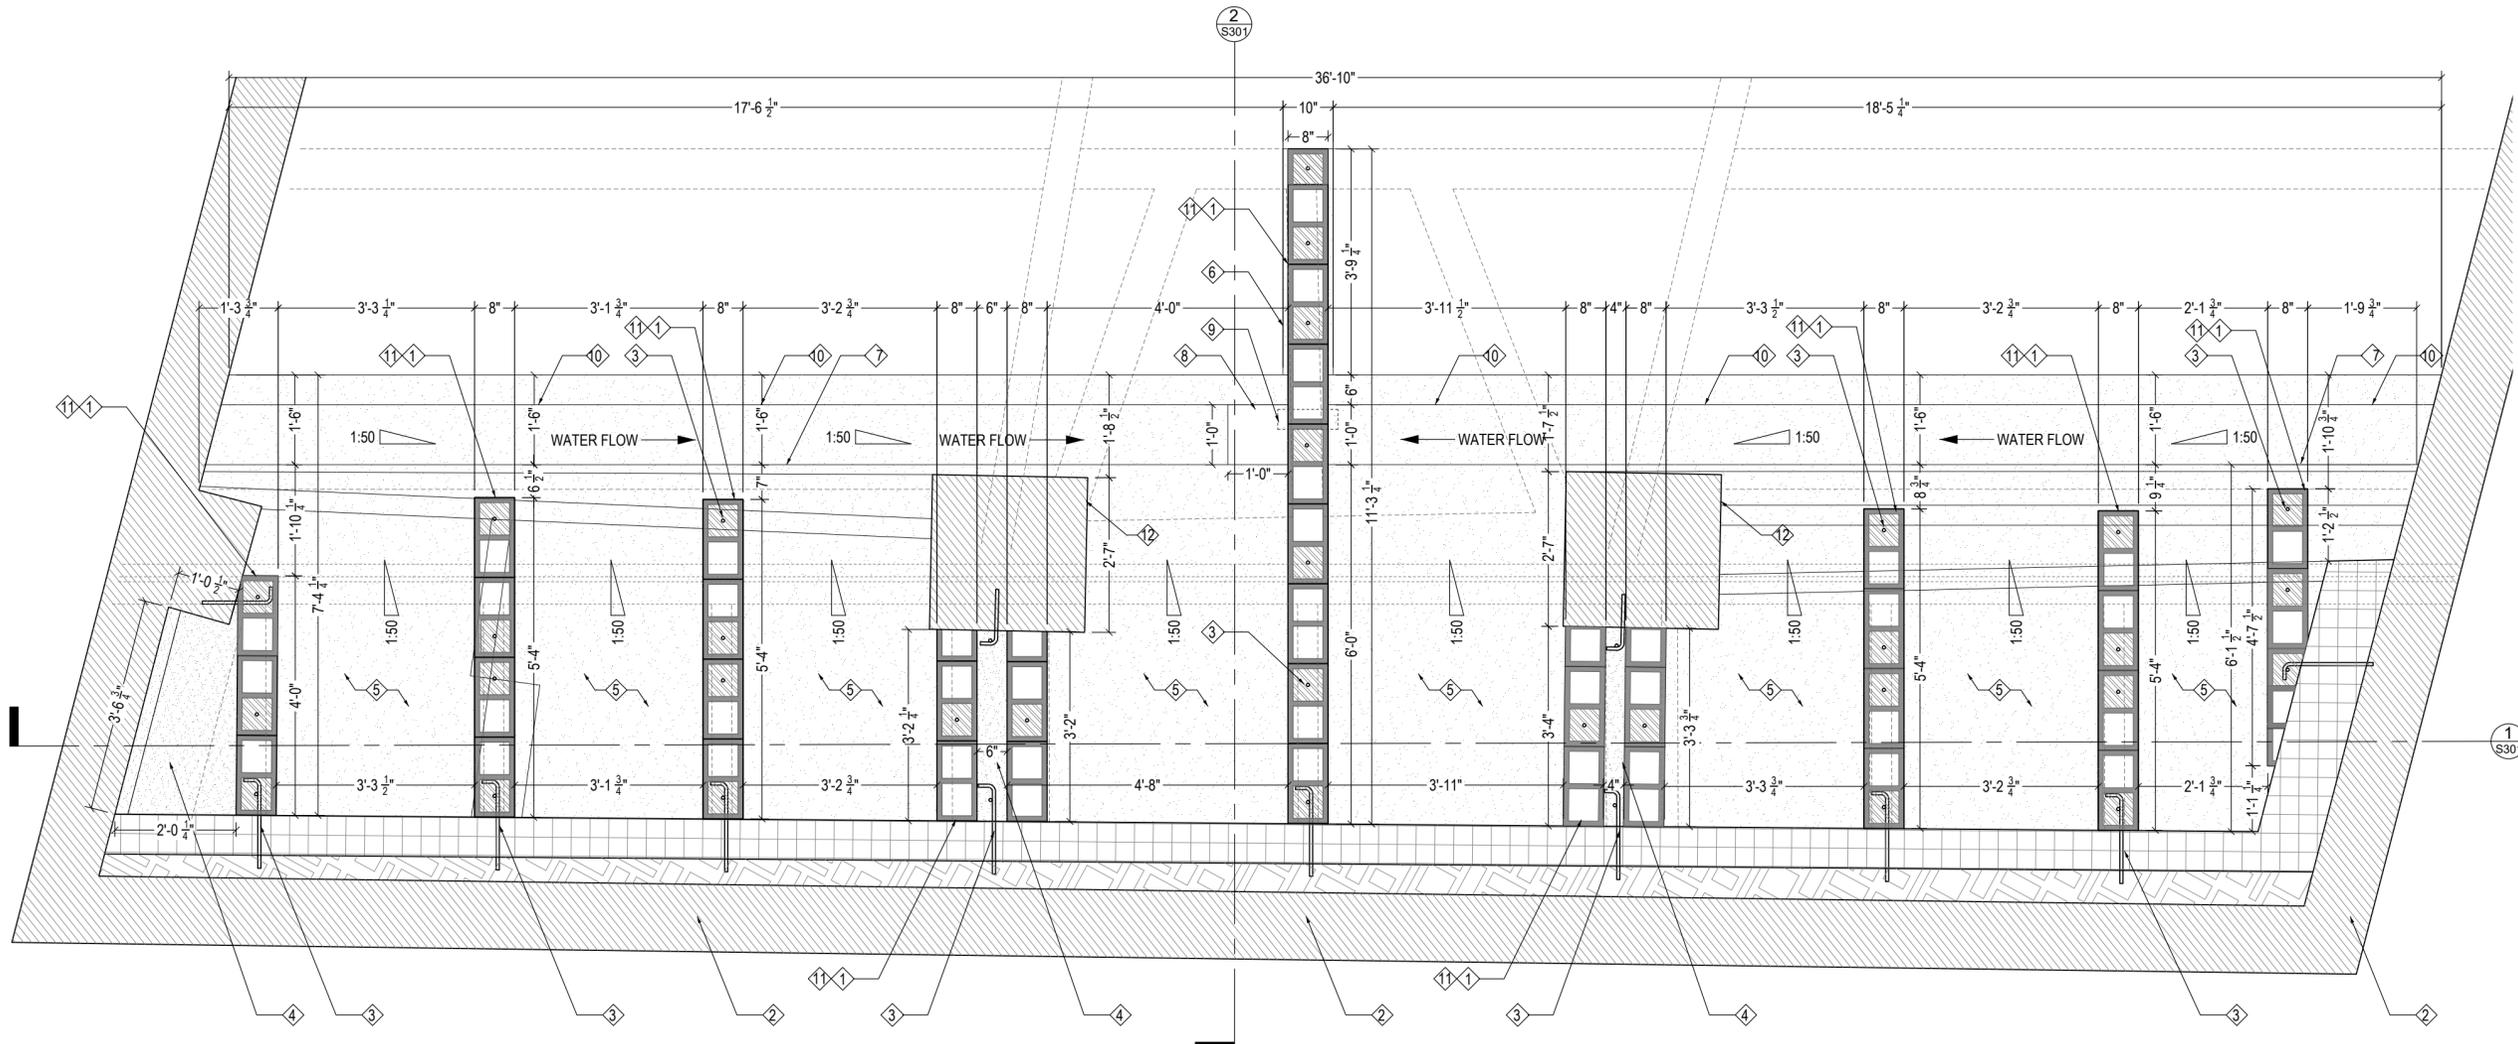
① BASEMENT - UNDER SIDEWALK
 SCALE: 1/2" = 1'

- ① (E) THE NUMBER AND SPACING OF GLASS TILES HAS BEEN CAREFULLY DOCUMENTED HERE AS A HISTORICAL RECORD FOR REPRODUCTION OR REPAIR.
- ② (E) CAST-IRON COLUMNS. WHEN SIDEWALK PANELS ARE REMOVED, THE BASE OF THESE COLUMNS NEED TO BE INSPECTED FOR CORROSION AND PROPER CONNECTION TO STRUCTURE BELOW.

- ③ (E) CONCRETE BEAMS ARE IN A STATE OF FAILURE DUE TO WATER INFILTRATION, ICE, SALT, AND VIBRATION. NUMBER AND SPACING OF REBAR VARIES AND IS UNKNOWN.

- ④ (E) SHADED AREAS DENOTE DAMAGED SKYLIGHT TILES. SEE S501 FOR DETAILS.
- ⑤ (N) SEE SHEET S501 FOR SIDEWALK PANEL REPAIR AND REINFORCEMENT DETAILS.
- ⑥ (N) GUARDRAILS 4"DIA X 40"H. FILL UP WITH CONCRETE.

- ⑦ (N) 6" THICK CONCRETE SLAB TO FILL EXISTING SIDEWALK AND BETWEEN NEW FRAMED SIDEWALK PANELS.
- ⑧ (N) #4 BARS EMBEDDED IN NEW CONCRETE SIDEWALK SLAB.

- ⑨ (E) SIDEWALK PANEL DIMENSION TO BE CUT ALONG GLASS BLOCK. SEE SHEDULE ON S501 FOR DIMENSIONS.
- ⑩ (E) SIDEWALK PANEL CUTTING LINE
