COPPER QUEEN LIBRARY BISBEE, ARIZONA

BUILDING CONDITION ASSESSMENT

May 20, 2021

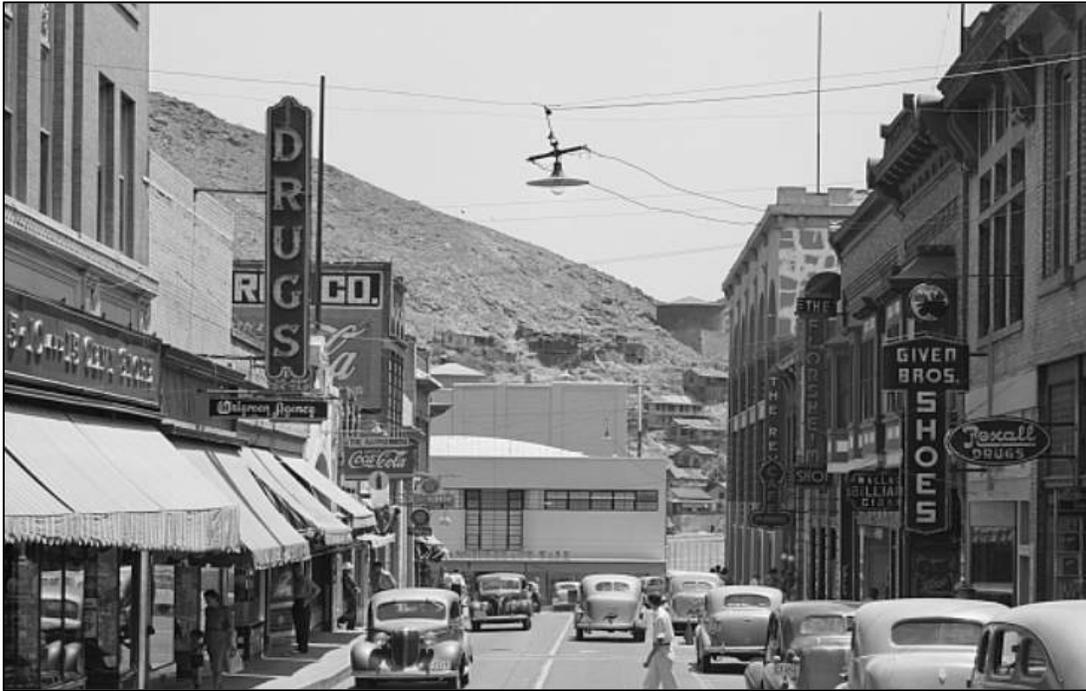
Figure 22. “Wraparound” façade corner visible on right hand side of street. Note cracking in concrete parge coat which likely explains need for later braces. Lee, Russell, photographer. May 1940. Courtesy of Library of Congress.

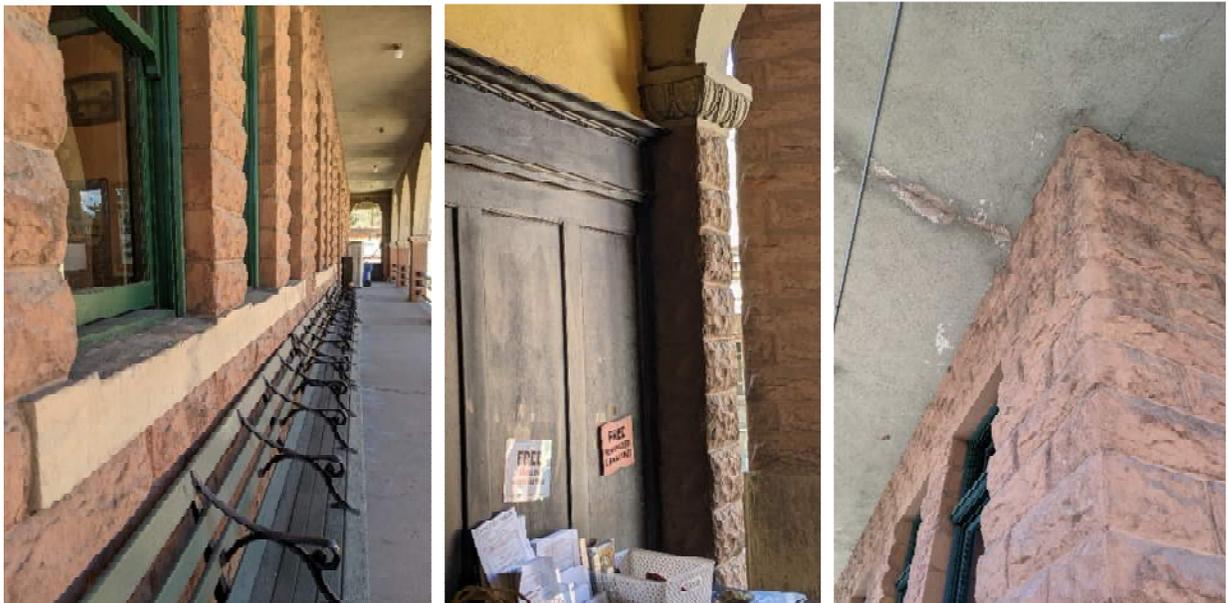
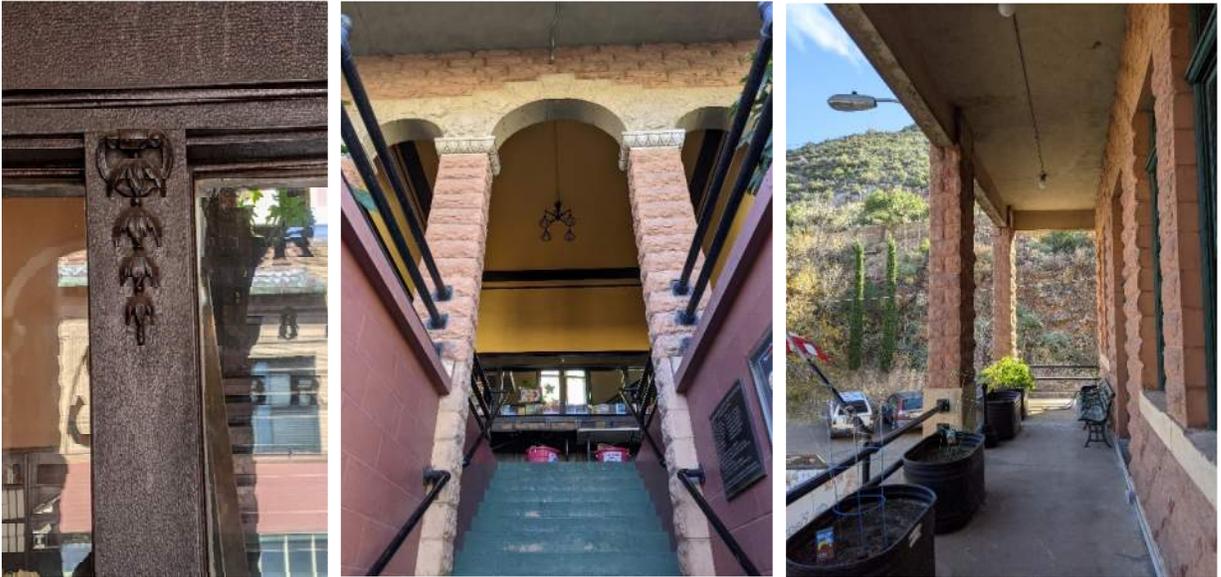
Because three of the four sides of the upper two levels of the Library have been protected by the veranda, the exterior walls of the Library inside the veranda are in generally very good condition, including the wood panel areas.

Protected exterior walls

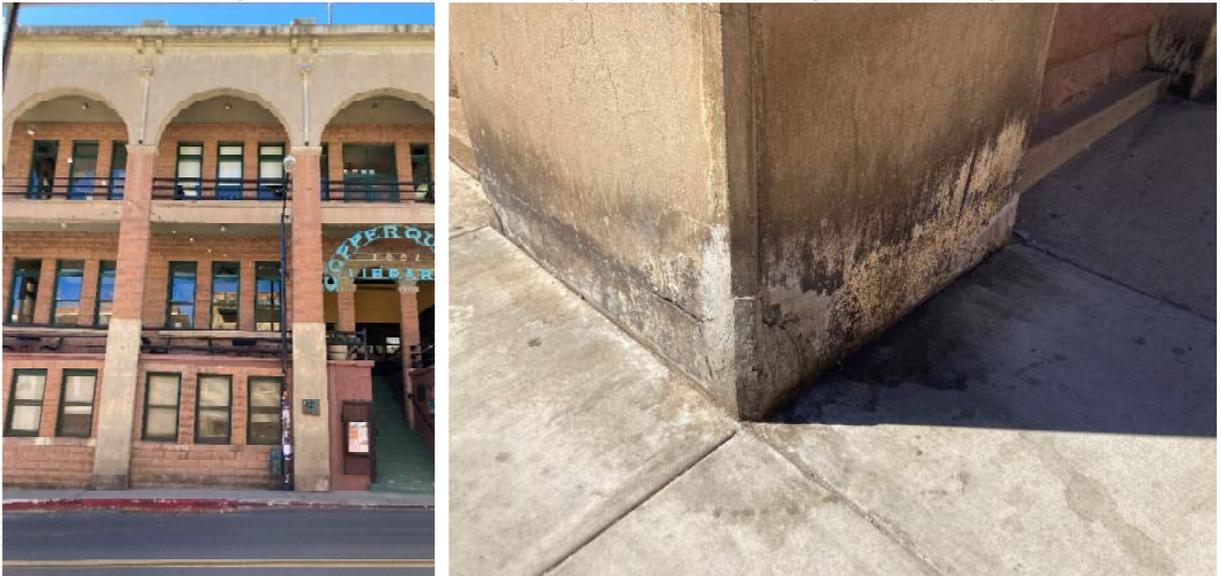
Unprotected exterior walls

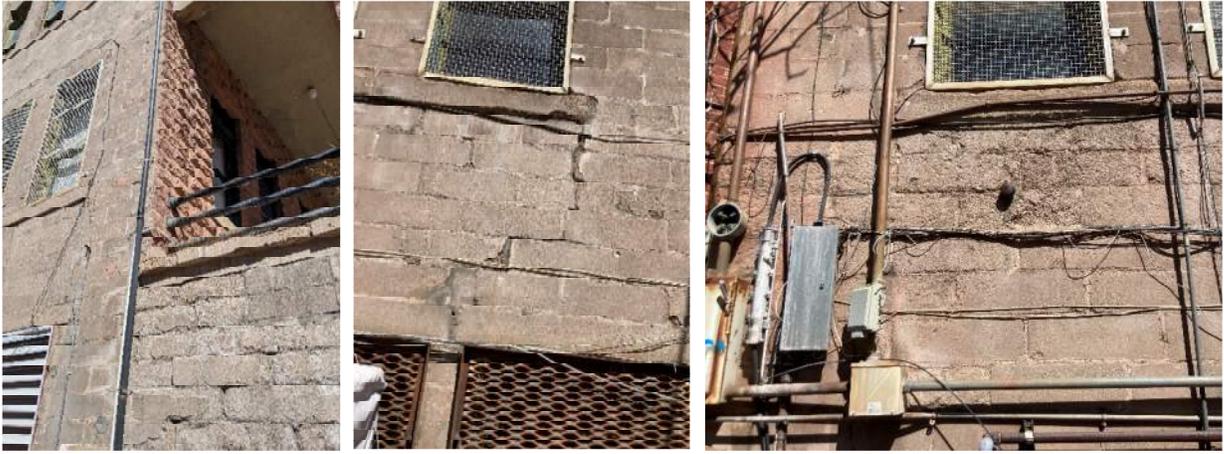
Unprotected and utilitarian south wall in need of more substantial repairs.

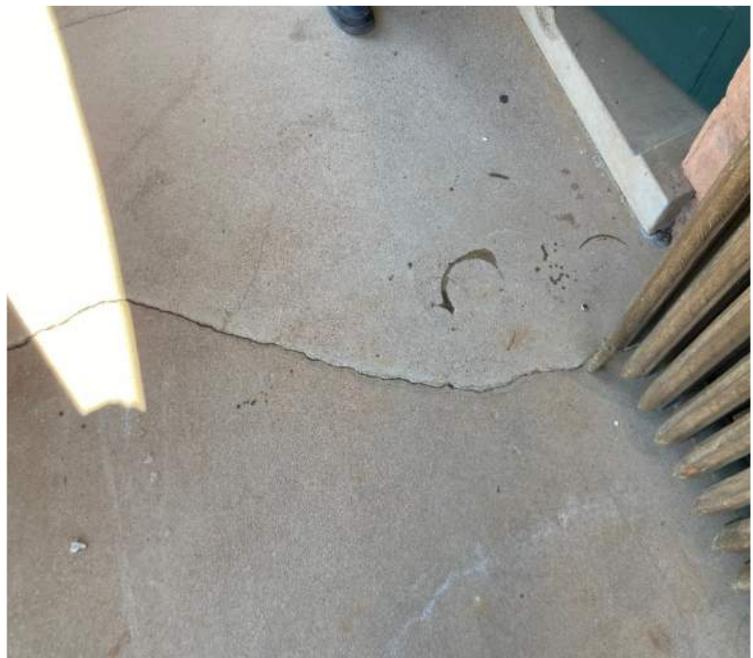
The exterior deck of the veranda has substantial cracking. It is recommended that a new 1/2" cementitious topping with appropriate score spacing be placed on top of the existing veranda surface. This will restore a good quality walking surface outdoors and provide waterproofing to prevent leakage to the ceiling below.

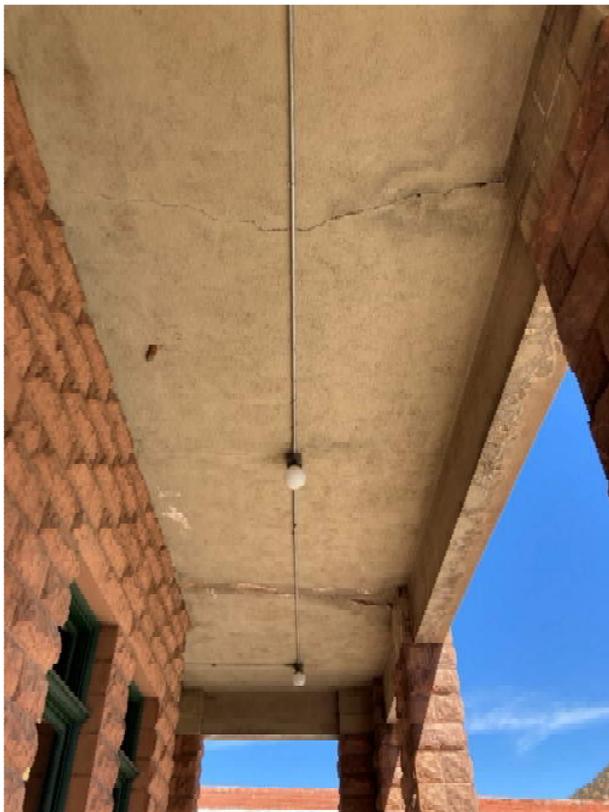
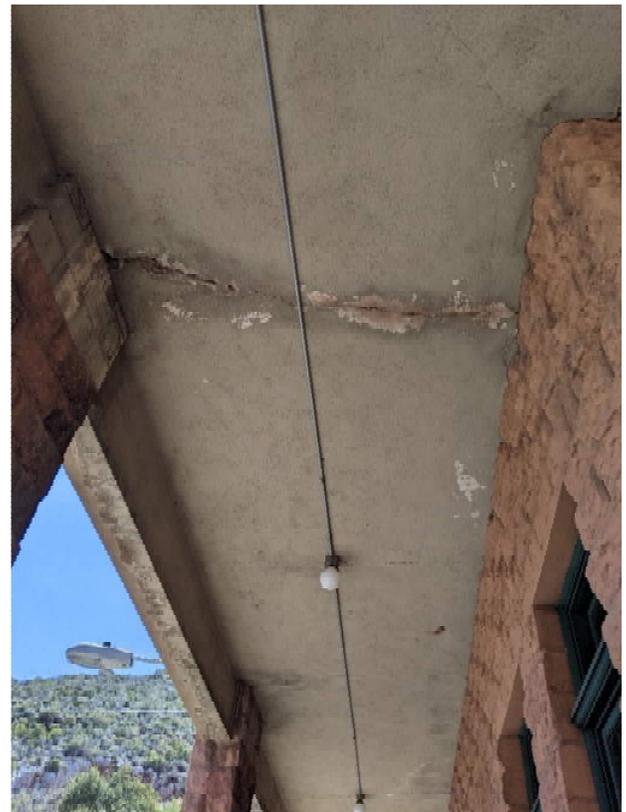
The exterior veranda ceiling is substantially damaged for water infiltration. The leakage from above needs to be repaired. These exterior ceilings should have a new finish coat of cement plaster and then be repainted.

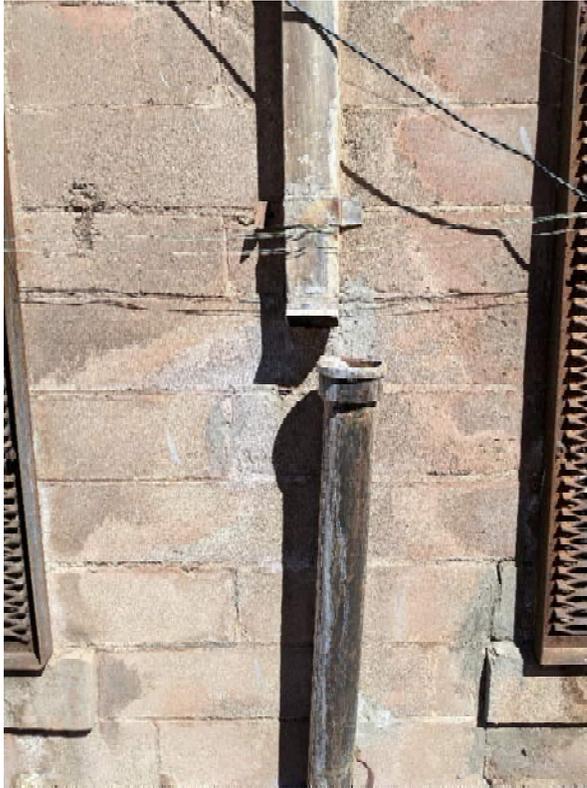
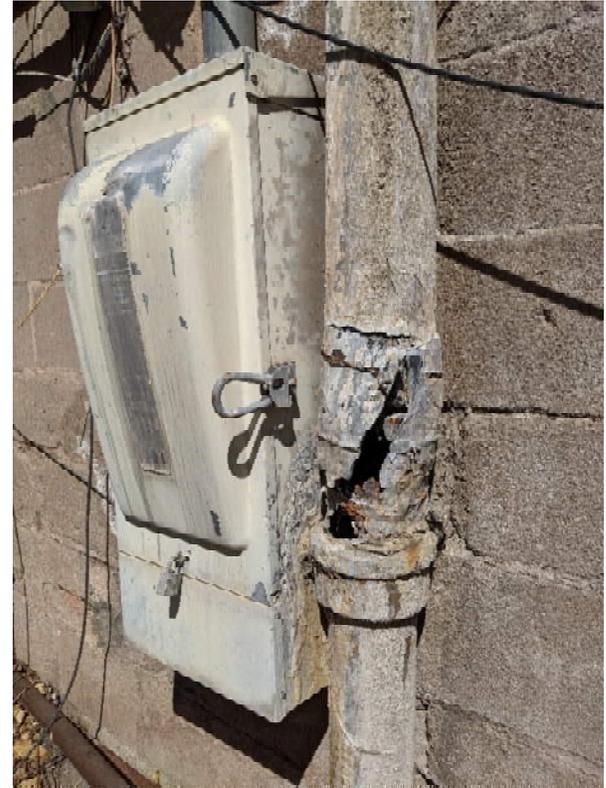
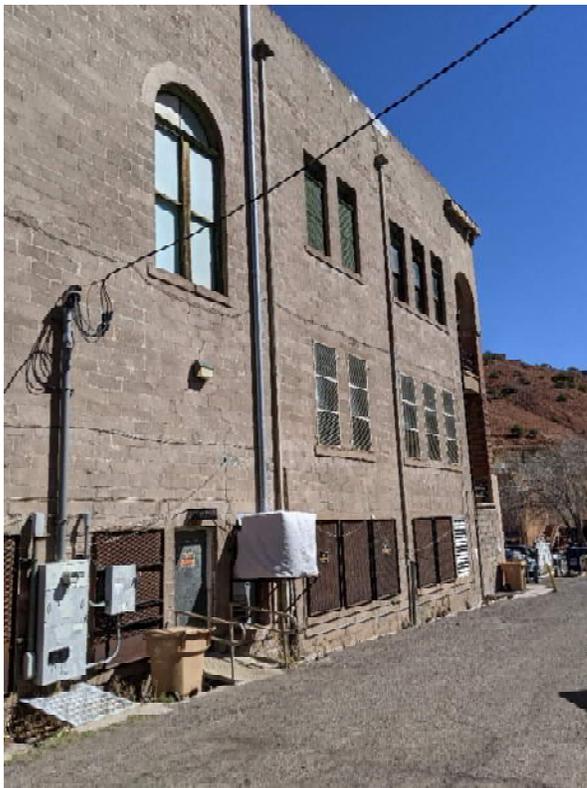
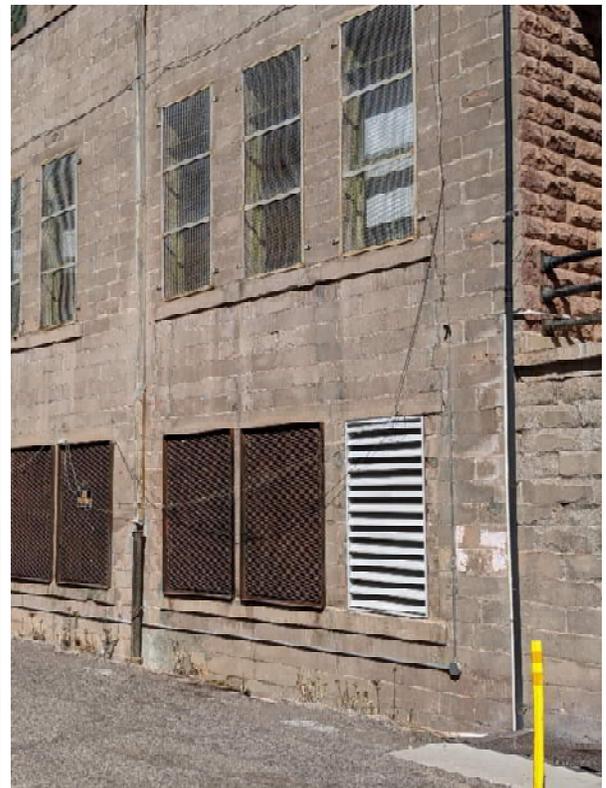
The roofing downspouts are in very poor shape with serious deficiencies in the connections of the roof piping and poor delivery of roof water to the channel running east for drainage. The downspouts need to be replaced with "like-for-like" and the channel that carries the roof water east needs to be clarified and cleaned.

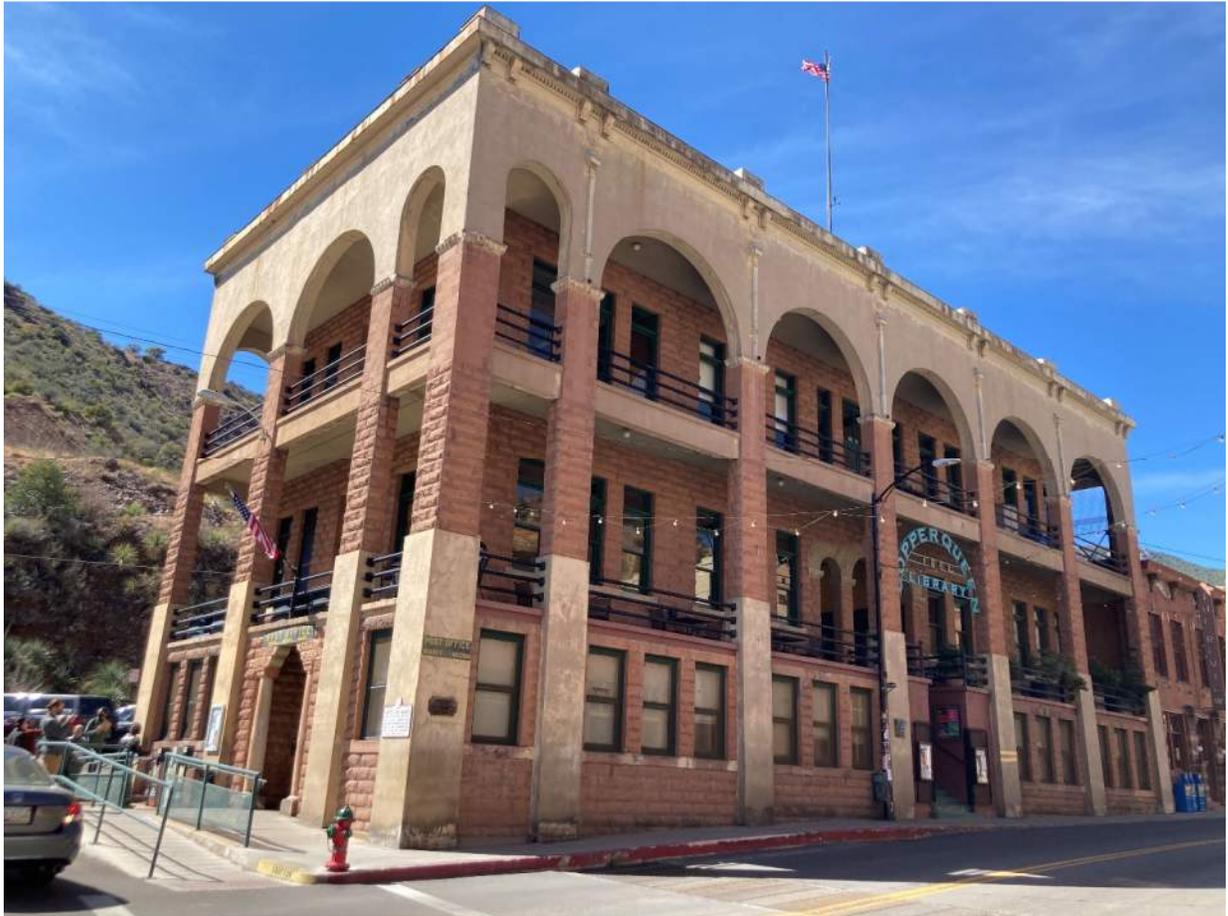
The railing of the veranda is the most significant code issue presenting a significant danger to users. It is recommended that the public not be allowed to access the veranda until this danger is eliminated. The railing has two problems: it is 29" tall compared to the code required 42" tall. In addition, the code requires that a "4 inch ball shall not pass," meaning that no opening in the railing itself should be larger than 4". The current railing meets neither of these requirements for the full length of the veranda.

The solution is complicated by the fact that the pipe rails are a character-defining element of the exterior design of the veranda railing. From an historic preservation perspective, it would be best to maintain the material, scale, proportion, and character of the railing.

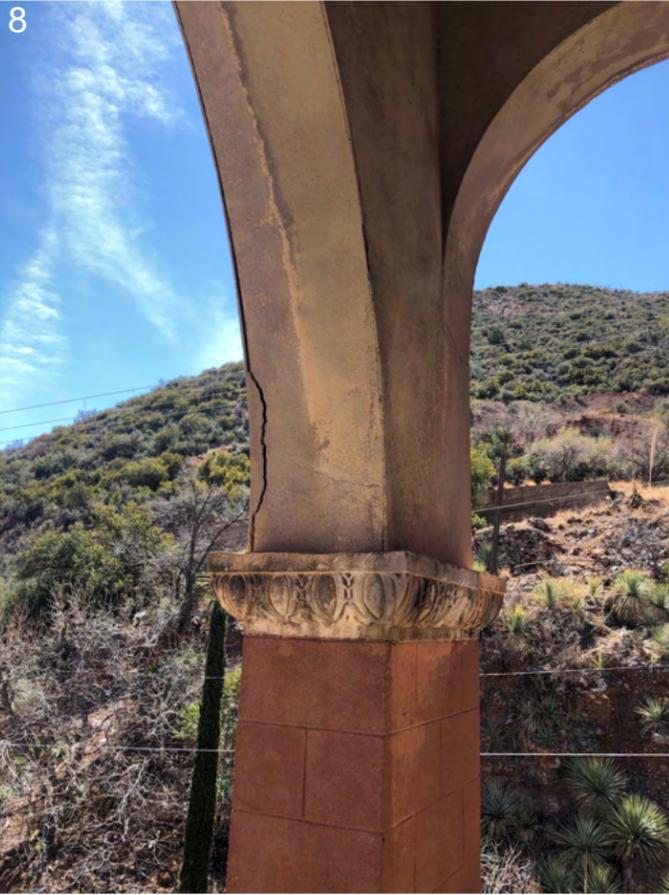
Photo 8 shows cracking in cement parging. See elevation view for location.

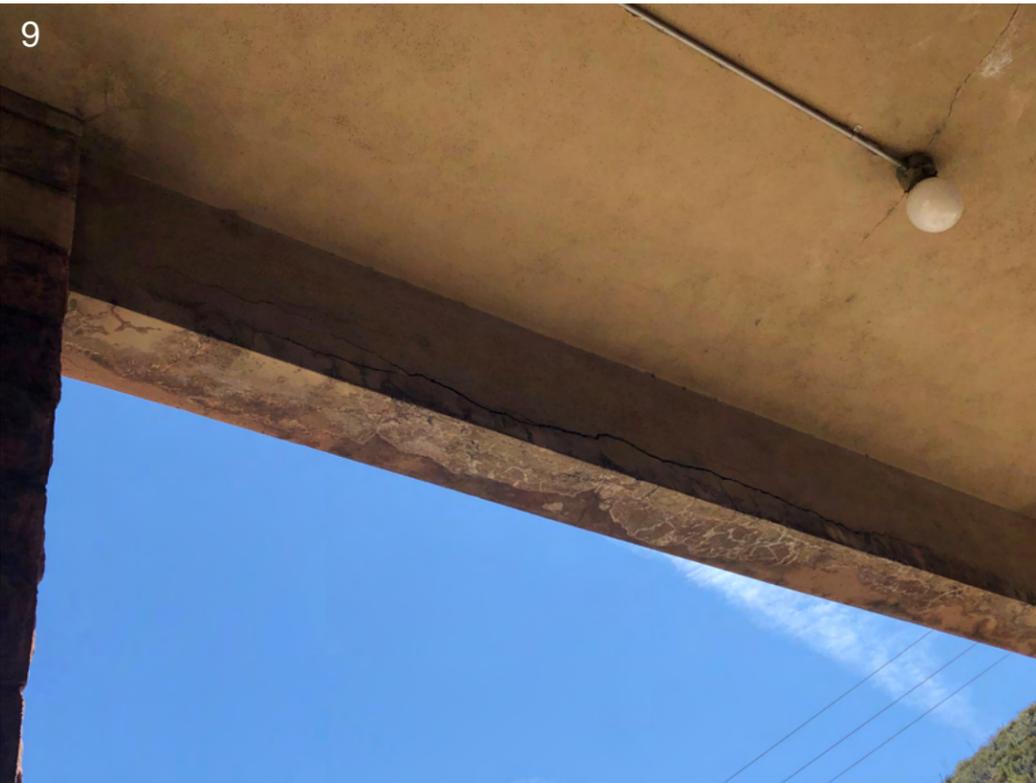
Photo 9 shows cracking in concrete beam supporting level 3 concrete porch deck. See elevation view for location.
