# **COPPER QUEEN LIBRARY BISBEE, ARIZONA**

*BUILDING CONDITION ASSESSMENT*

*May 20, 2021*

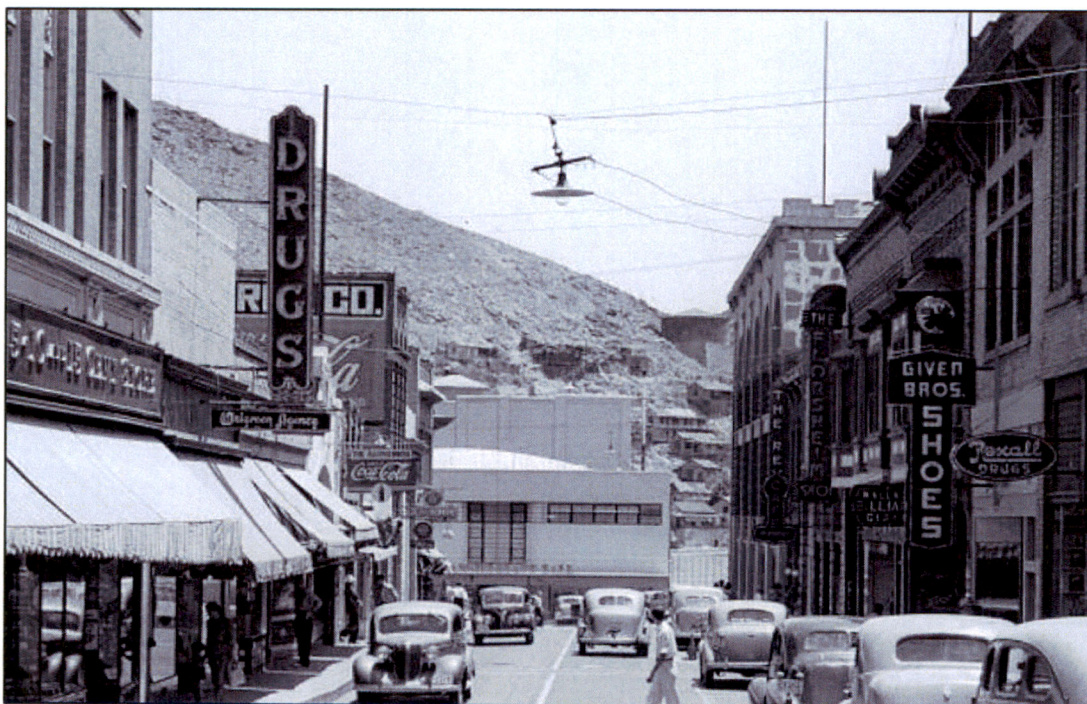
Figure 22. "Wraparound" façade corner visible on right hand side of street. Note cracking in concrete parge coat which likely explains need for later braces. Lee, Russell, photographer. May 1940. Courtesy of Library of Congress.

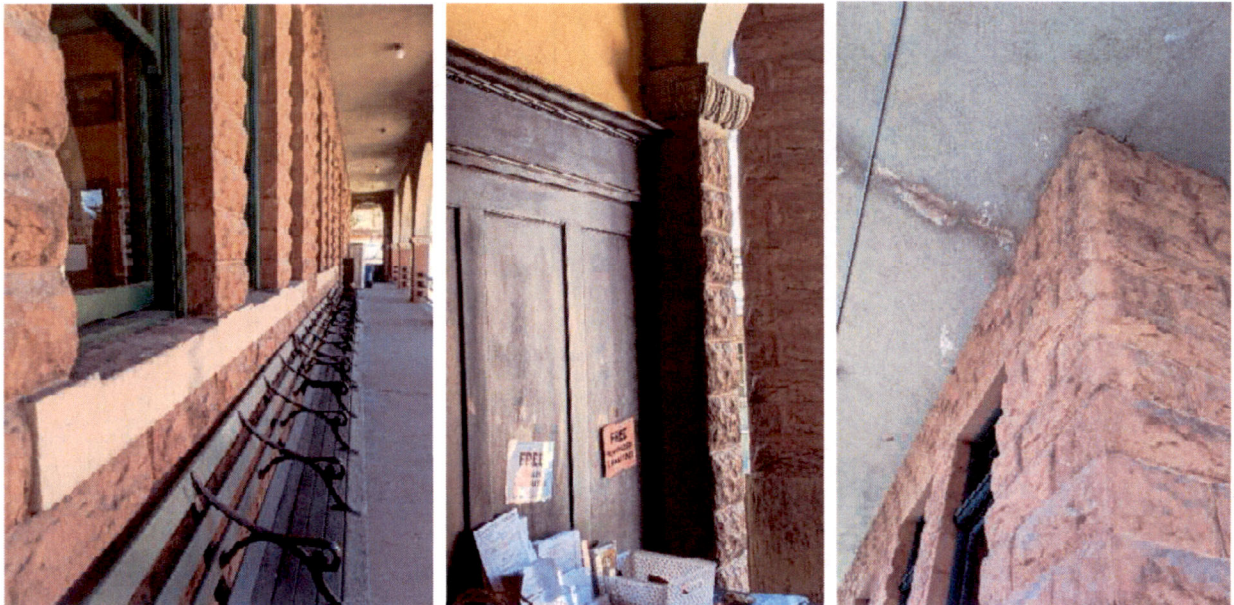
Because three of the four sides of the upper two levels of the Library have been protected by the veranda, the exterior walls of the Library inside the veranda are in generally very good condition, including the wood panel areas.

*Protected exterior walls*

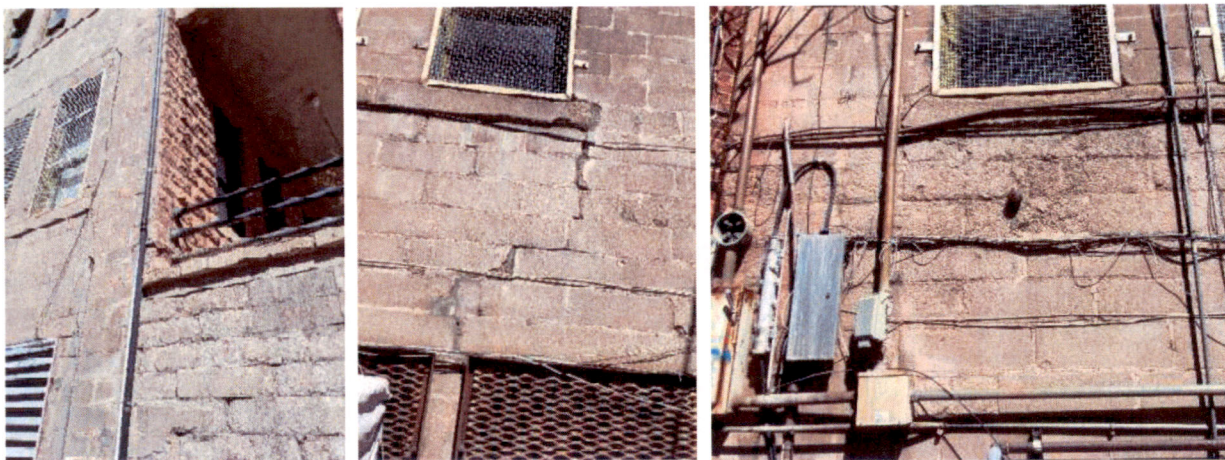
By contrast the portions of the three sides not protected by the veranda has some minor damage, and the south wall facing Commerce, unprotected by the veranda, has significant damage

*Unprotected and utilitarian south wall in need of more substantial repairs.*

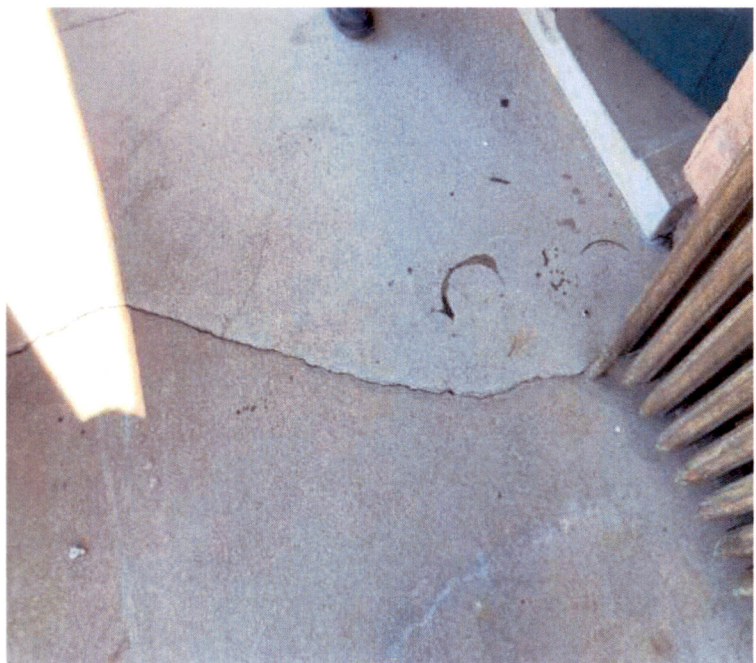
The exterior deck of the veranda has substantial cracking. It is recommended that a new 1/2" cementitious topping with appropriate score spacing be placed on top of the existing veranda surface. This will restore a good quality walking surface outdoors and provide waterproofing to prevent leakage to the ceiling below.

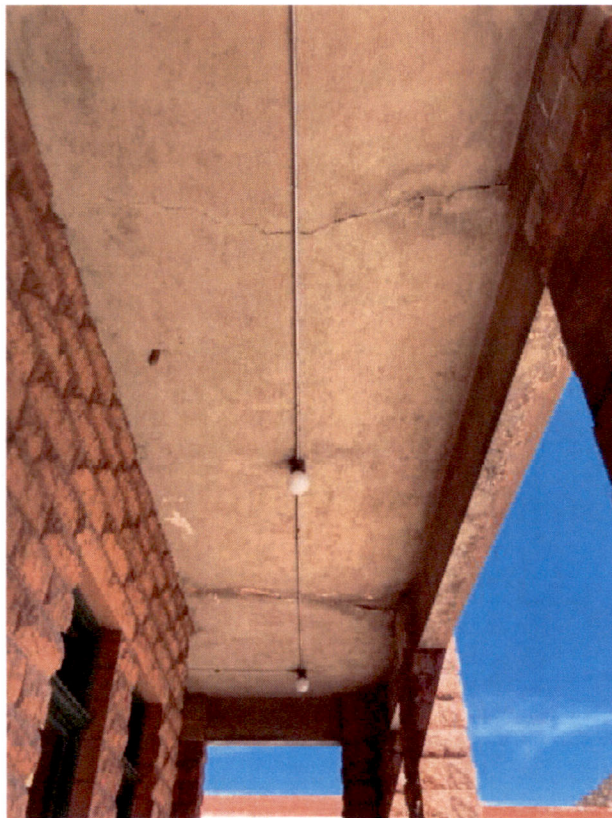
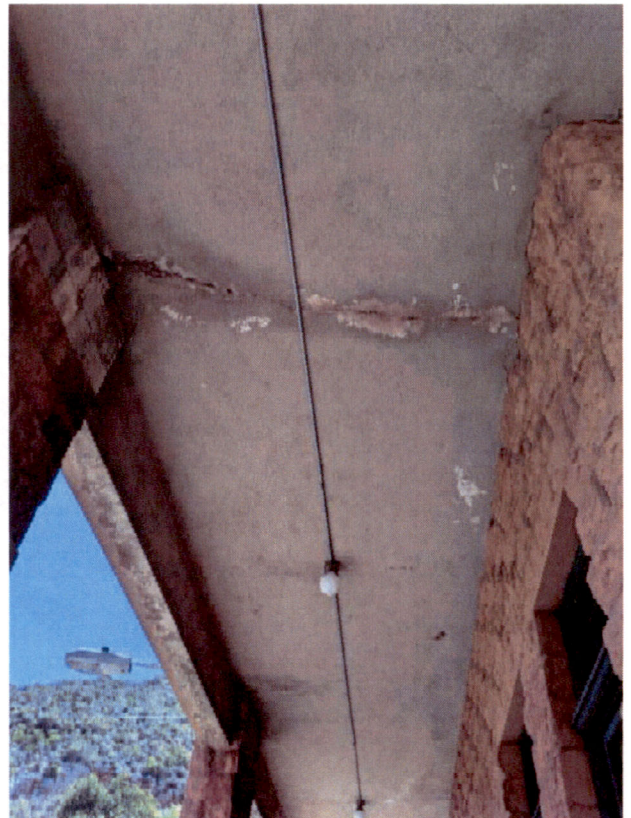
The exterior veranda ceiling is substantially damaged for water infiltration. The leakage from above needs to be repaired. These exterior ceilings should have a new finish coat of cement plaster and then be repainted.

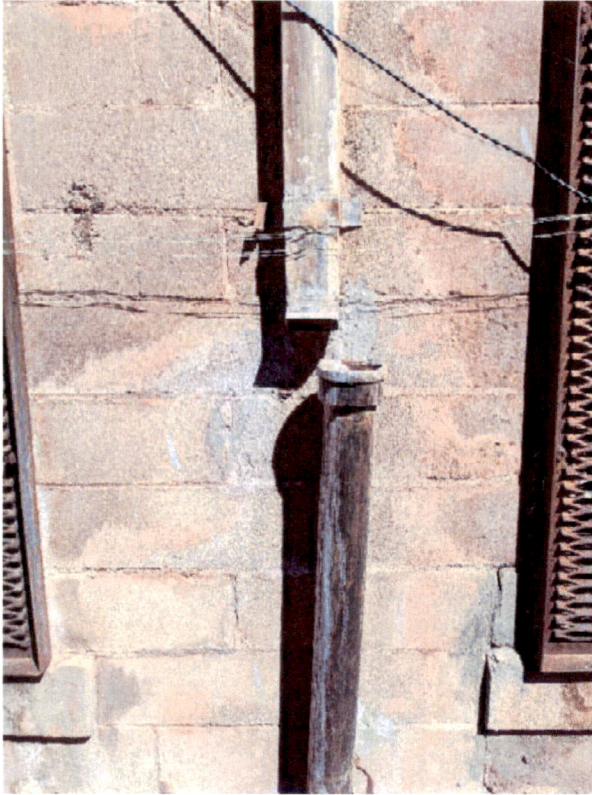
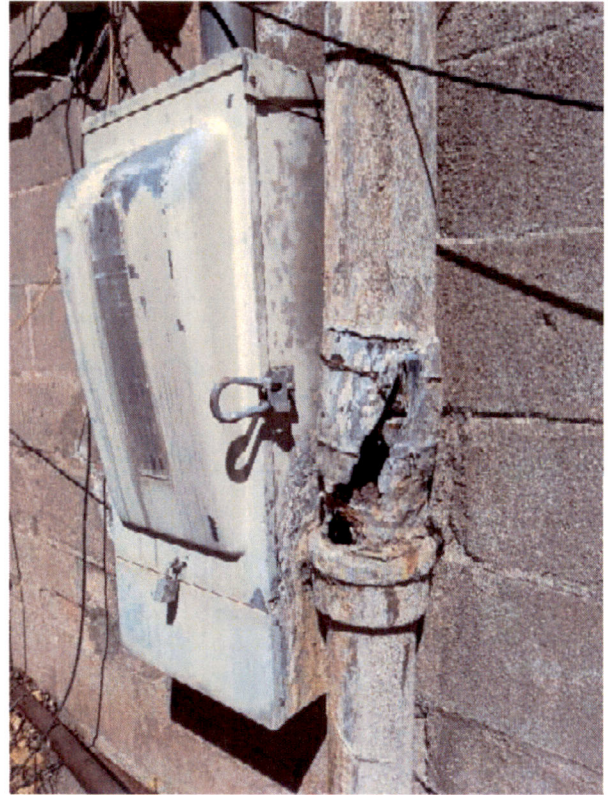
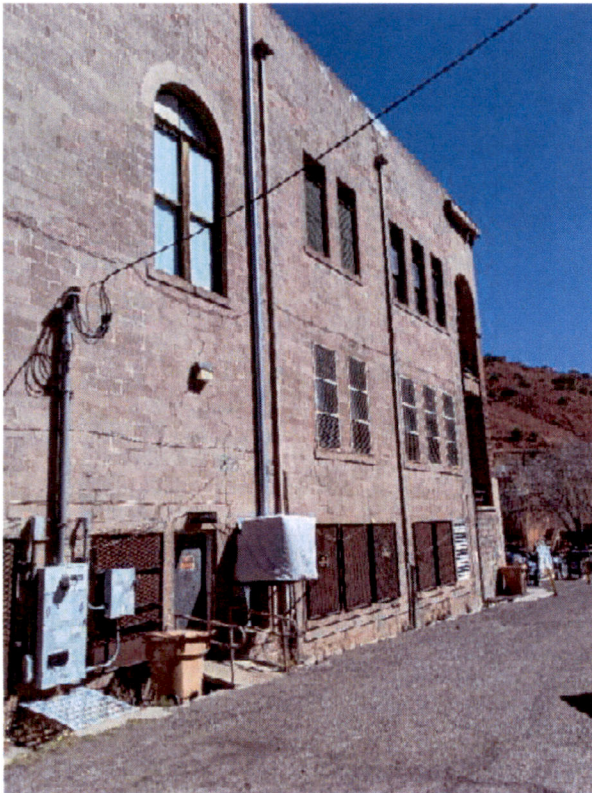
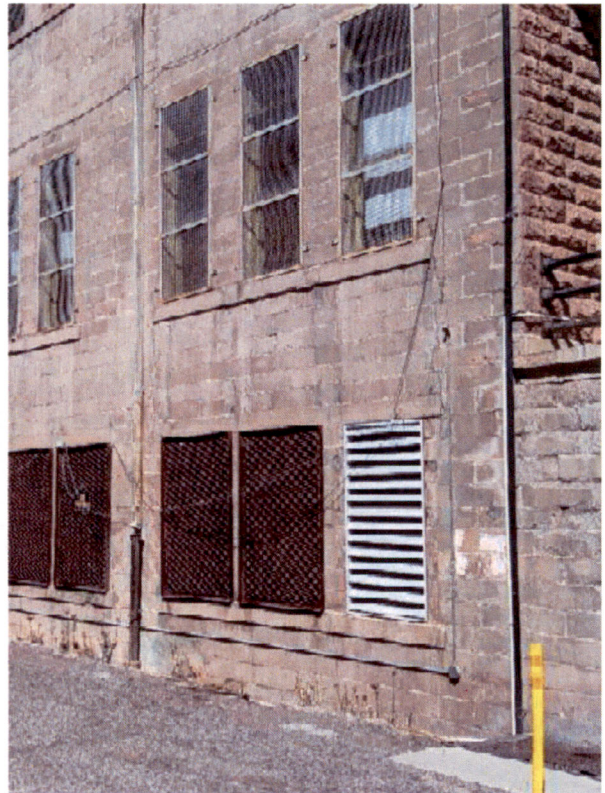
The roofing downspouts are in very poor shape with serious deficiencies in the connections of the roof piping and poor delivery of roof water to the channel running east for drainage. The downspouts need to be replaced with "like-for-like" and the channel that carries the roof water east needs to be clarified and cleaned.

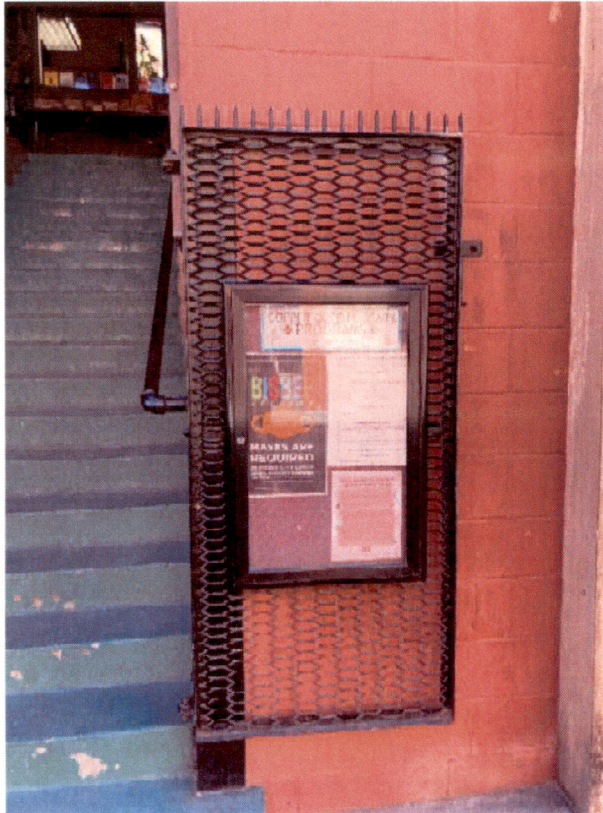
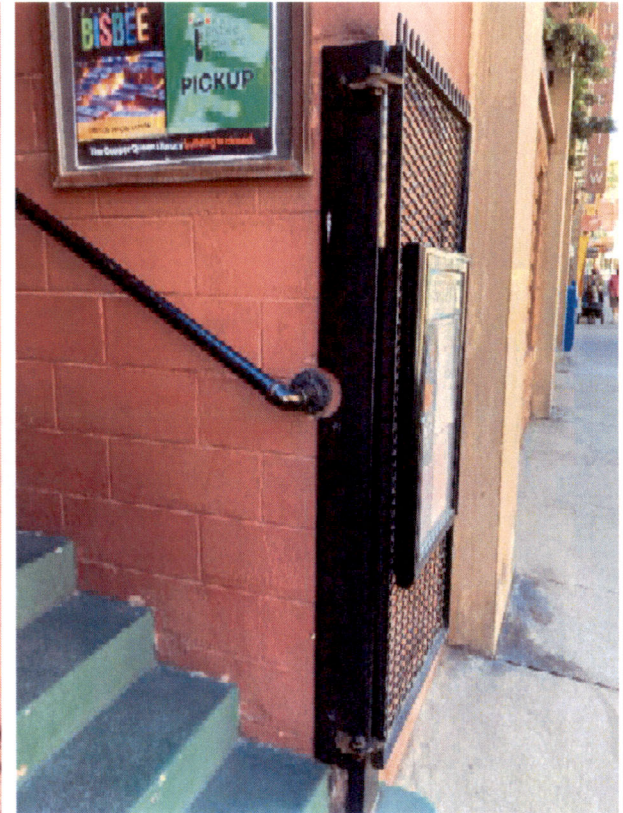
There is a required run-off (extension of the railing past the staircase) that does not meet code, but that would put the railing into the public right-of-way as a dangerous obstruction. This conflict will require a discussion with the building official.

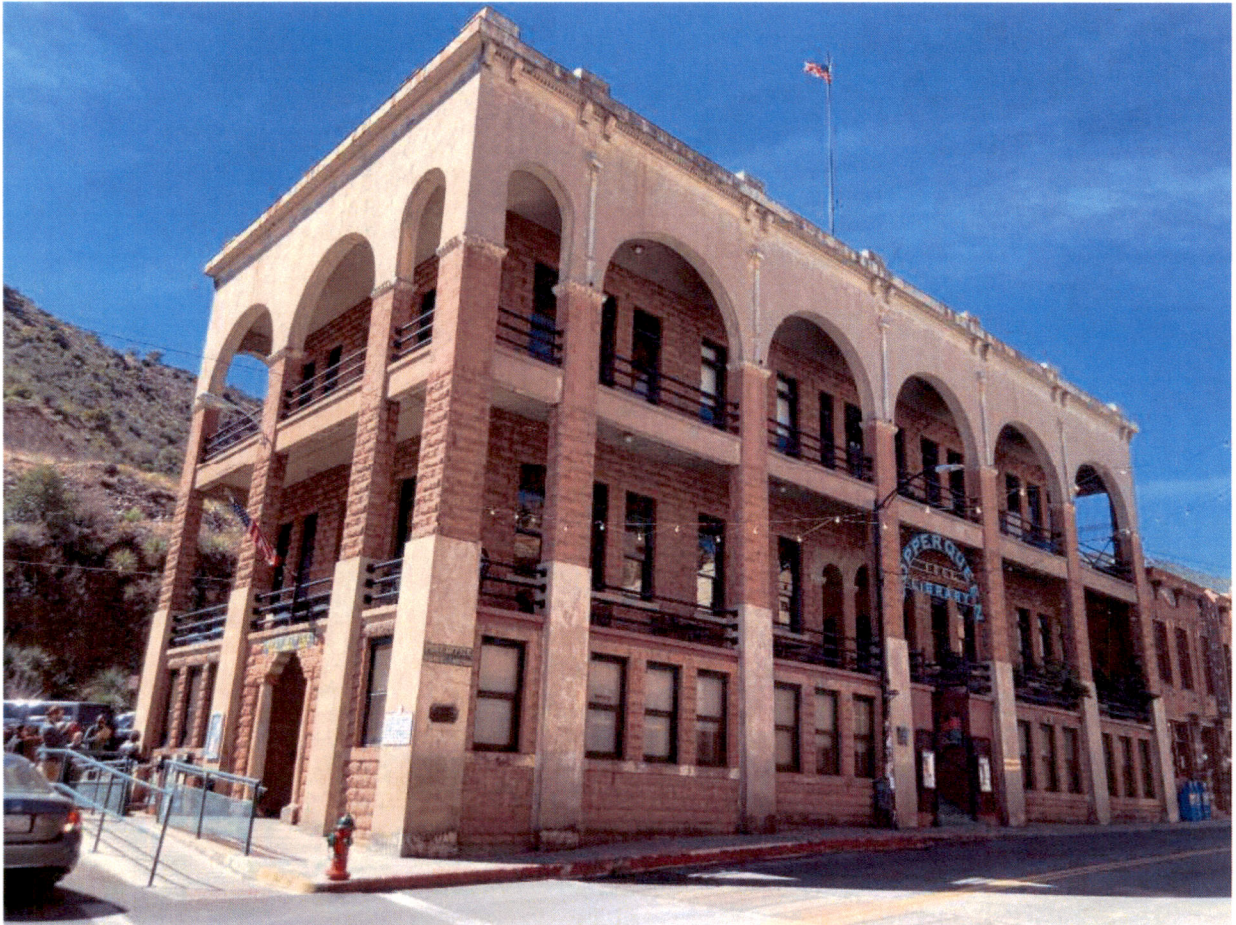
The railing of the veranda is the most significant code issue presenting a significant danger to users. It is recommended that the public not be allowed to access the veranda until this danger is eliminated. danger to users. The railing has two problems: it is 29" tall compared to the code required 42" tall. In addition, the code requires that a "4 inch ball shall not pass," meaning that no opening in the railing itself should be larger than 4". The current railing meets neither of these requirements for the full length of the veranda.

The solution is complicated by the fact that the pipe rails are a character-defining element of the exterior design of the veranda railing. From an historic preservation perspective, it would be best to maintain the material, scale, proportion, and character of the railing.

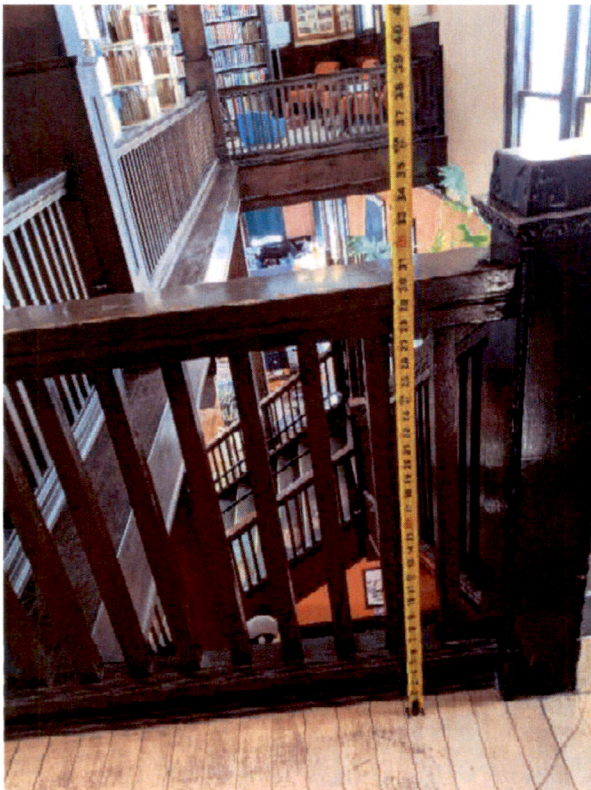
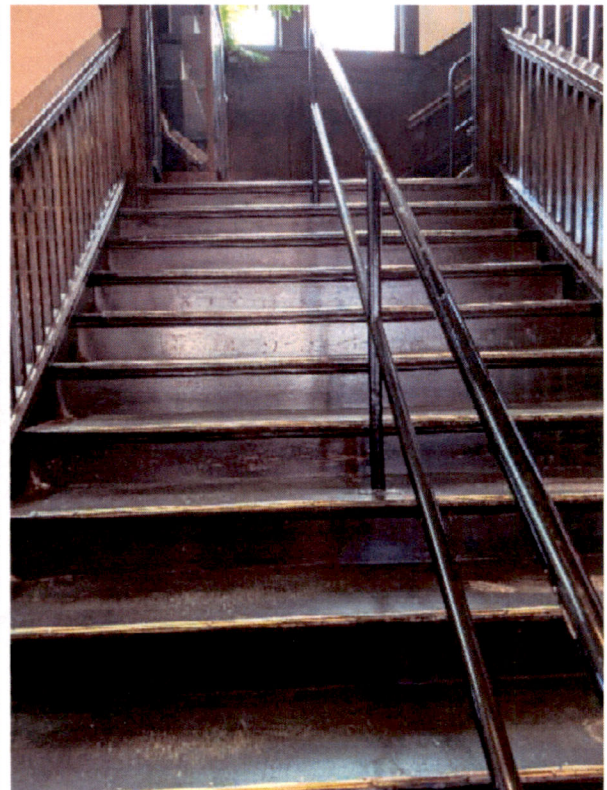
- The stair railing is also a significant code violation and presents a danger, particularly on the 3<sup>rd</sup> floor. The railing is 29" tall in most locations. The code requires a much higher railing at 42". On the upper half of the stair where the wainscoting sits behind the handrail, the handrail can simply be raised to the appropriate height using the existing hardware. At the other three location where there is a low slat rail, a simple pipe rail (similar to the center rail) can be added. This needs to be studied, by our initial recommendation is to "L"-shape a bracket and attach it to the side, not the top of the square top rail, at the appropriate height. The height of the center pipe rail may need to be raised as well. At the 3<sup>rd</sup> floor, a similar pipe rail needs to be added all around the stair opening. That top rail also needs to comply with the 4" ball shall not pass, although there may be some code leniency in this regard.

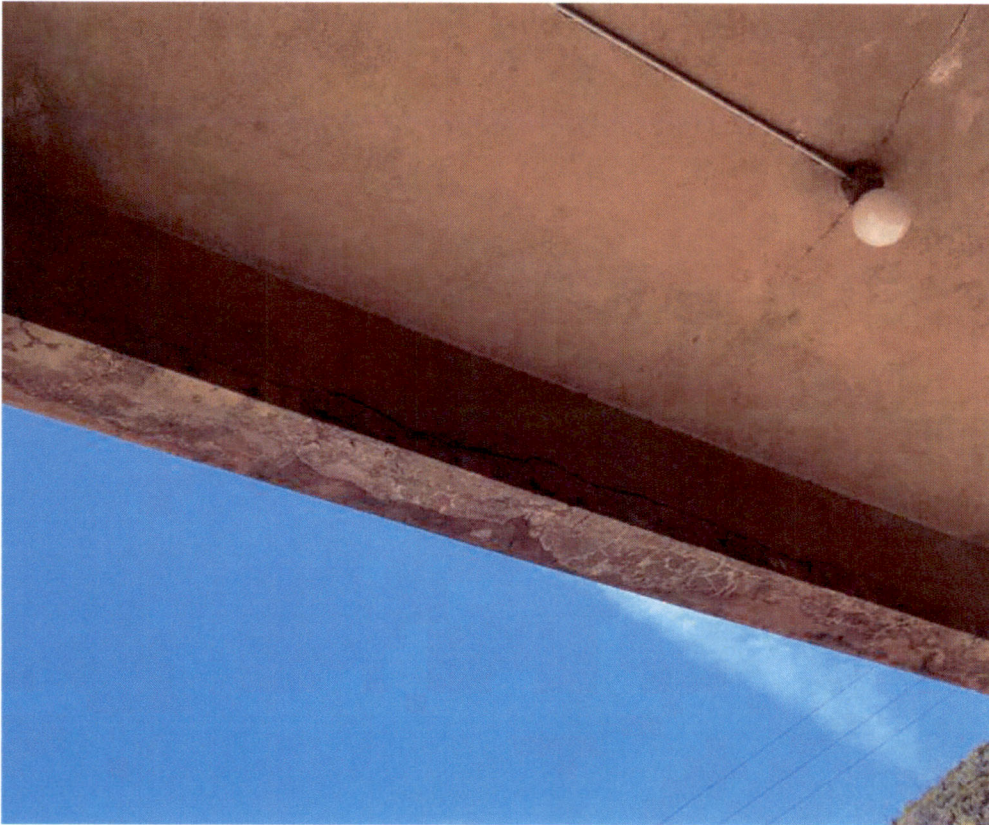
Photo 9 shows cracking in concrete beam s  
concrete porch deck. See elevation view for
