City of Bisbee Comprehensive Transportation Plan

Task Assignment
MPD 34-10

Final Report

February 20, 2012

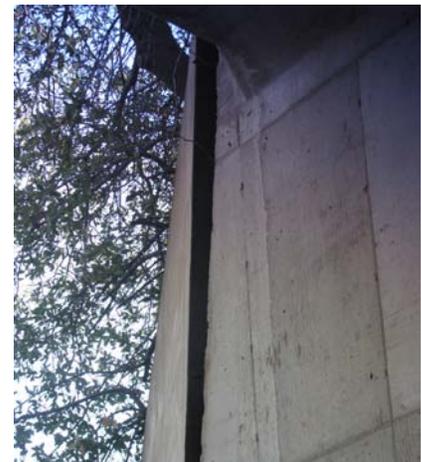
Spring Canyon Structure

The condition of the Spring Canyon Bridge (Structure # 10540) under SR 80 is being monitored by the ADOT District Engineer's office. The wing walls of this structure are separated from the headwall (see photo to right). At present, the district has not yet identified a priority need for a structure rehabilitation project.

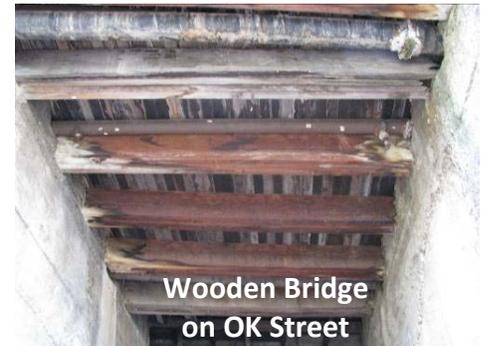
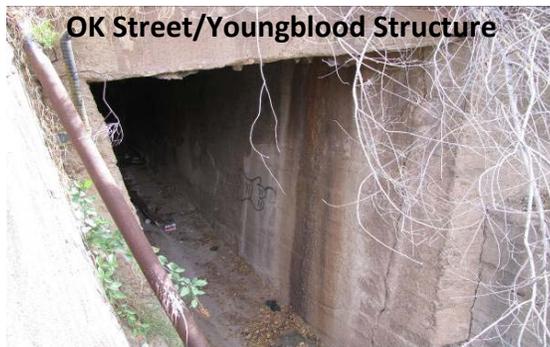
Three structures were found in Old Bisbee that are not in the regular rotation for inspection. Two of these structures are on OK Street. One of these structures (labeled A on Figure 20) is found near Brewery Gulch and consists of timber decking with built up timber beams. Based on visual observation, the beams are either 4 – 2x8 beams or 4 – 2x10 beams spaced approximately 5’ on center (C/C). The decking is in poor condition and shows strong evidence of failure. The roadway surface is asphalt.

Per Bisbee officials, during recent rehabilitation work on homes uphill of the structure, a temporary structure was placed over the limits of the wooden bridge so that the trucks would not overstress the structure. This structure is in need of immediate replacement in order to bring it up to standards and allow continued use of OK Street.

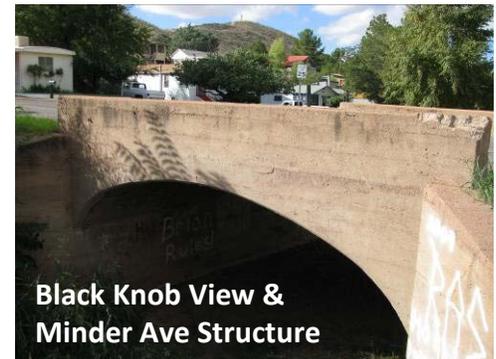
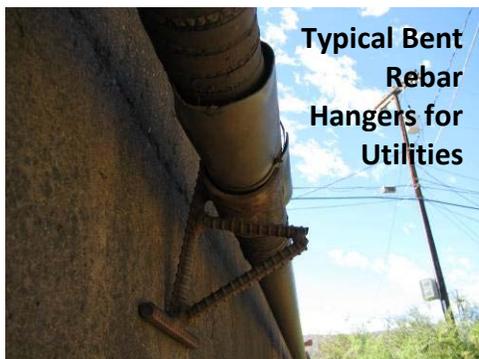
The second structure (labeled B on Figure 20) is located at the intersection of OK Street and Youngblood. This structure is a concrete slab bridge over a drainageway. The structure is in fair condition. The underside of the structure shows signs of efflorescence and overall aging since the structure is approximately 80 to 90 years old. There is a large vertical crack in the downhill side of the abutment wall. The crack shows no sign of recent movement and looks to be stable. There are some signs of deterioration due to water intrusion and vegetation growth on the canal walls. Overall, the structure needs little rehabilitation work and should be added to the biennial inspection list along with the other structures located within the City of Bisbee.

The third structure (labeled C on Figure 20) is on Minder Avenue just north of Black Knob View. This structure is a concrete arch and is in fair condition. The railing on the structure needs repair or replacement due to a vehicle collision. There is some minor cracking and efflorescence due to the structure being about 64 years old.

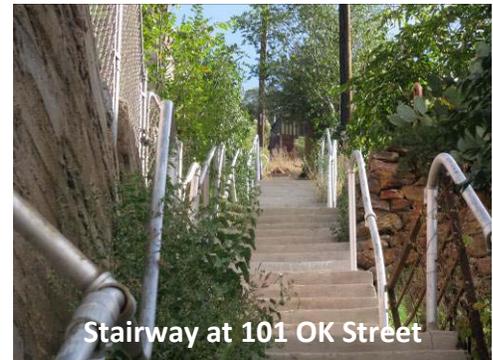
The stairways themselves are generally in fair condition. Some of the stairways occasionally have water running down the middle of the stairways that is contributing to their overall degradation. Most of the stairs currently do not meet current code for both height and depth of the treads. Some of the stairways have been recently rehabilitated by either the property owners or the City of Bisbee. Most of the repairs that have been recently completed are in good condition and should extend the life of the stairway for another 10 to 15 years without major rehabilitation work from the City. A few stairways are in need of immediate rehabilitation due to erosion of the subbase of the stairway.

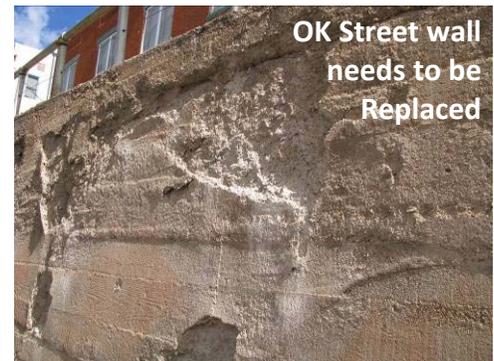
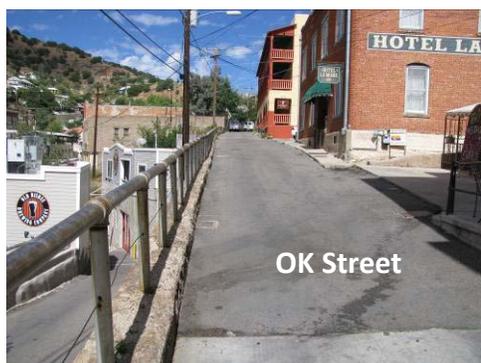
The wall located on OK Street at Review Avenue is a classic example of a wall at the end of its useful life. The wall crumbles when touched and the above supported roadway is showing stress cracks due to movement of the wall away from the roadway. The wall needs to be replaced as soon as possible due to its state of disrepair and its potential impact on the use of OK Street and access to property owners.
