City of Bisbee Comprehensive Transportation Plan

Task Assignment
MPD 34-10

Final Report

February 20, 2012

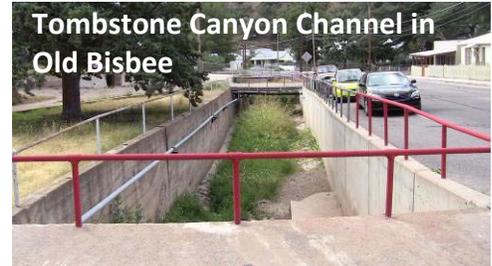
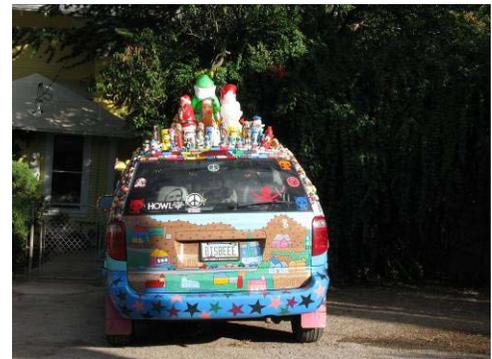
- Many of the streets in Warren and Old Bisbee have poor and rough road surface conditions and need either an overlay or, in many cases, complete reconstruction.

- Some of the public staircases and retaining walls have no handrails and safety rails, or the rails are in poor condition.

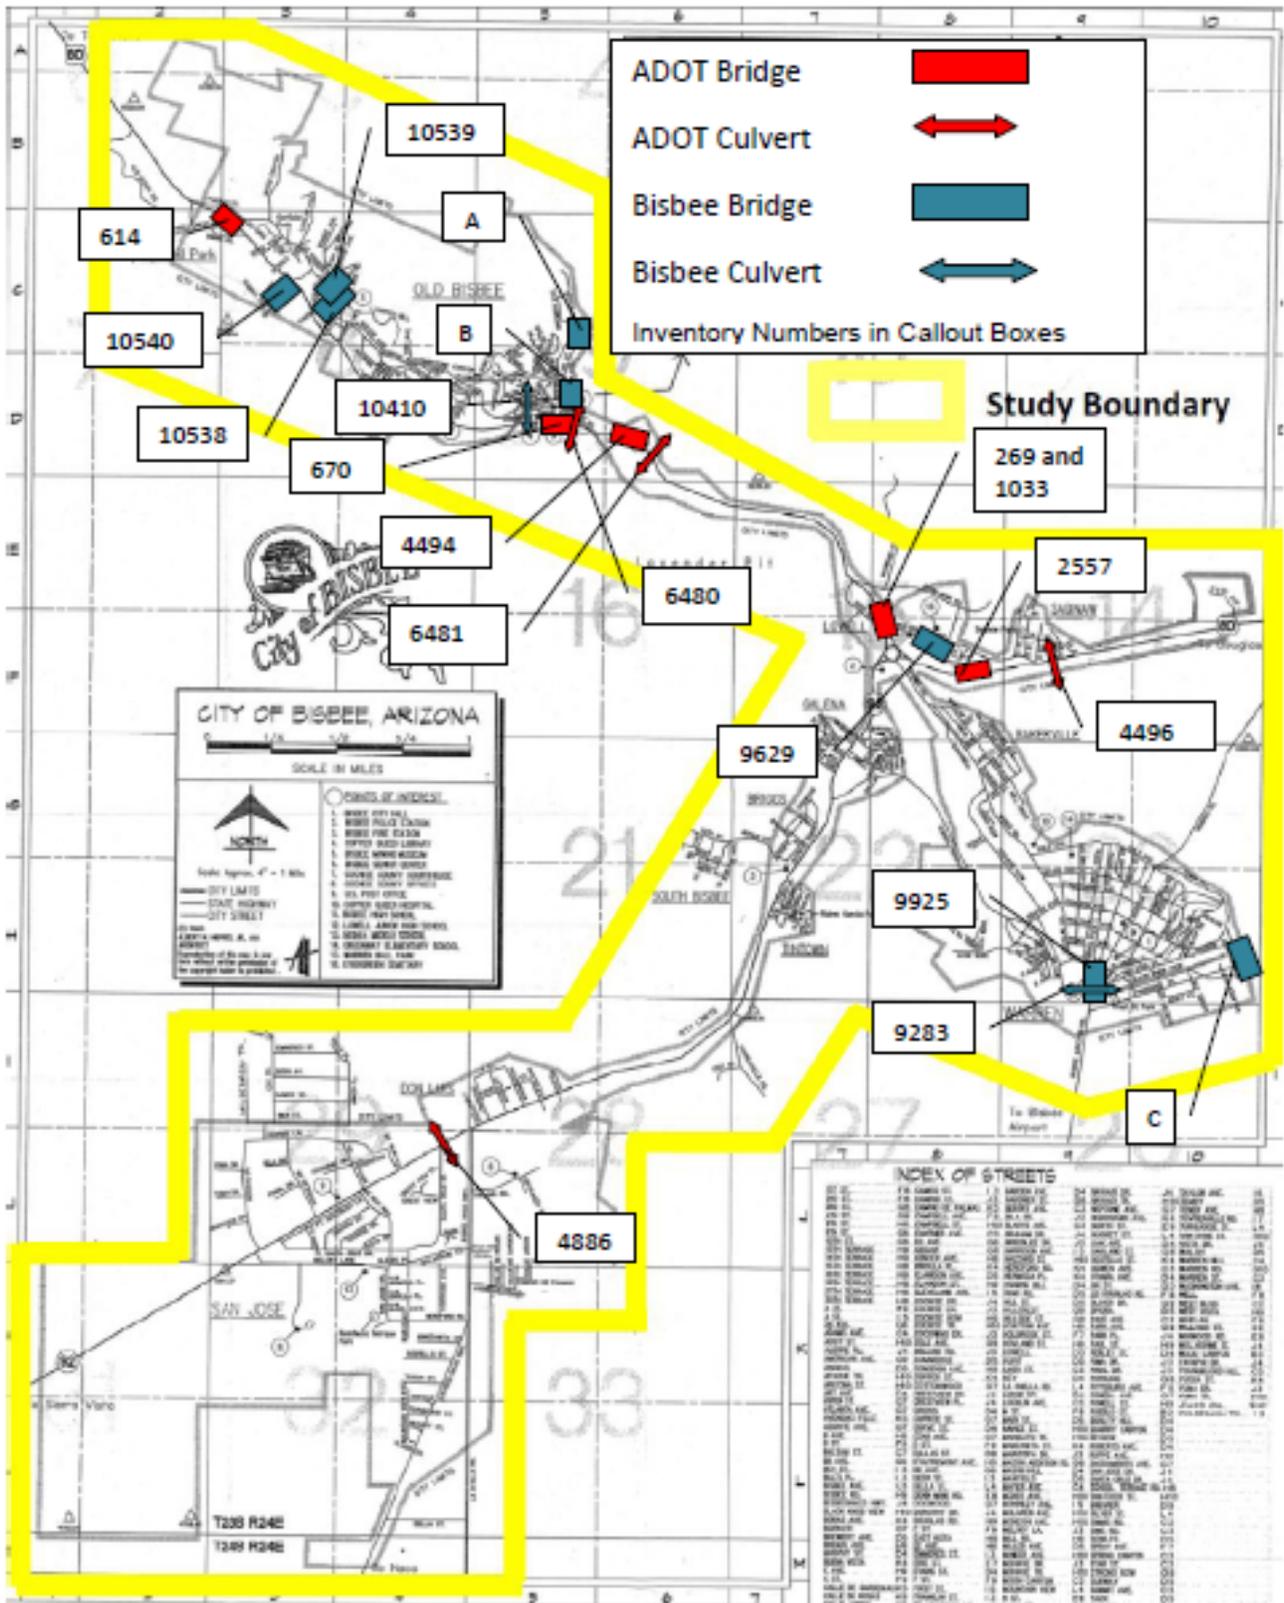
Figure 20 Bridge and Culvert Structure Locations

Three structures were found in Old Bisbee that are not in the regular rotation for inspection. Two of these structures are on OK Street. One of these structures (labeled A on Figure 20) is found near Brewery Gulch and consists of timber decking with built up timber beams. Based on visual observation, the beams are either 4 – 2x8 beams or 4 – 2x10 beams spaced approximately 5’ on center (C/C). The decking is in poor condition and shows strong evidence of failure. The roadway surface is asphalt.

The second structure (labeled B on Figure 20) is located at the intersection of OK Street and Youngblood. This structure is a concrete slab bridge over a drainageway. The structure is in fair condition. The underside of the structure shows signs of efflorescence and overall aging since the structure is approximately 80 to 90 years old. There is a large vertical crack in the downhill side of the abutment wall. The crack shows no sign of recent movement and looks to be stable. There are some signs of deterioration due to water intrusion and vegetation growth on the canal walls. Overall, the structure needs little rehabilitation work and should be added to the biennial inspection list along with the other structures located within the City of Bisbee.

The third structure (labeled C on Figure 20) is on Minder Avenue just north of Black Knob View. This structure is a concrete arch and is in fair condition. The railing on the structure needs repair or replacement due to a vehicle collision. There is some minor cracking and efflorescence due to the structure being about 64 years old.

Per Bisbee officials, during recent rehabilitation work on homes uphill of the structure, a temporary structure was placed over the limits of the wooden bridge so that the trucks would not overstress the structure. This structure is in need of immediate replacement in order to bring it up to standards and allow continued use of OK Street.

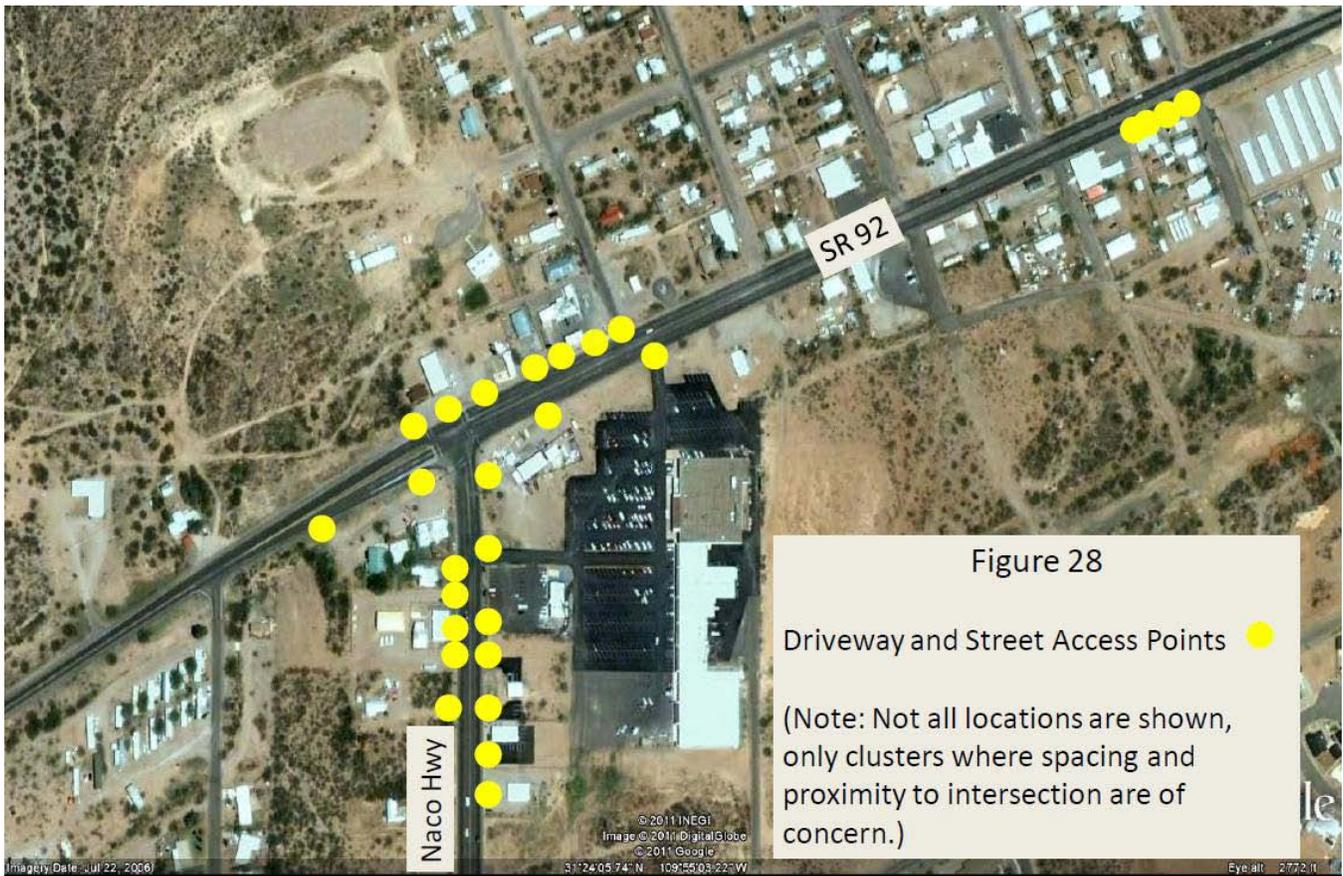
Figure 28 SR 92 and Naco Highway Access Points

- SR 92 has an excessive number of driveway access points in the vicinity of the Naco Highway intersection. Twelve of these are within 700 feet of the intersection and seven are within 100 feet, including one at the direct north side of this “T” intersection.

- At the southwest corner of Taylor Lane and SR 92, there are four driveway openings in a space of less than 100 feet.
- A connection to the Safeway Center from Collins Road to the south would help alleviate conflicts at the entrance on SR 92.

- The lack of turn lanes on SR 92 exacerbates this high number of conflict points. There appears to be adequate physical space (although additional right of way may be required) to add a center turn lane or a four lane cross section with a median and turn lanes in the segment from Melody Lane to School Terrace Road.

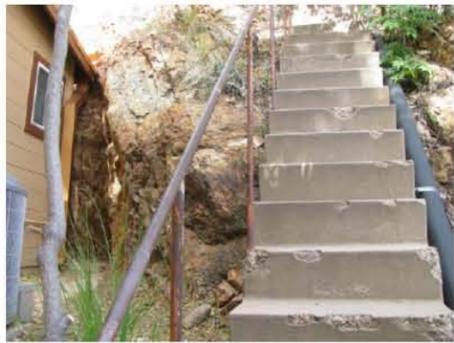
<p>461</p>

Tombstone	129	131		Stairway	Concrete	Handrail is in poor condition	Narrow steps but the steps and treads are in fair condition. (See Pics. 461-463)			X			No immediate need of rehabilitation work. Handrail may need to be brought up to code.
