COPPER QUEEN LIBRARY BISBEE, ARIZONA

BUILDING CONDITION ASSESSMENT

May 20, 2021

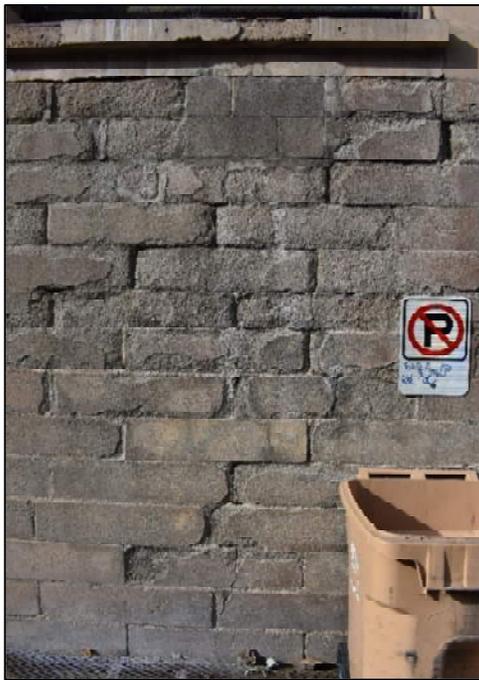
Figure 4. Damaged/undamaged gray smooth-faced blocks at ground story of south elevation. March 2021.

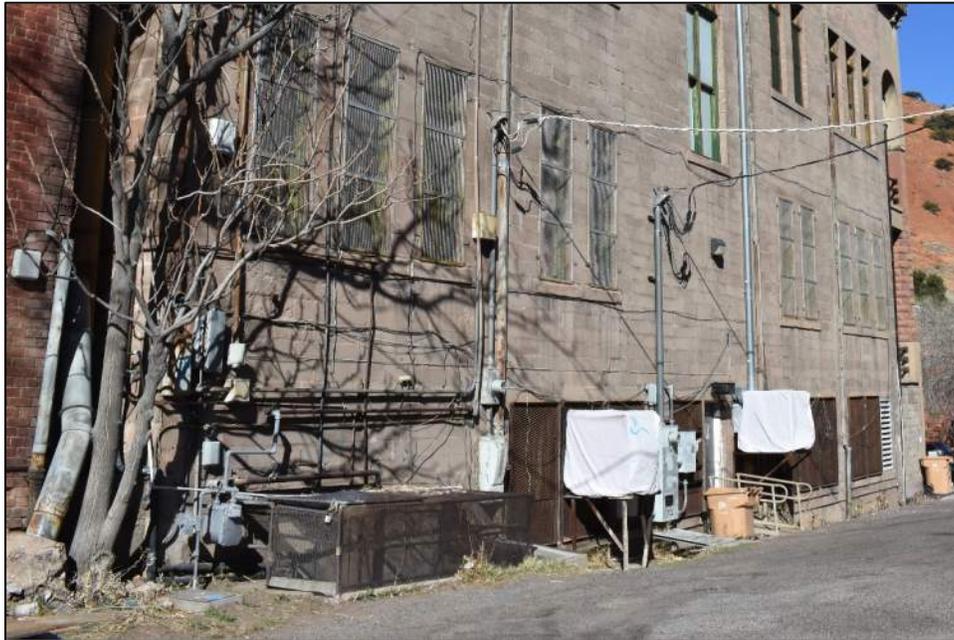
Figure 26. Base of south elevation along Commerce Street. March 2021.

Along the surface of the elevation, are three downspouts which are placed after the first, third, and fourth bays from the east. These run from scuppers located beneath the parapet to drain into the gutter but are heavily degraded and not fully functional. Additional surface components include electrical masts and boxes, various wires, and other forms of utility conduit.

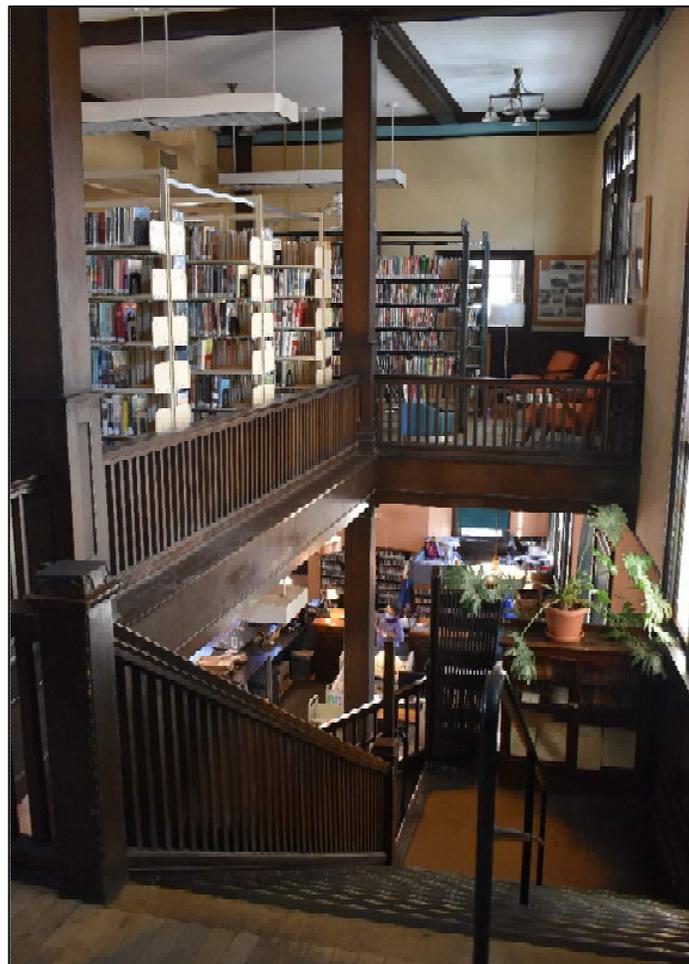
Figure 46. View of main stairway looking down from third story. The L-shaped circulation pattern of this stairway including its banister, woodwork, and lower gate should be preserved. Later elements including the metal hand rail or particle board flooring are not character-defining and may be removed or altered. Note that although these features are not representative of the building's original architecture, they are illustrative of its history and age and could be retained as a testament to the library's long-standing use. Library Bureau issued tables and chairs are original to building and should be preserved and retained. View looking east. March 2021.

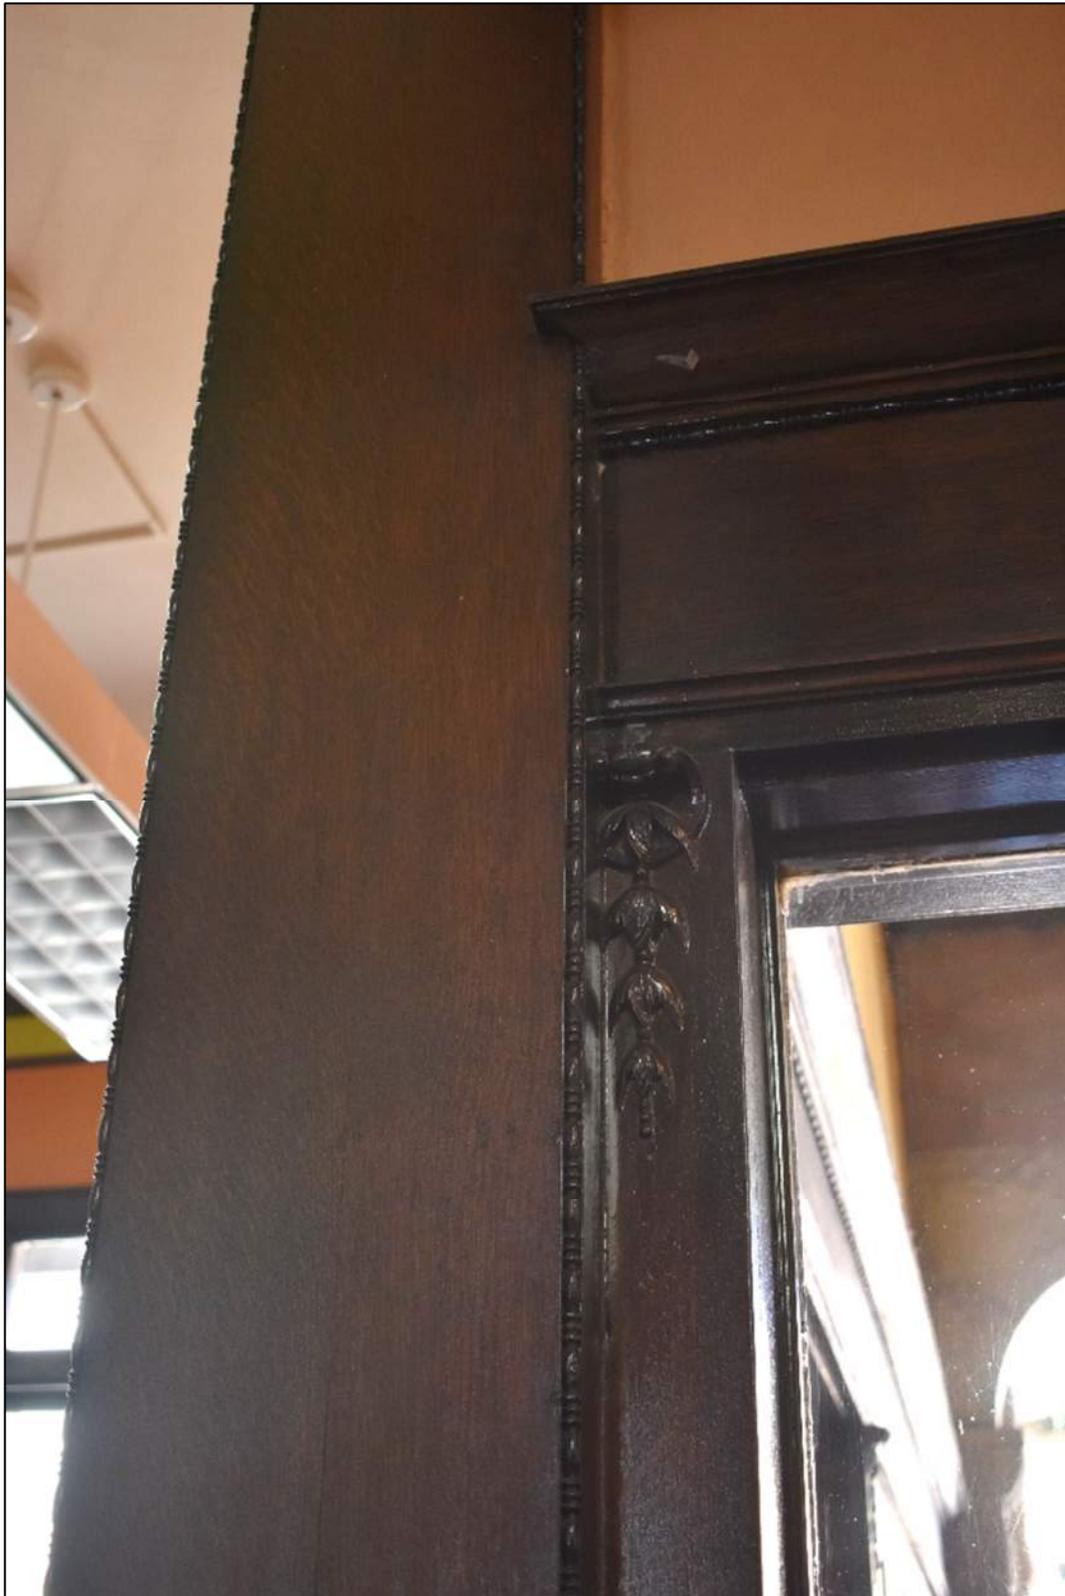
Figure 47. Character-defining molding along second story entry vestibule. Note bead and reel string course and dropped drops of husks, with view looking north. These elements are character-defining and should be preserved or restored. They should not be painted or otherwise altered. March 2021.

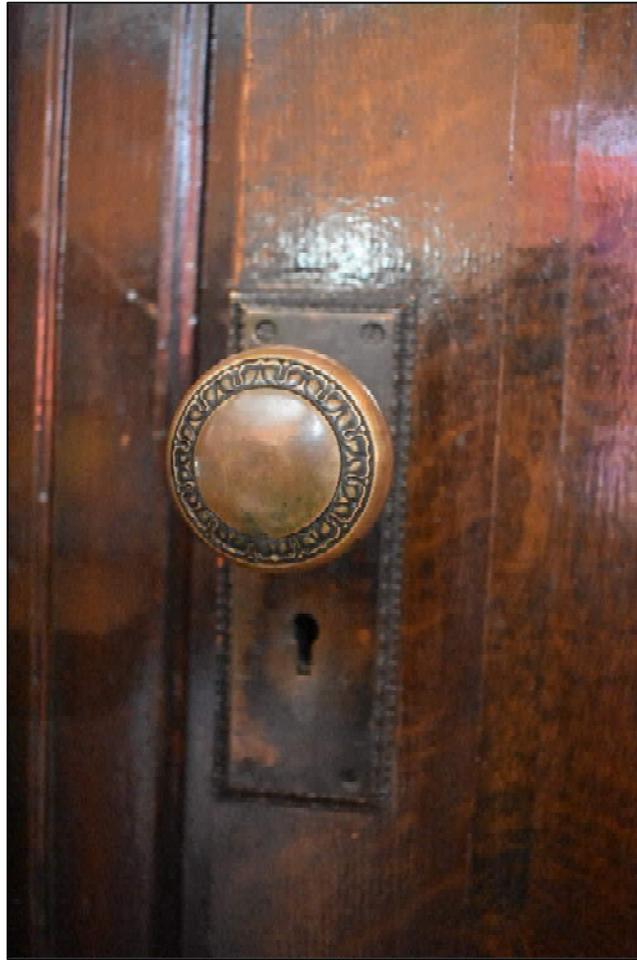
Figure 48. Doorknob on second story door beneath stairway. Small-scale features such as door hardware should, where possible, be retained and preserved. March 2021.

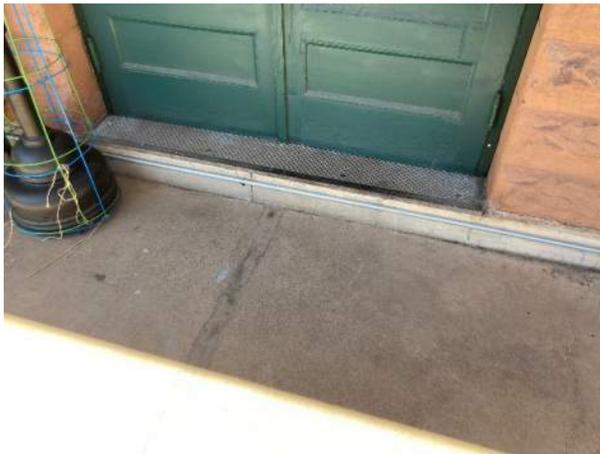
ADA access to the *veranda* from the Library on the upper two floors is not available because of 2.5" steps at all doors leading from the Library to the outer porch. The front doors of the library do exit at grade to a portion of the porch, but that area is ADA isolated from the remainder of the *veranda* with the same grade change. We recommend a platform at the eastern doors of the Library on the 2nd and 3rd floors with a 1:20 sloping sidewalk heading north from that western door platform of the Library.

Library to veranda at east Library exit

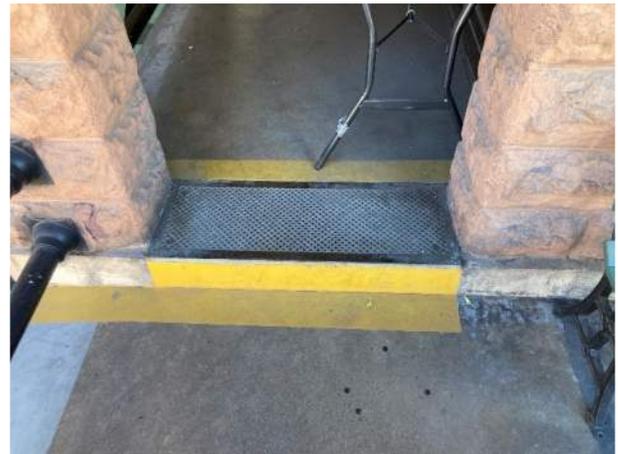
Grade change from entry veranda to wrapping verandah.

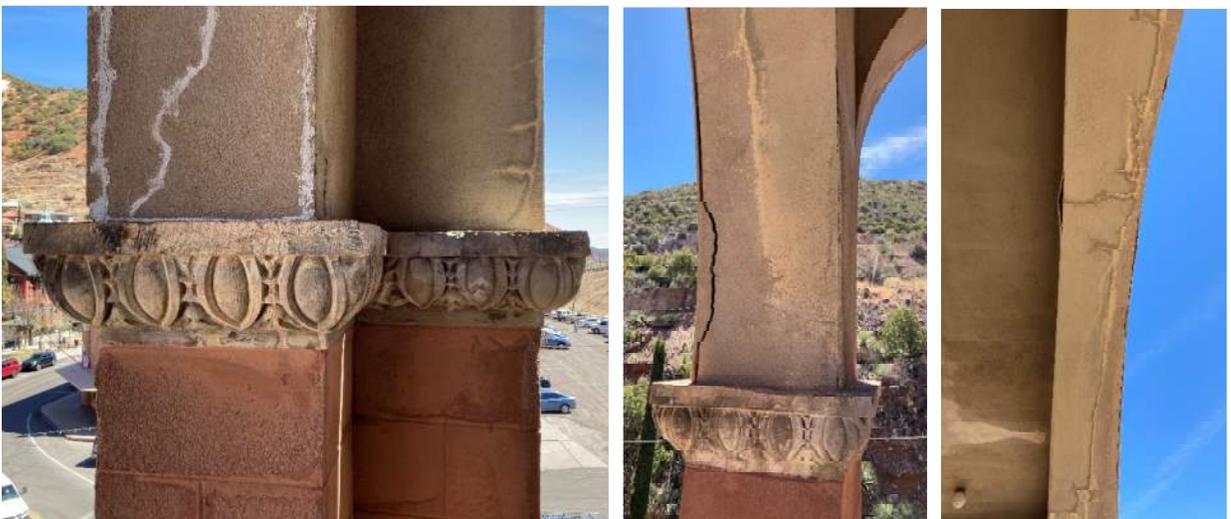
By contrast the portions of the three sides not protected by the veranda has some minor damage, and the south wall facing Commerce, unprotected by the veranda, has significant damage

Delamination of unprotected exterior walls

- walls protected by the veranda need minor cleaning and repair
- walls on the north, east and west exterior walls need substantial cleaning, repair, and especially repair of delamination of exterior plaster coats
- the south wall needs major improvements, starting with removal of obsolete piping and conduit, panels, meter bases, etc.

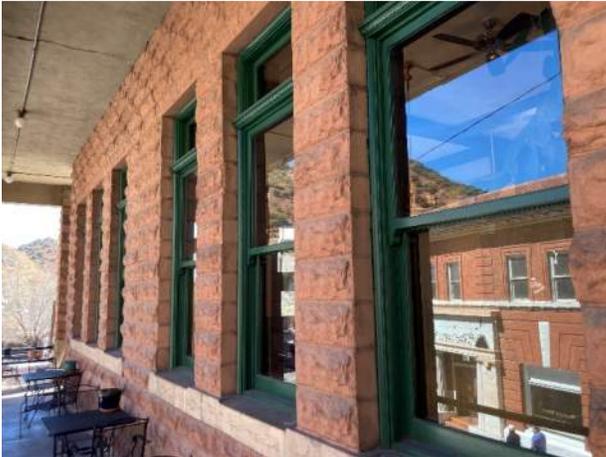
The windows in the Copper Queen Library follow the pattern of the walls described above. The windows protected by the veranda are in extraordinarily excellent condition. The windows on the east and north at the lower level (not protected by the veranda) are in good condition, and the windows on the south wall are in fair condition with several of the windows covered with security screens at the lower level.

Windows covered by veranda

- the windows that face onto the veranda need light sanding (check for lead-based paint content) and repainting, inside and out.
- the windows on the north side that face onto Main Street and the four windows on the east side need some repair, more substantial sanding (check for lead-based paint content), and repainting inside and out.

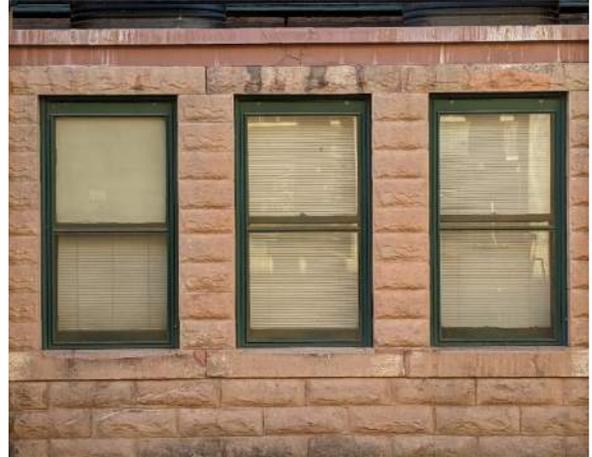
North windows facing Main

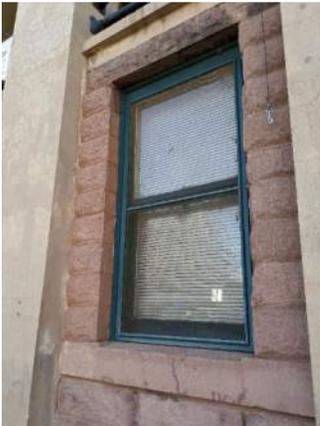
East window at Post Office

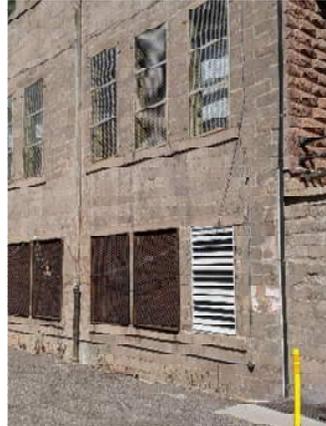
South windows facing Commerce (1st floor, 2nd floor and 3rd floor)

- the windows on the south wall should receive the following treatment: lower level windows into the Post Office should keep their steel expanded metal security screens (these should be repainted dark green.) The interior of these windows need sanding and repainting. The windows on the second level should have their tabbed security screens removed. The wood windows beneath the security screen, damaged by extensive exposure to south sun, should be repaired as necessary, scraped (check for lead-based paint content), and repainted, inside and out. The windows on the 3rd level are in poor conditions and will need extensive repair and repainting, inside and out.

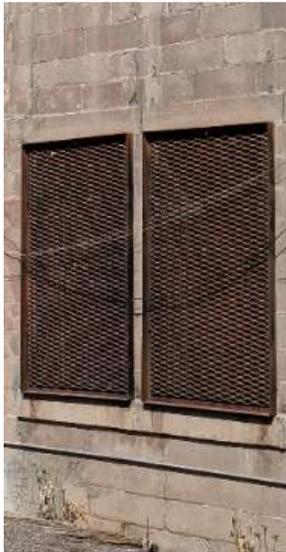
1st level metal security

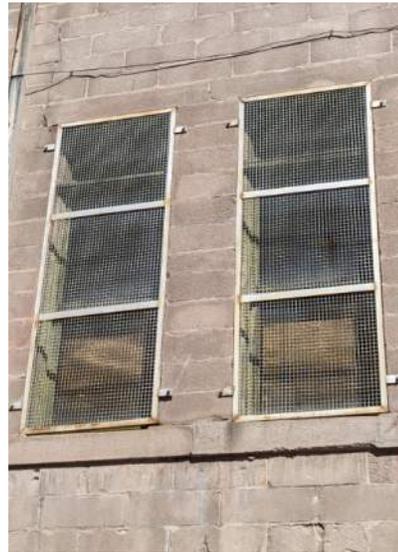
2nd level metal security

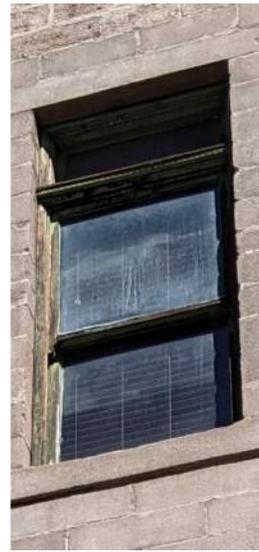
3rd level wood windows in poor condition

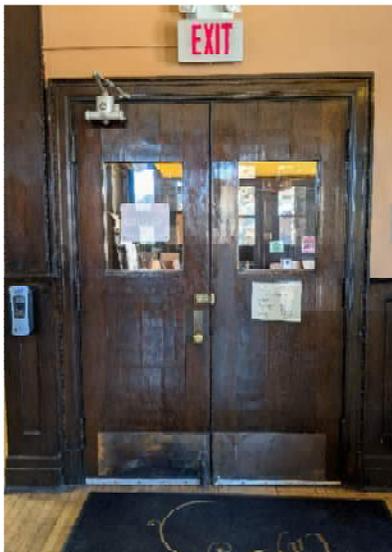
Most interior and exterior doors are in excellent condition with irreplaceable materials, ornamental trim, and hardware. These doors just need routine maintenance and preservation.

Entry door

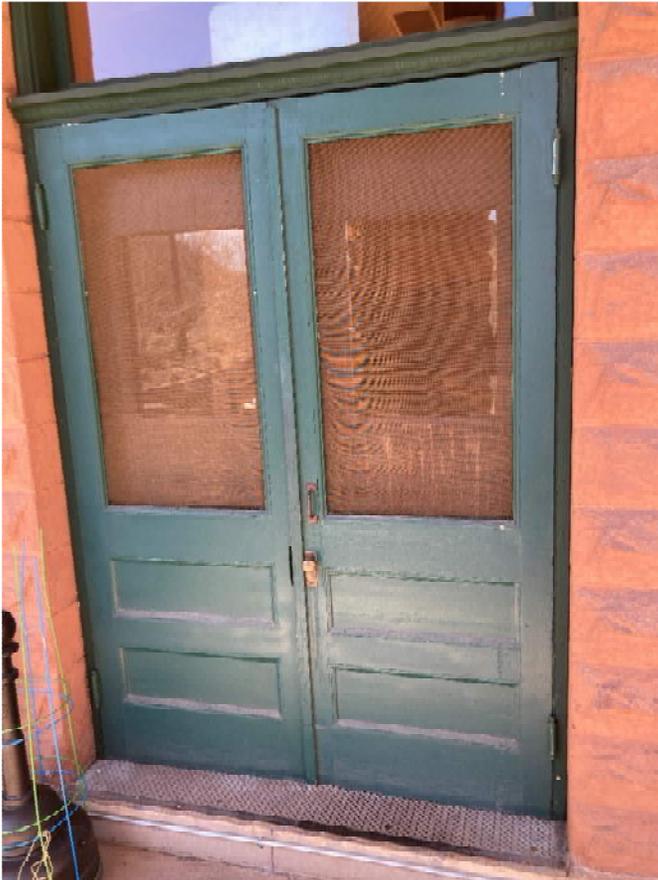
East exterior door to veranda (veranda view)

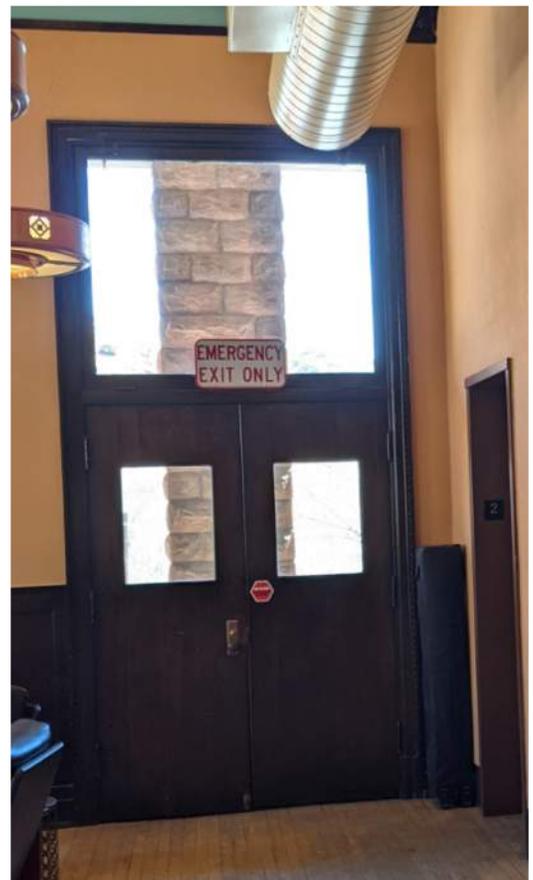
East exterior door to veranda (interior view)

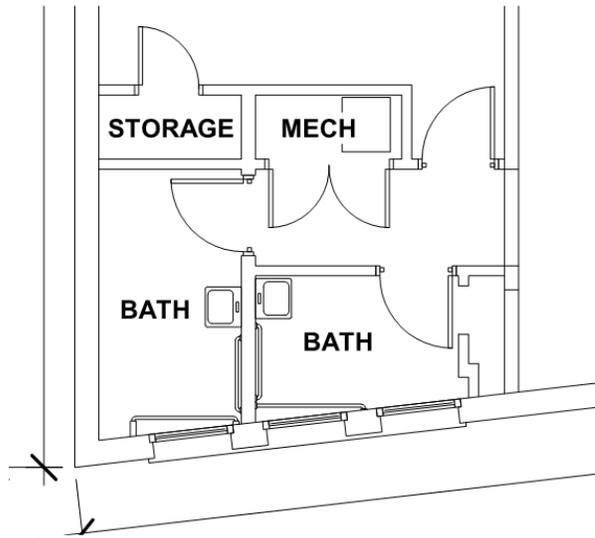
The bathrooms on the 2nd floor seem to be in good order and are both ADA accessible. The 3rd floor bathroom is not accessible.

2nd floor accessible bathrooms (WC not shown)

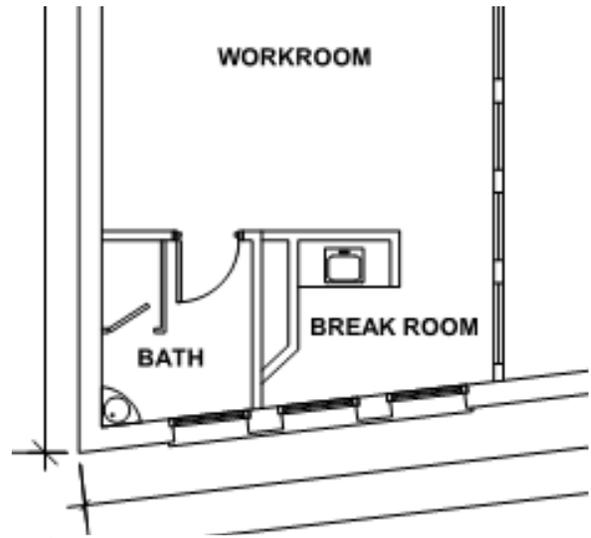
3rd floor bathroom not accessible (WC not shown)

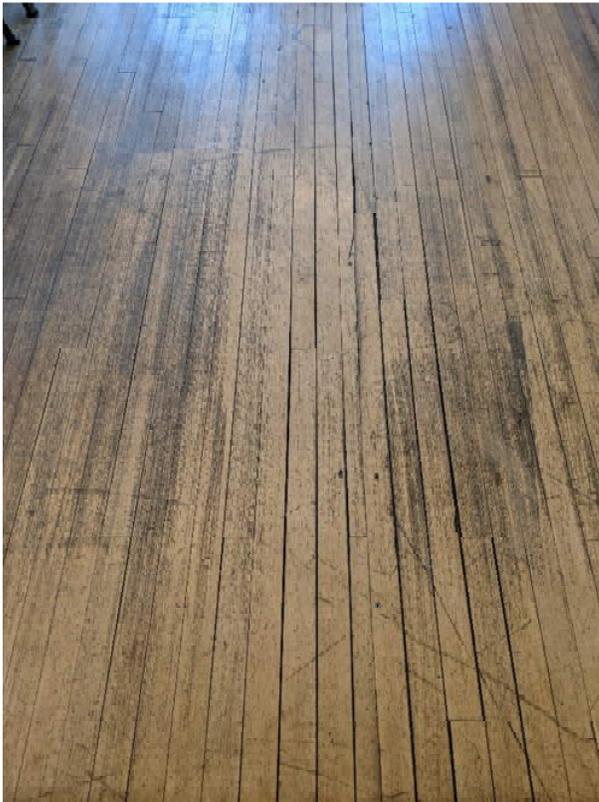
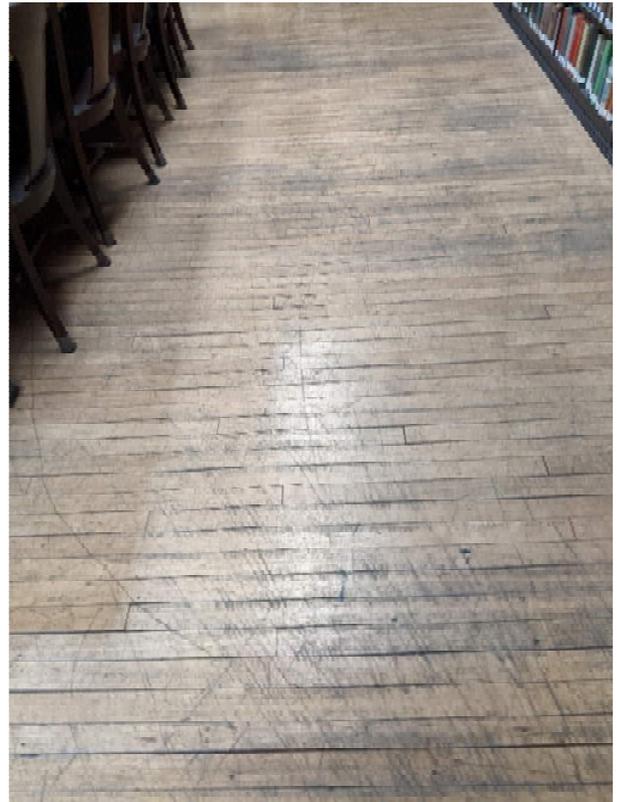
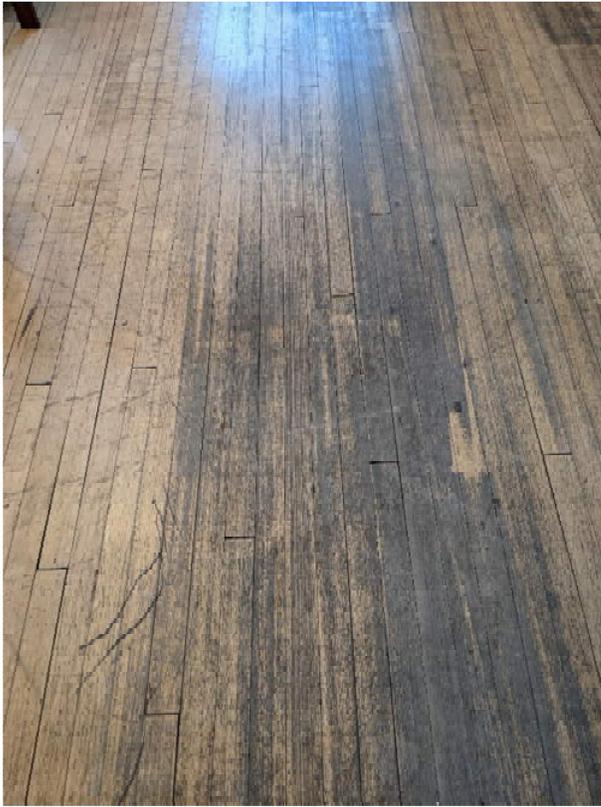
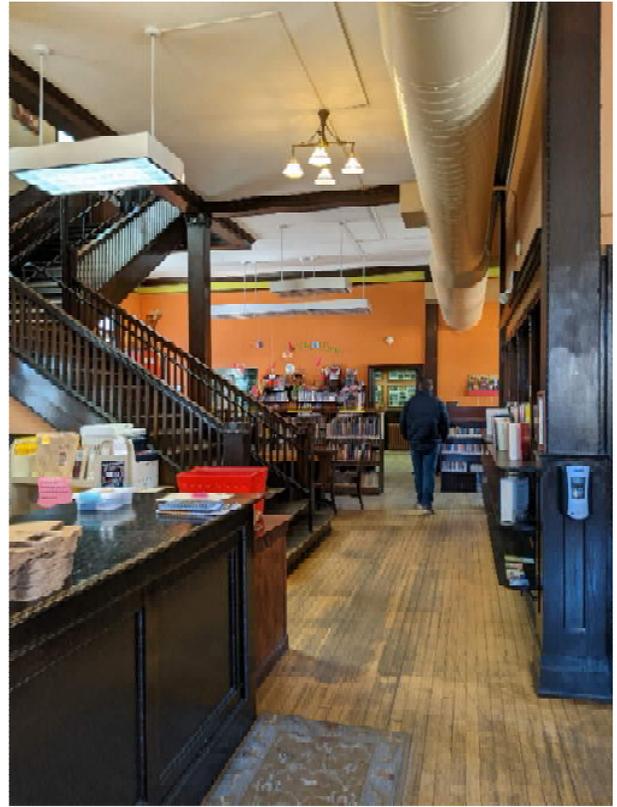
The flooring in the library is high quality wood flooring (maple?) that appears rough, but is simply in need of a machine re-sanding and refinishing. It looks as if it has not been refinished before, so it should easily handle the sanding without endangering the top tongue of the tongue and groove. It can be beautifully restored. The scuff marks and damage should be easily repaired. The open joints will close in wetter season and the floor will do better with a more stable HVAC system. Evaporative coolers are very rough on wood floors.

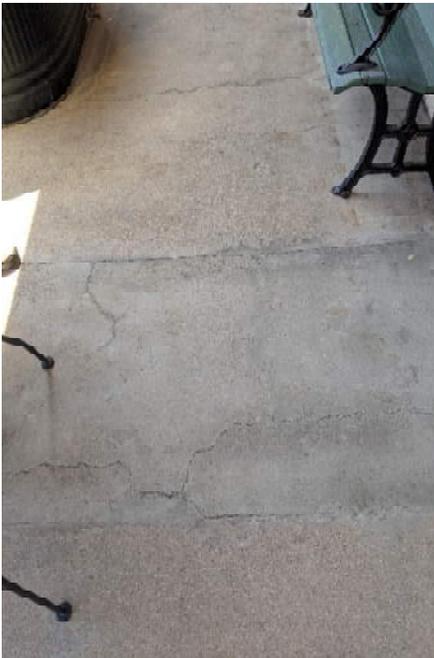
The exterior deck of the veranda has substantial cracking. It is recommended that a new 1/2" cementitious topping with appropriate score spacing be placed on top of the existing veranda surface. This will restore a good quality walking surface outdoors and provide waterproofing to prevent leakage to the ceiling below.

The level 3 deck was observed to have some cracks occurring on the underside in alignment with the exterior pillars. There is evidence of moisture seeping through the crack from exposure to rain on the top surface. A surface applied sealer over the top surface of the exposed decks would help mitigate moisture seepage through the deck that can promote corrosion of slab reinforcing.

2. The exterior porch slabs appear to be allowing moisture from the weather to seep through and potentially causing corrosion of the reinforcing steel. It is advised to apply a surface sealant that will mitigate surface moisture from migrating through the slab.

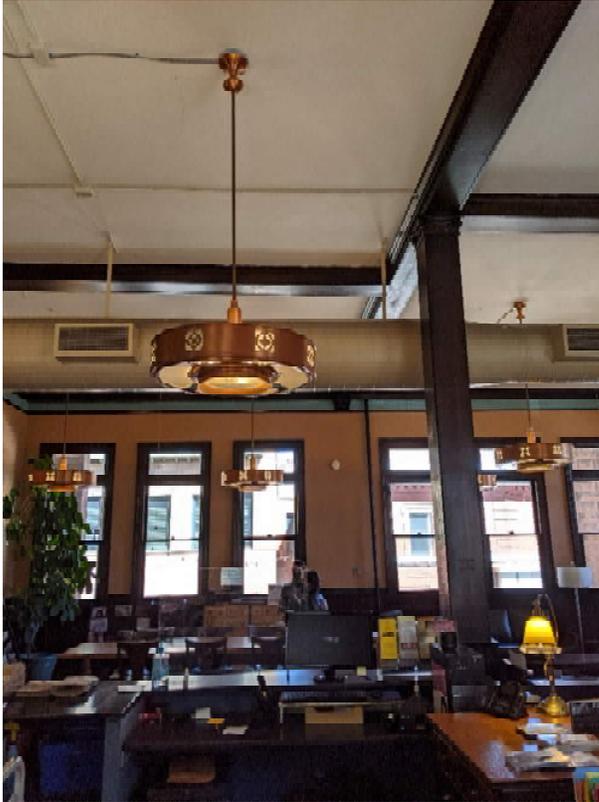
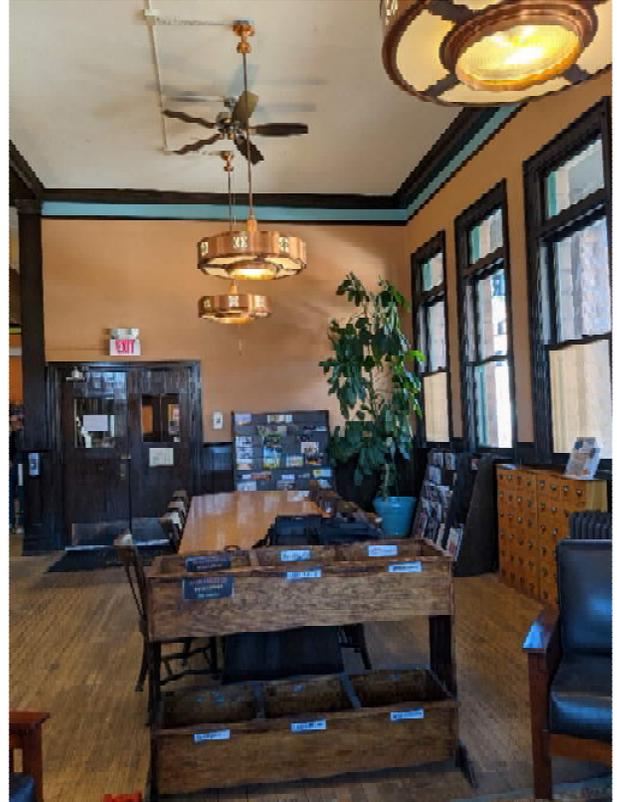
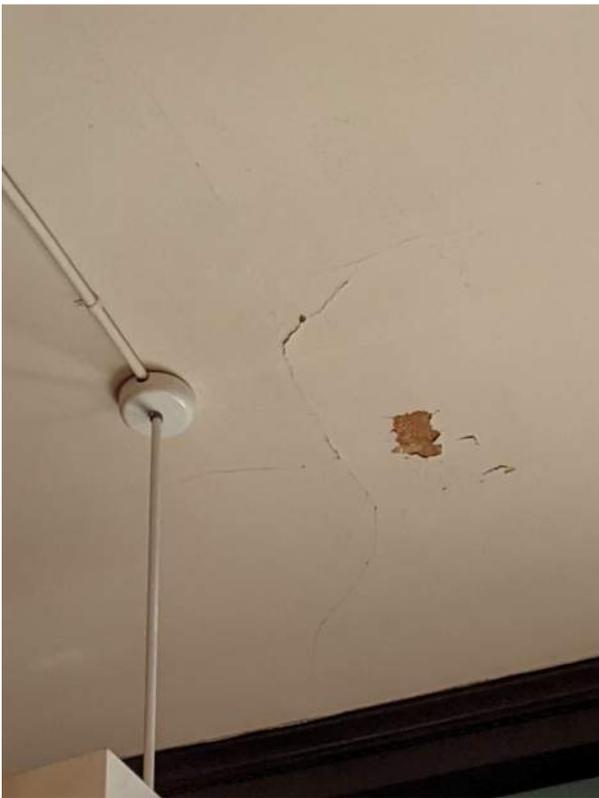
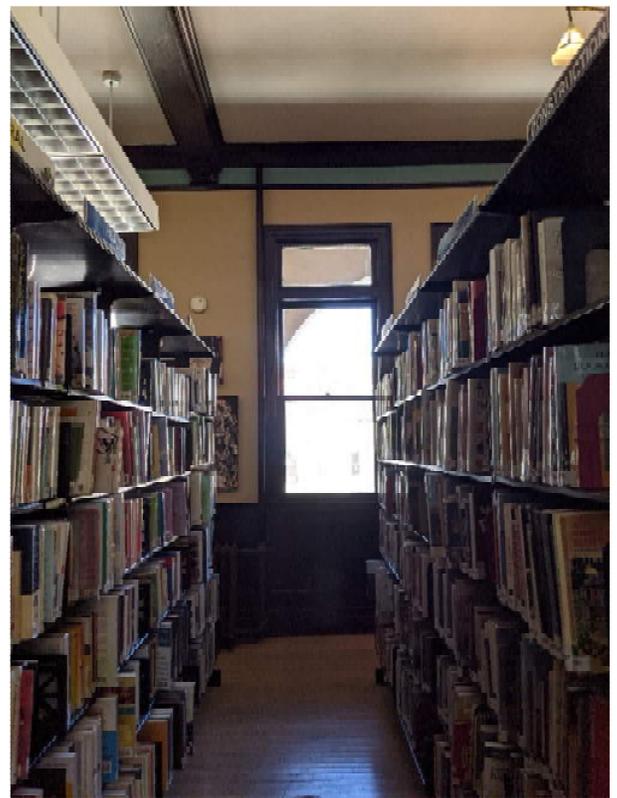
The ceilings in the Library interior are in generally very good conditions. They simply need to be cleared of electrical conduit and repainted.

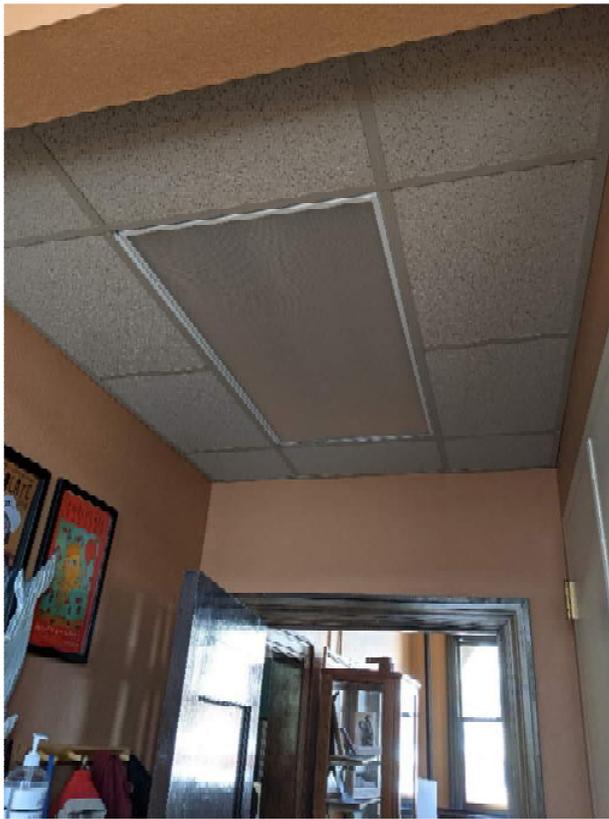
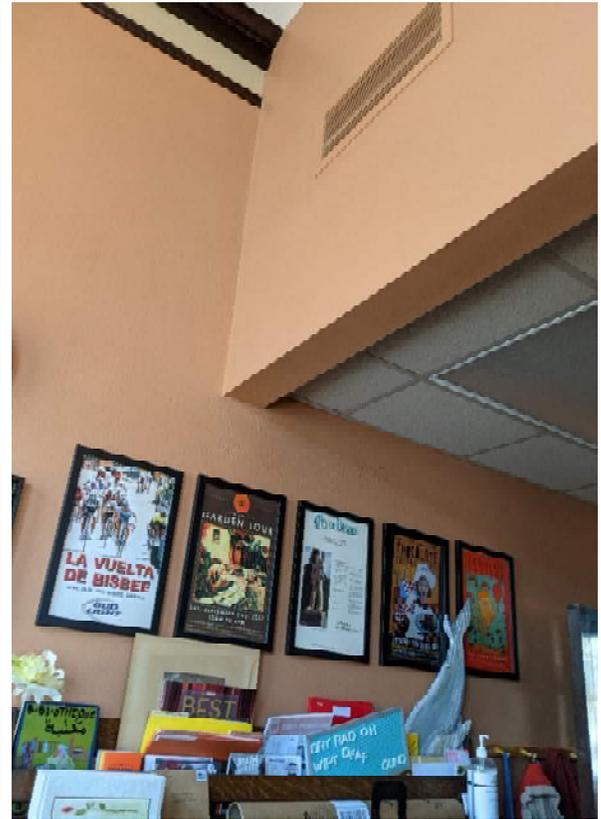
The dropped ceiling in the office on the east end of the 2nd floor is not original but can stay as it is.

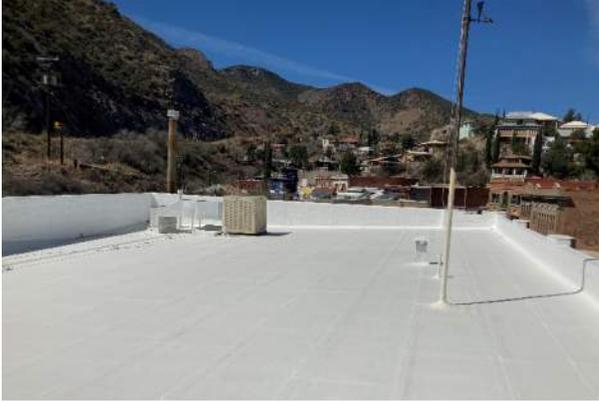
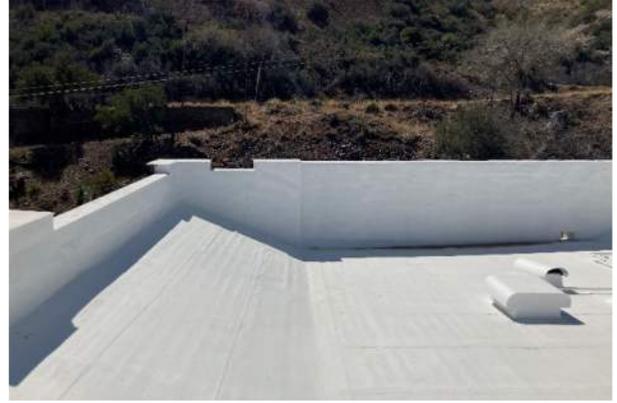
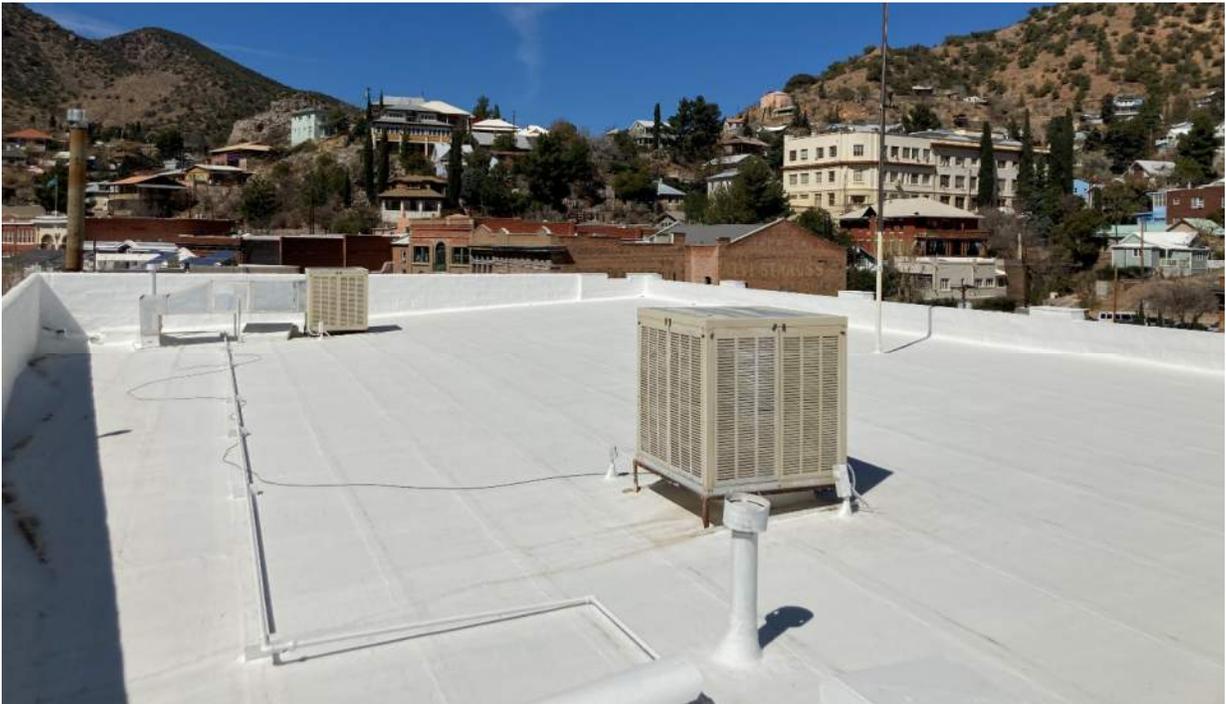
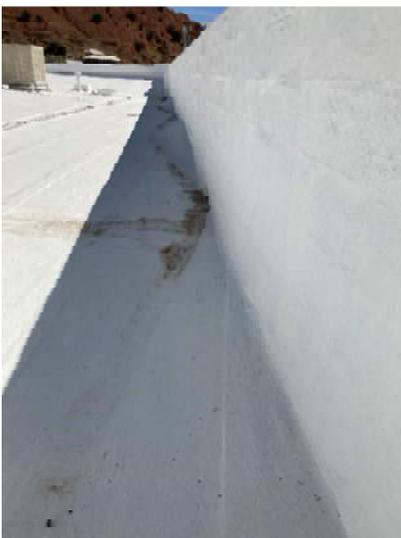
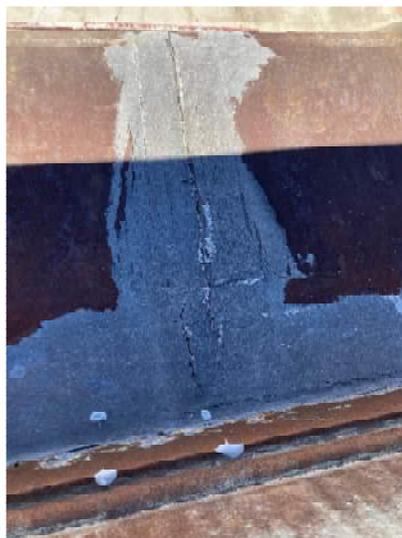
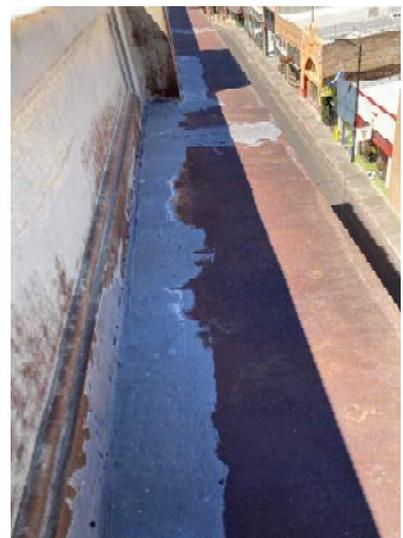
The roof is in excellent condition. Given the change in HVAC systems that will likely be roof mounted. The roof should be inspected for areas of repair and then recoated with a white acrylic coating.

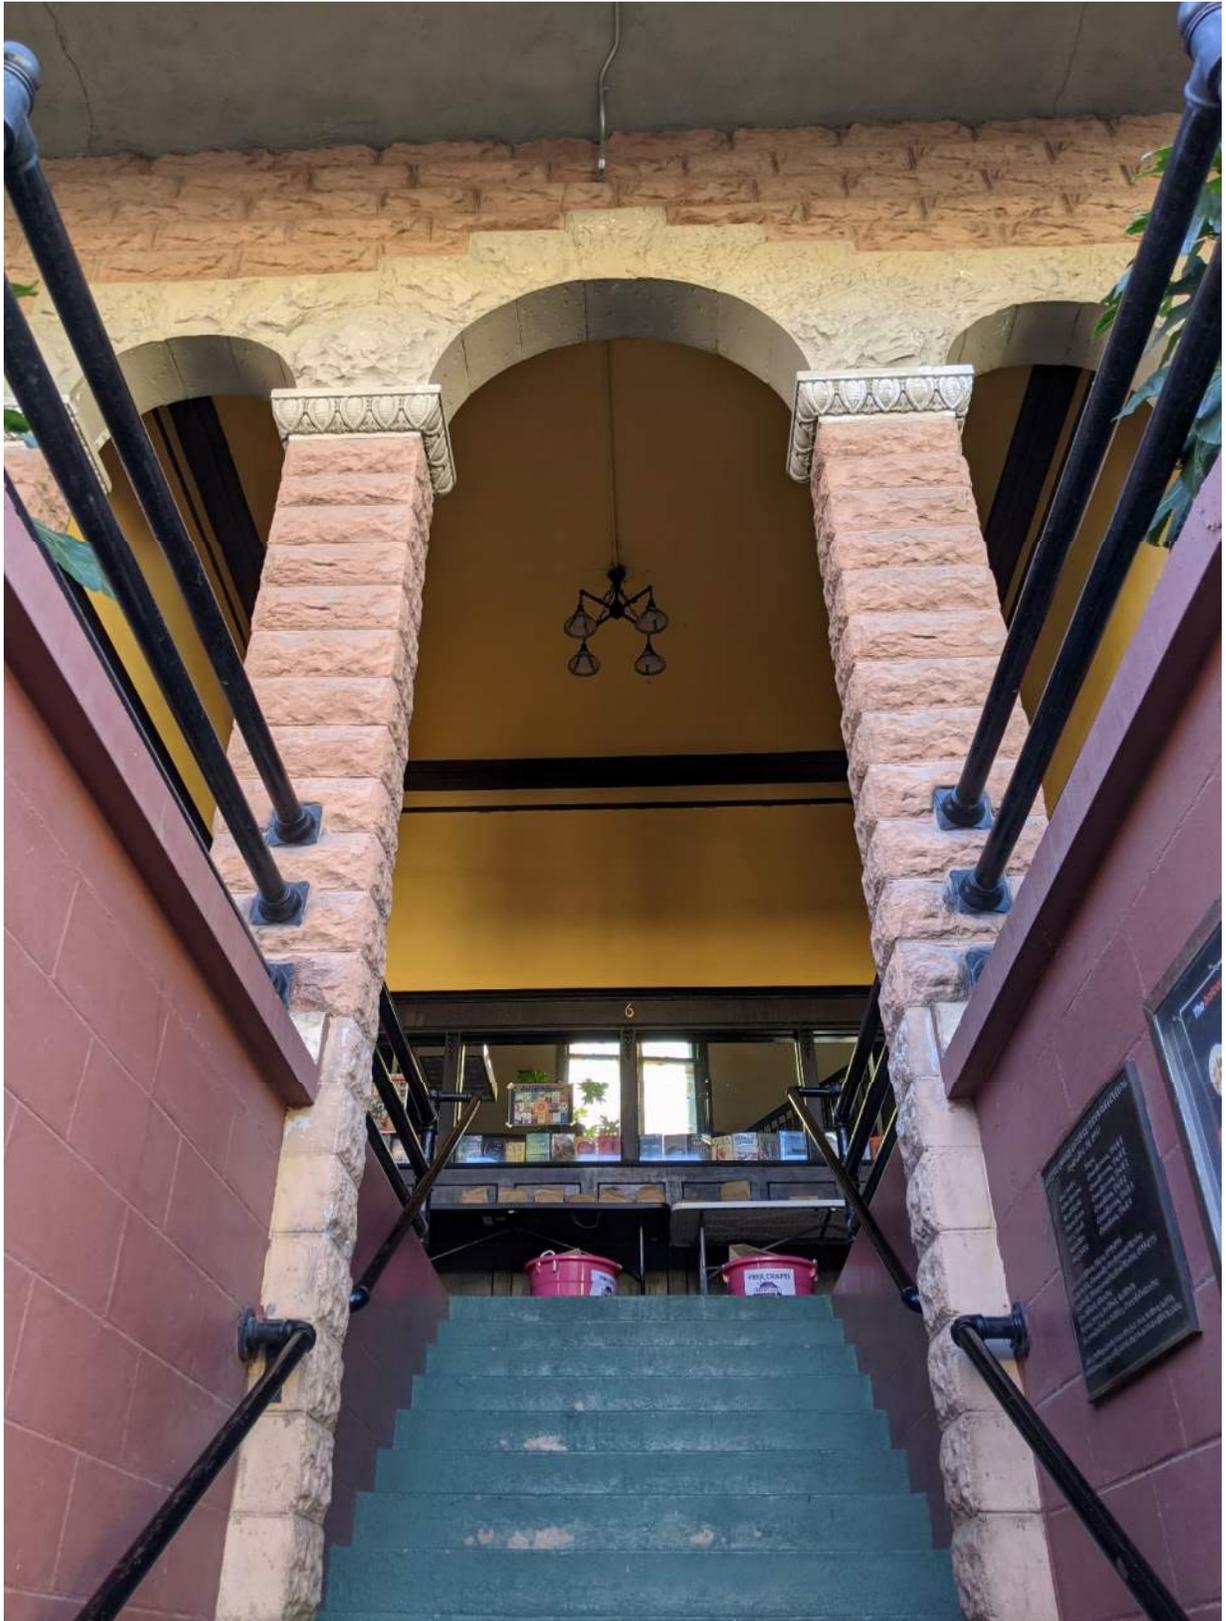
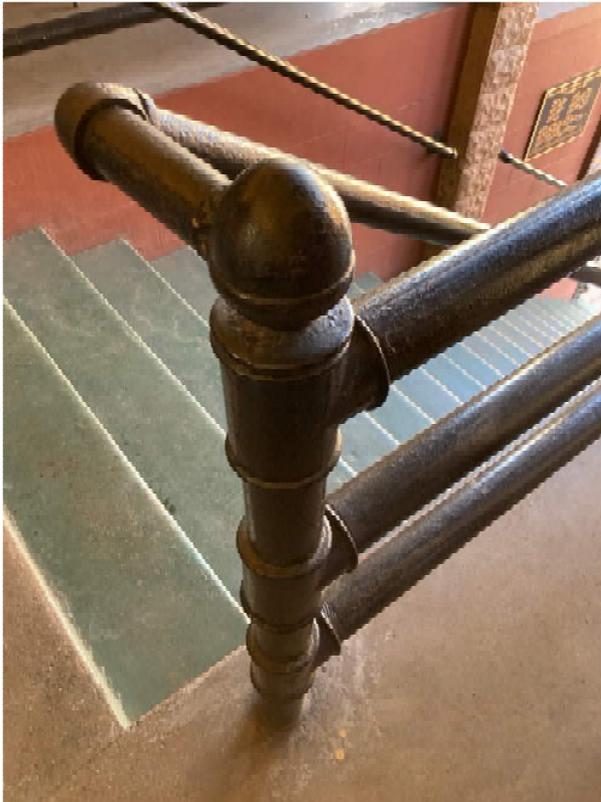
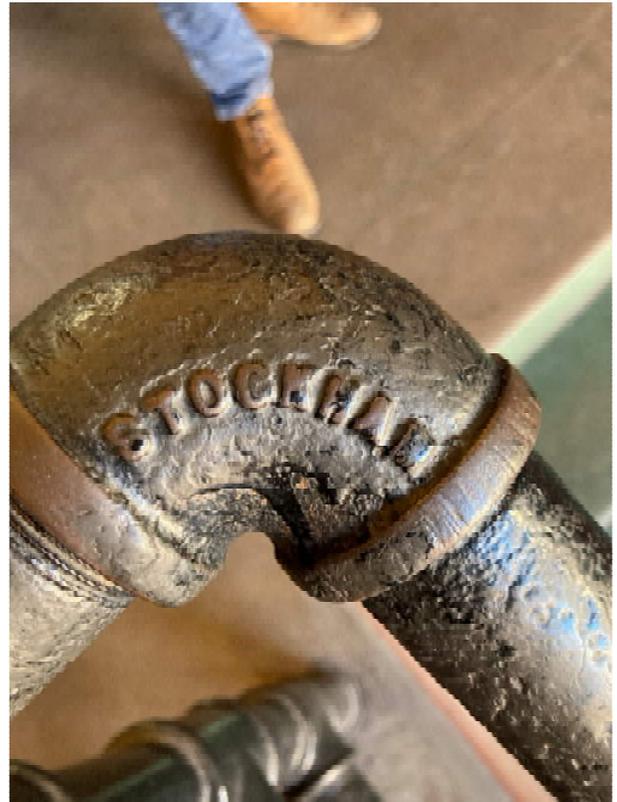
The exterior stairs from Main Street are up to the Library entrance are in good condition and the railing height (@+42") meets current IBC requirements.

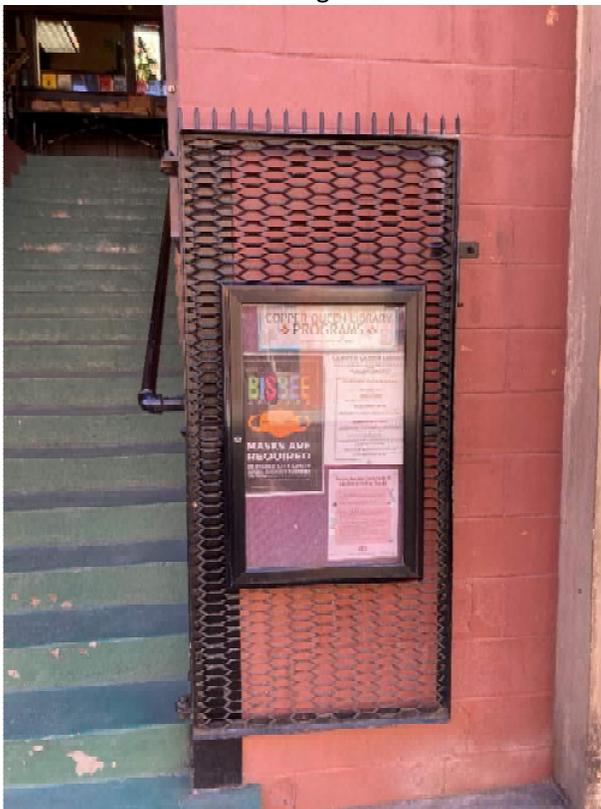
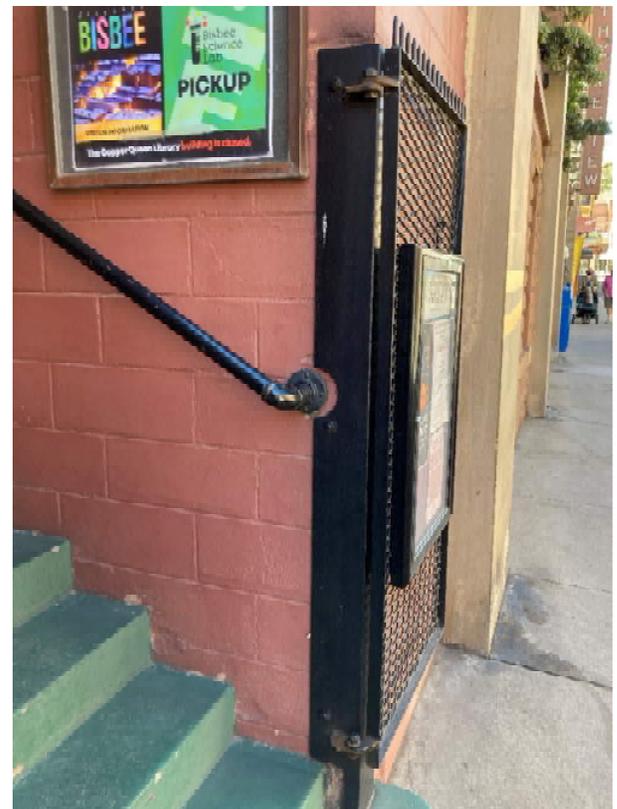
There is a required run-off (extension of the railing past the staircase) that does not meet code, but that would put the railing into the public right-of-way as a dangerous obstruction. This conflict will require a discussion with the building official.

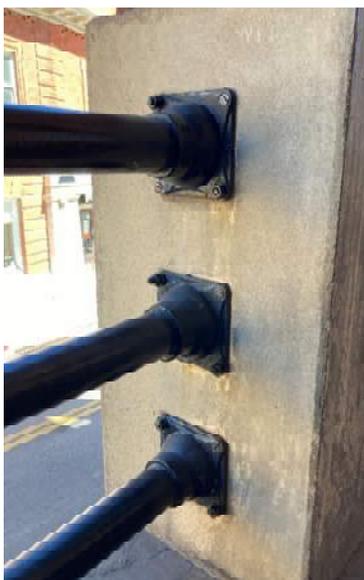
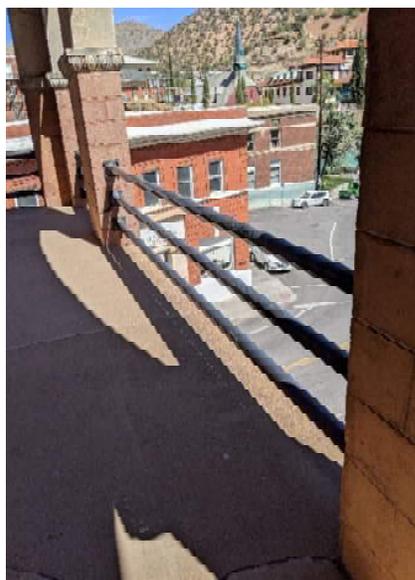
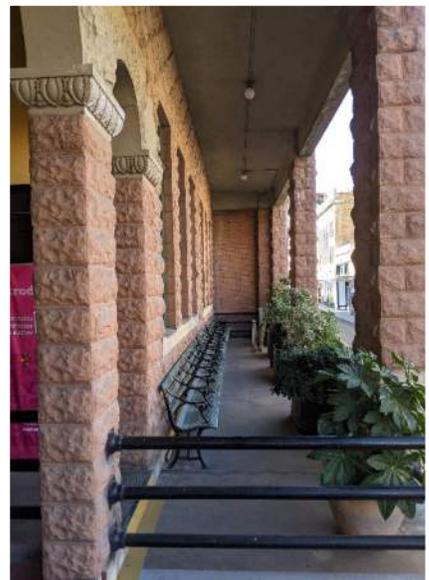
The railing of the veranda is the most significant code issue presenting a significant danger to users. It is recommended that the public not be allowed to access the veranda until this danger is eliminated. The railing has two problems: it is 29" tall compared to the code required 42" tall. In addition, the code requires that a "4 inch ball shall not pass," meaning that no opening in the railing itself should be larger than 4". The current railing meets neither of these requirements for the full length of the veranda.

The solution is complicated by the fact that the pipe rails are a character-defining element of the exterior design of the veranda railing. From an historic preservation perspective, it would be best to maintain the material, scale, proportion, and character of the railing.

PMM had a similar challenge in our rehabilitation of Old Main on the University of Arizona campus. With the enthusiastic approval of Arizona SHPO, PMM created a nearly invisible free-standing rail inside the historic railing. Building users were clearly able to understand that the railing was contemporary and installed for safety. Yet from the exterior, the historic material, scale, proportion, and character of the railing are maintained.
