COPPER QUEEN LIBRARY BISBEE, ARIZONA

BUILDING CONDITION ASSESSMENT

May 20, 2021

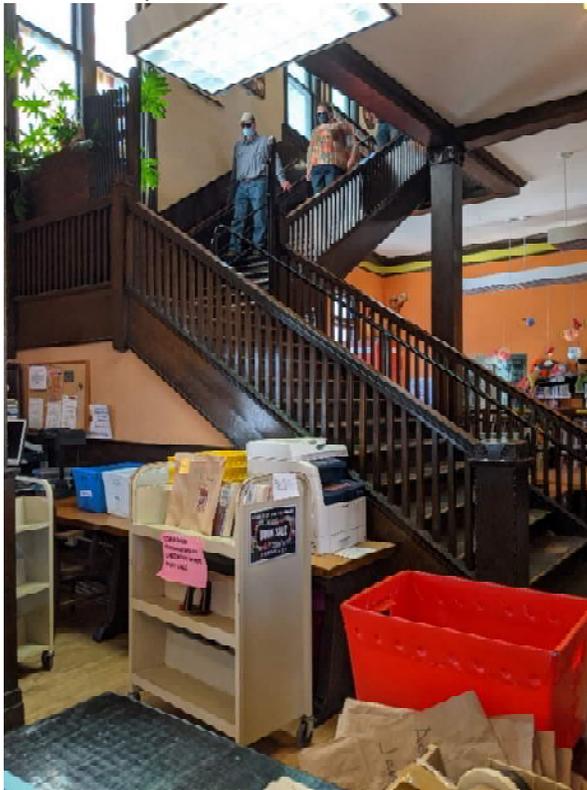
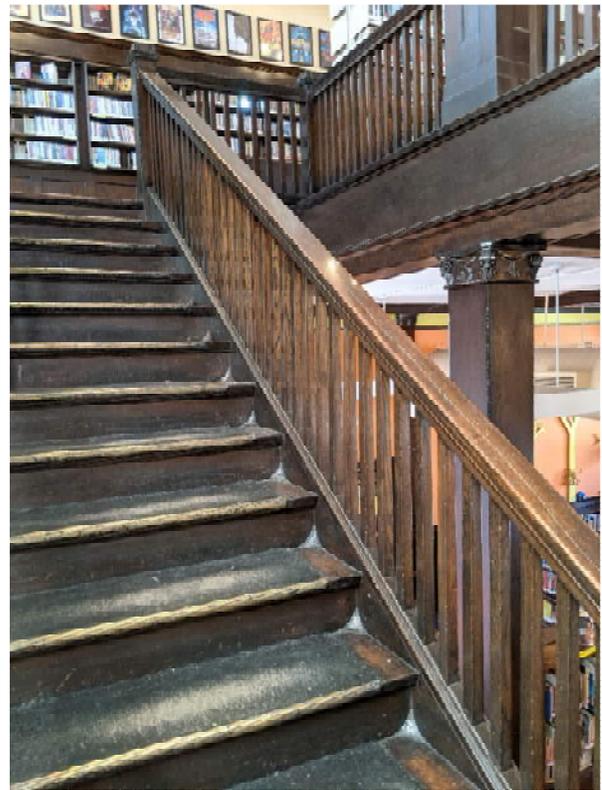
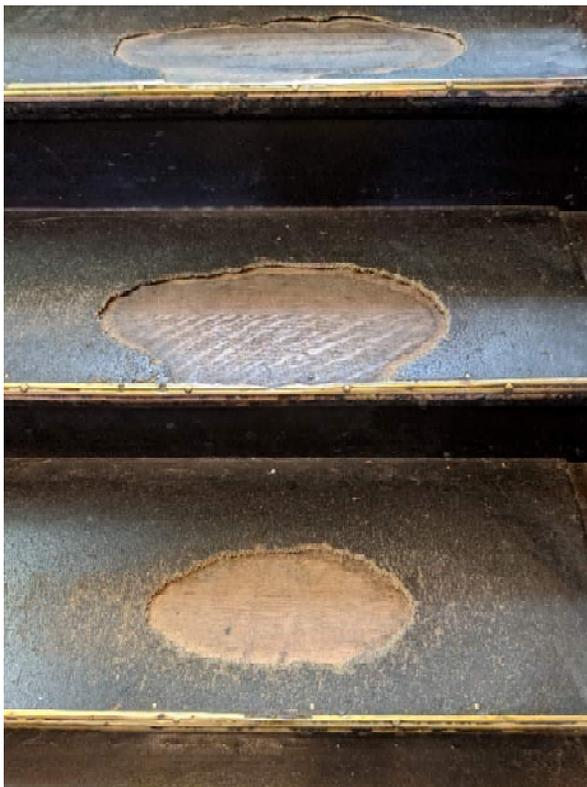
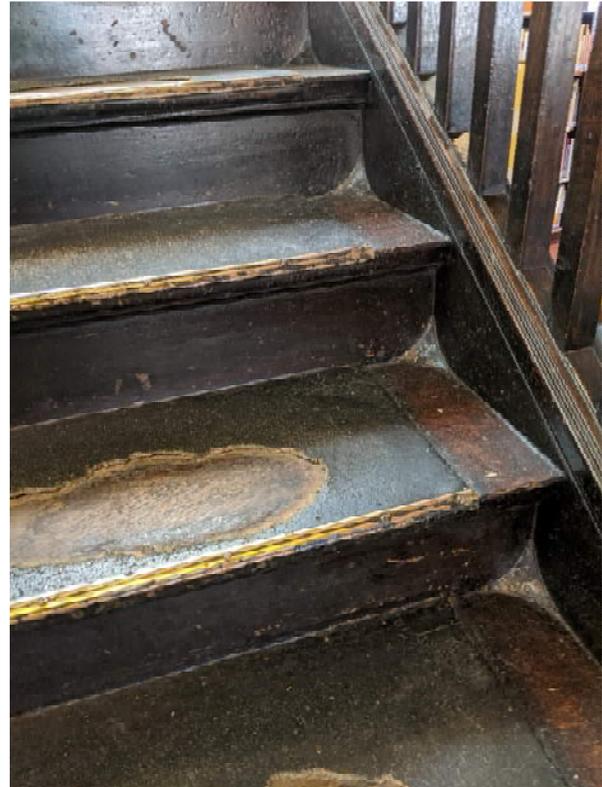
The interior staircase is generally in good condition except for two significant issues:

- The stair treads are seriously worn out and should be replaced for the entire staircase with a comparable composite material in thickness and color to match the original. Care should be taken to leave the exposed existing wooded tread for the last several inches. The brass nosing should be repaired or replaced as necessary to match existing. Care should also be taken to not compromise the unique “dust corner” inserts.

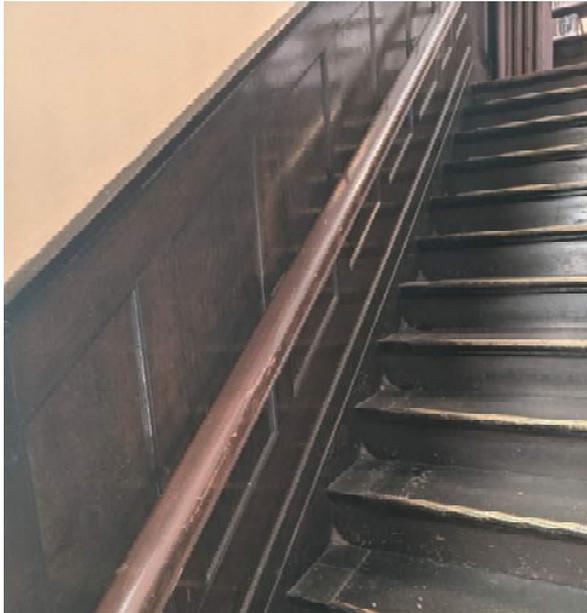
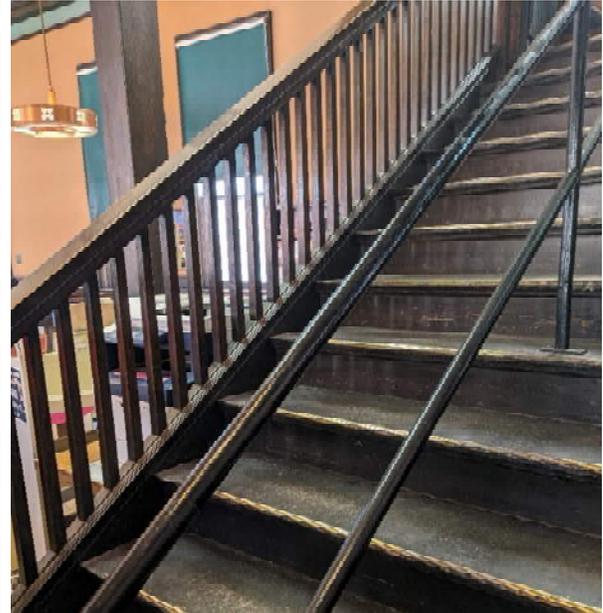
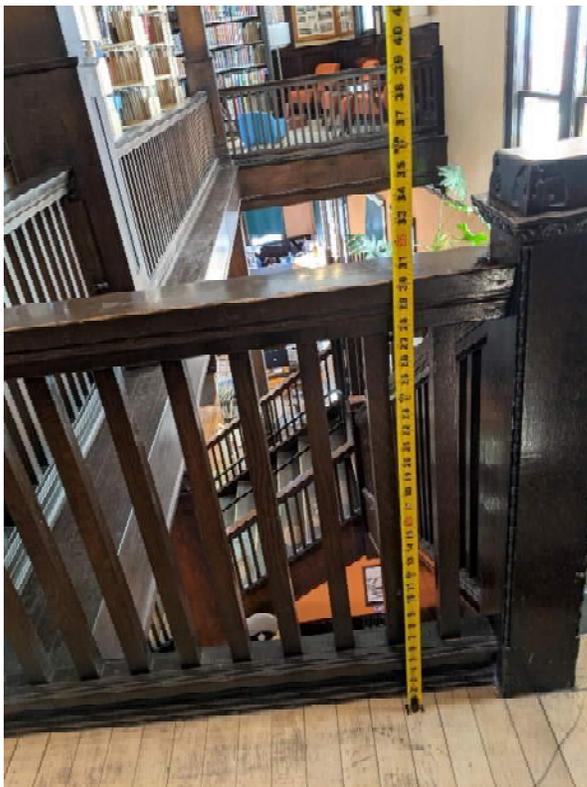
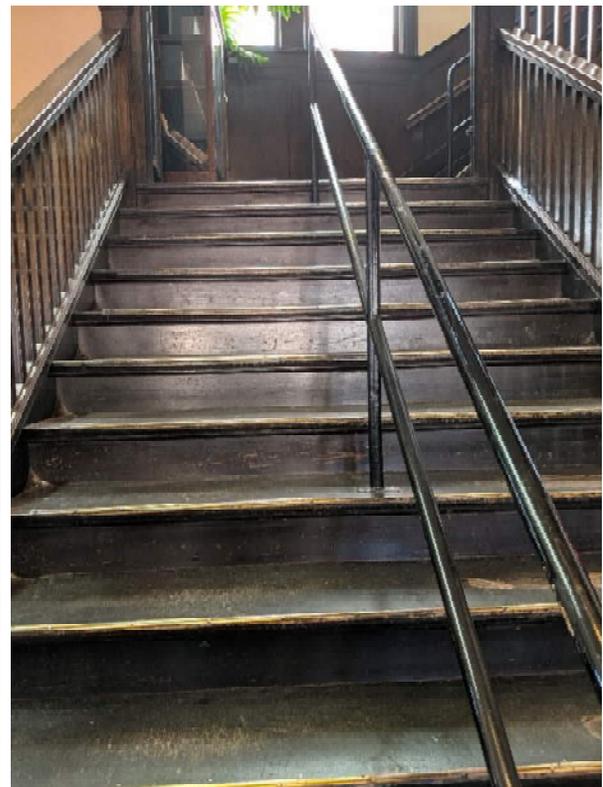
- The stair railing is also a significant code violation and presents a danger, particularly on the 3rd floor. The railing is 29" tall in most locations. The code requires a much higher railing at 42". On the upper half of the stair where the wainscoting sits behind the handrail, the handrail can simply be raised to the appropriate height using the existing hardware. At the other three location where there is a low slat rail, a simple pipe rail (similar to the center rail) can be added. This needs to be studied, by our initial recommendation is to "L"-shape a bracket and attach it to the side, not the top of the square top rail, at the appropriate height. The height of the center pipe rail may need to be raised as well. At the 3rd floor, a similar pipe rail needs to be added all around the stair opening. That top rail also needs to comply with the 4" ball shall not pass, although there may be some code leniency in this regard.

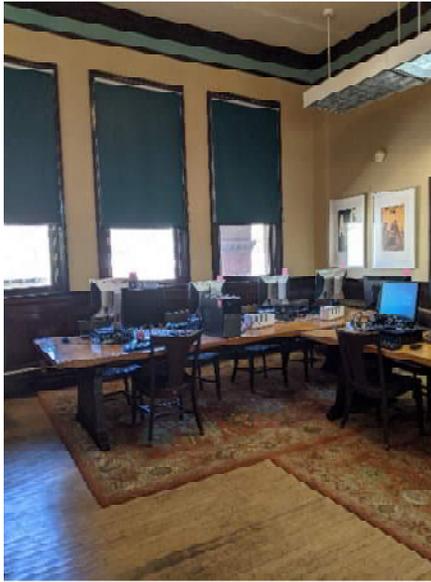
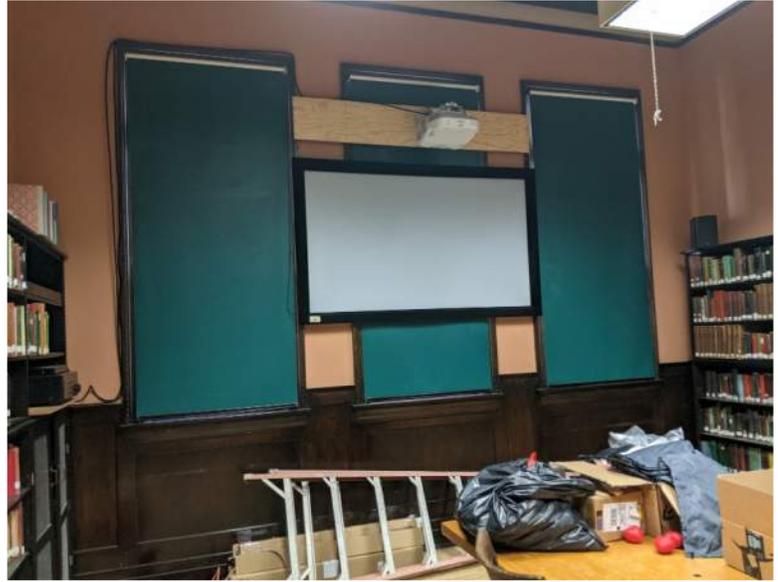
There are not window coverings on all windows. But where there are, they should be consistently installed. The roll-down, green, black-out shades seem to work well with the existing interior and it is recommended that they be installed as needed.

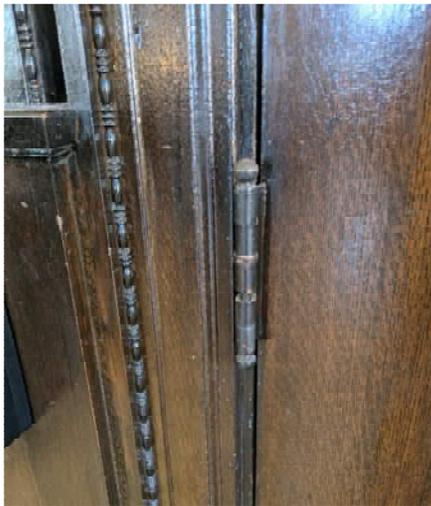
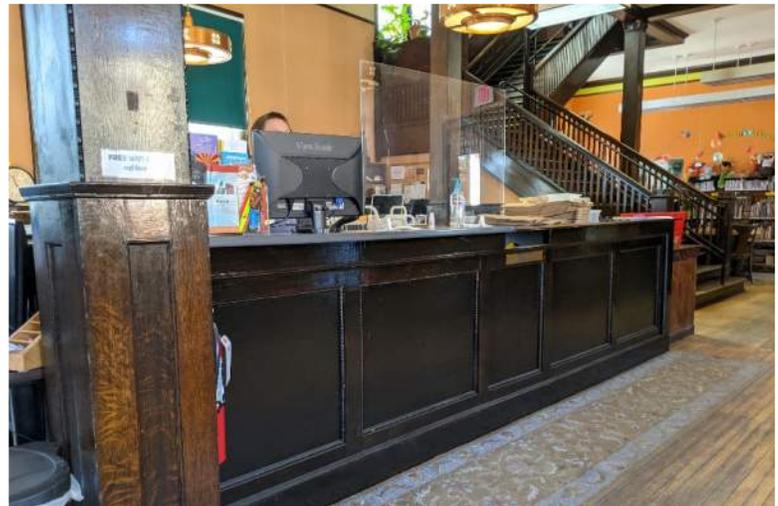
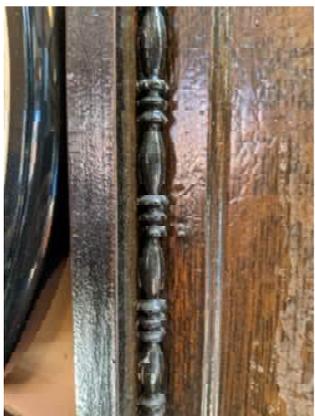
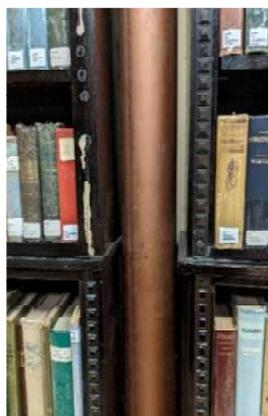
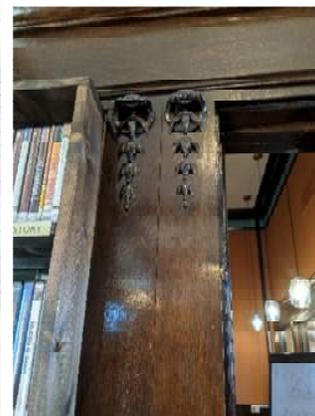
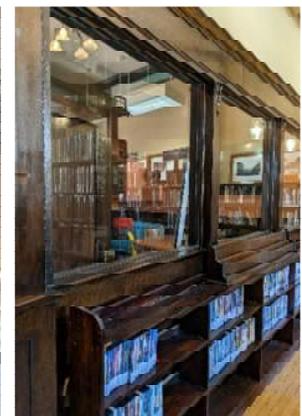
Interior cabinet work, wood work, and furniture

One of the most valuable aspects of the Copper Queen Library is the extraordinary woodwork and the high level of integrity in those materials. The same is true for much of the furniture, which is original and must be maintained and preserved. It is recommended that all of the cabinet work and furniture be repaired and restored to its original quality, including shelving, trim, window trim, and furniture, etc.

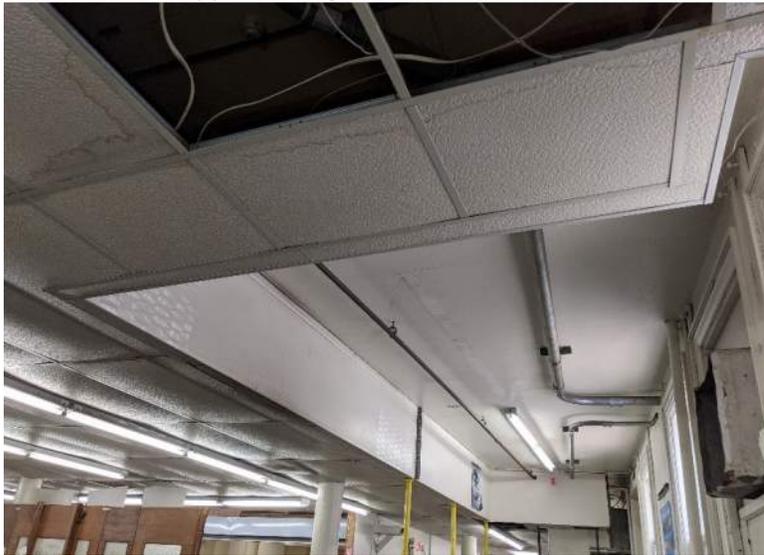
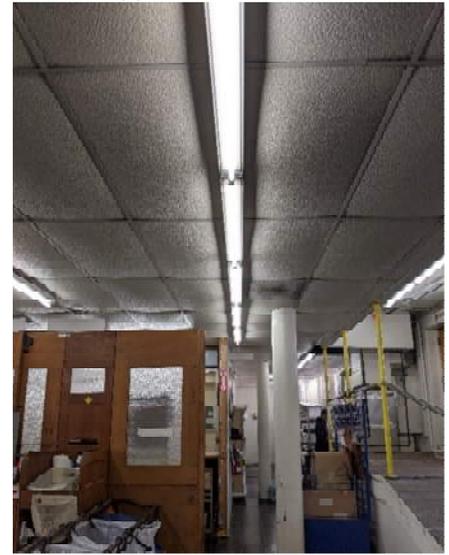
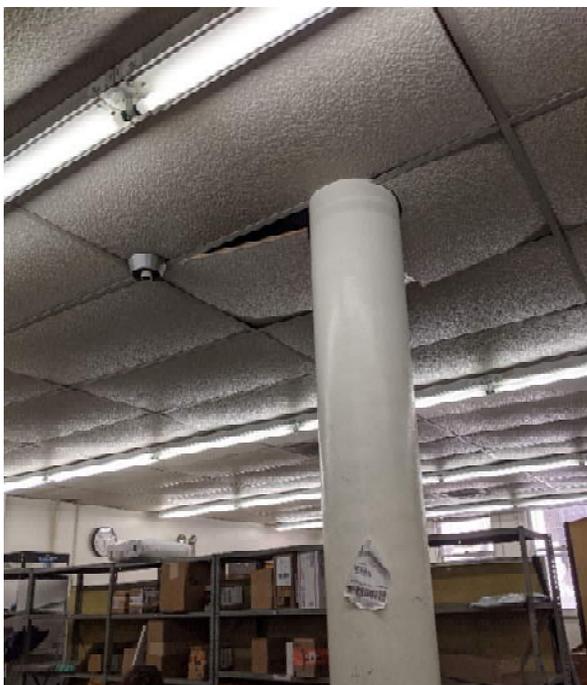
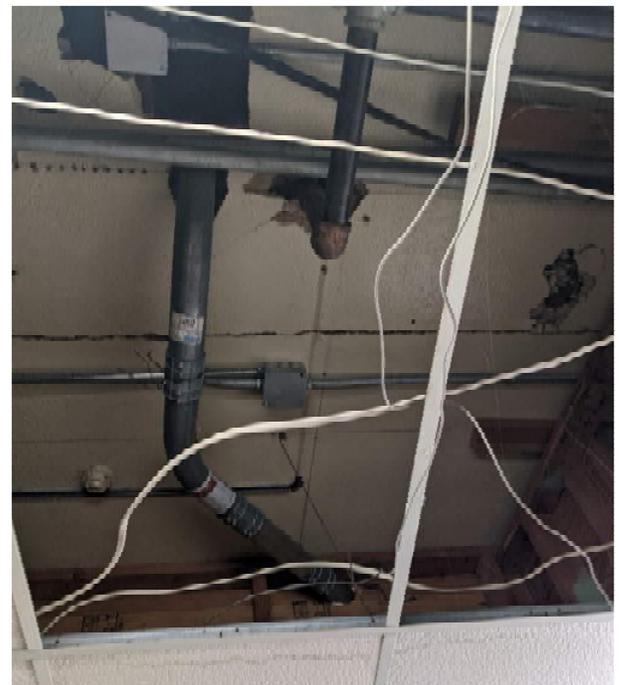
- The ceiling of the Post Office is in terrible condition and has dramatically reduced the spatial quality of the lower level space. There are additional recommendations in the lighting and mechanical sections of this report. There is currently a dropped ceiling at 24" below the original plaster ceiling. It is recommended that, to the extent allowable by the need of lighting and mechanical ductwork, the ceiling be raised by as much as 12". This will improve the spatial quality of the Post Office and the new dropped ceiling will reduce the shabbiness of the Post Office appearance.

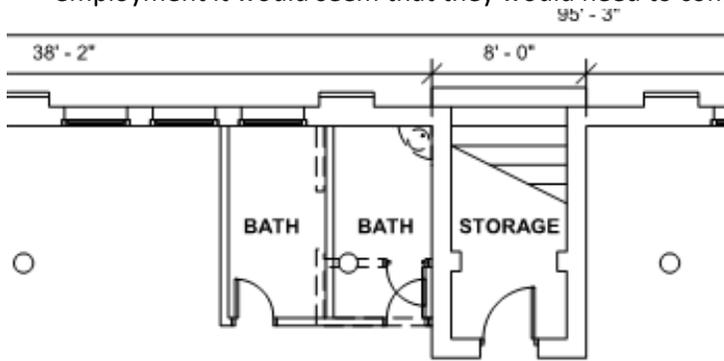
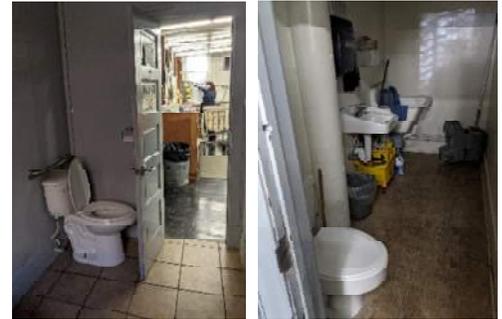
- The Post Office does not have an accessible bathroom on the first level. Given the varied population employment it would seem that they would need to comply. There is room to remodel for ADA.

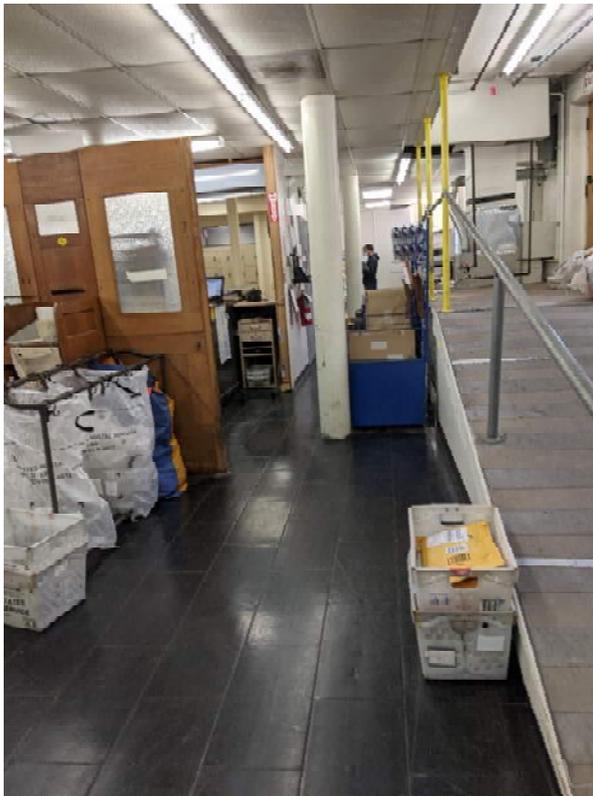
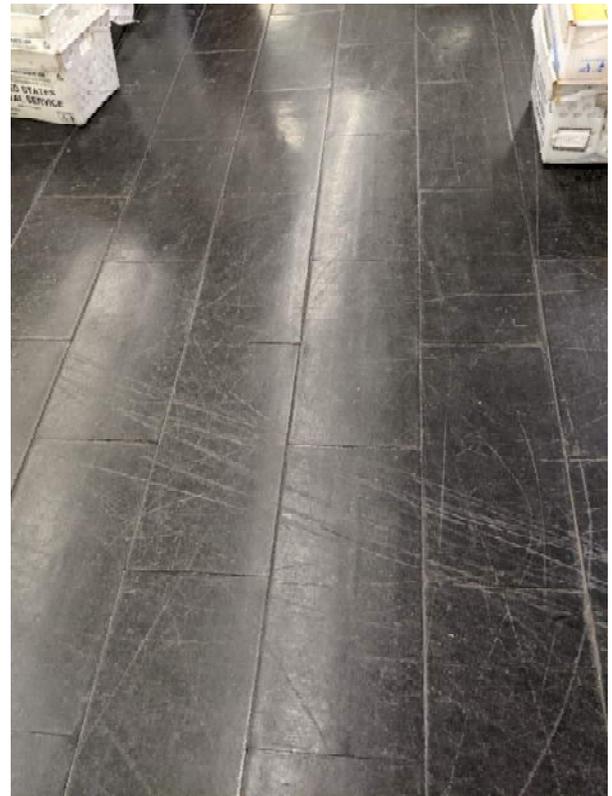
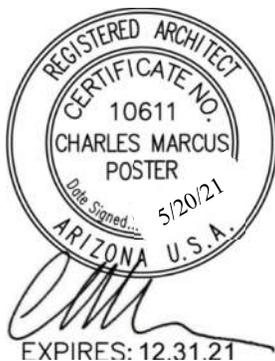
- The floor in the Post Office is an interesting composite running-bond material that is in poor shape. Amazingly there is a stash of extra flooring material in the deep basement accessible from Commerce Street. This extra material could be used to repair damaged areas. The entire floor could be repolished and brought back to an interesting finish.

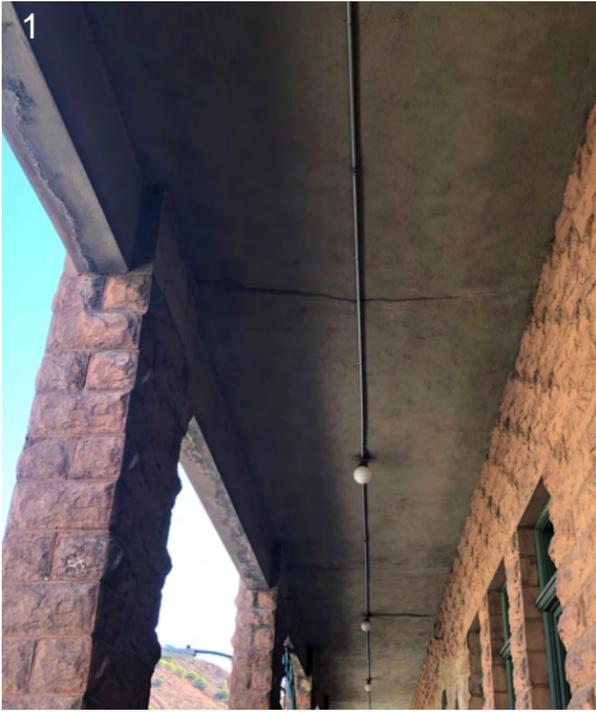
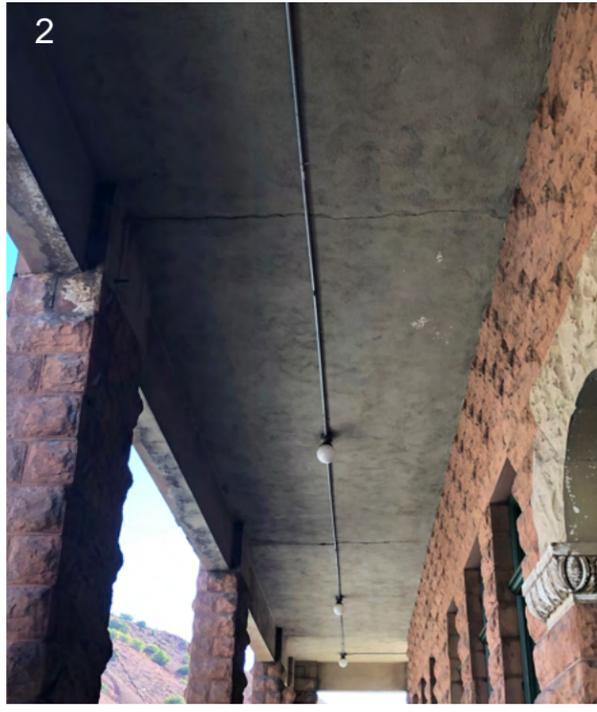
The level 3 deck was observed to have some cracks occurring on the underside in alignment with the exterior pillars. There is evidence of moisture seeping through the crack from exposure to rain on the top surface. A surface applied sealer over the top surface of the exposed decks would help mitigate moisture seepage through the deck that can promote corrosion of slab reinforcing.

Photos 1 and 2 above were taken from the level 2 porch looking up at the underside of the level 3 porch concrete deck. Cracking can be seen spanning in the north/south direction from the CMU pillars to the CMU wall. See plan view for photo locations.

2. The exterior porch slabs appear to be allowing moisture from the weather to seep through and potentially causing corrosion of the reinforcing steel. It is advised to apply a surface sealant that will mitigate surface moisture from migrating through the slab.

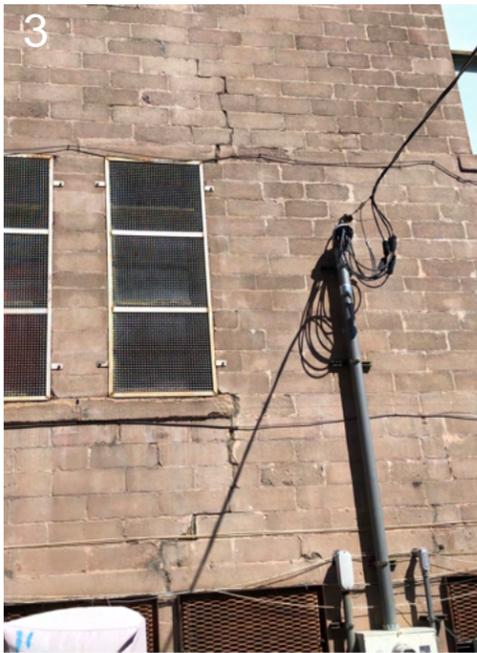
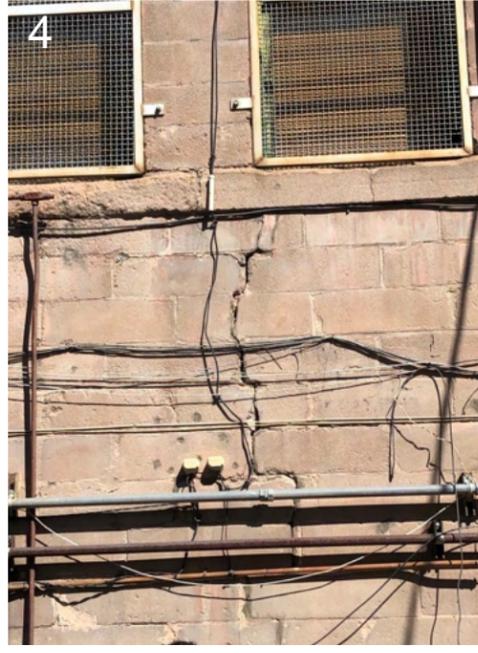
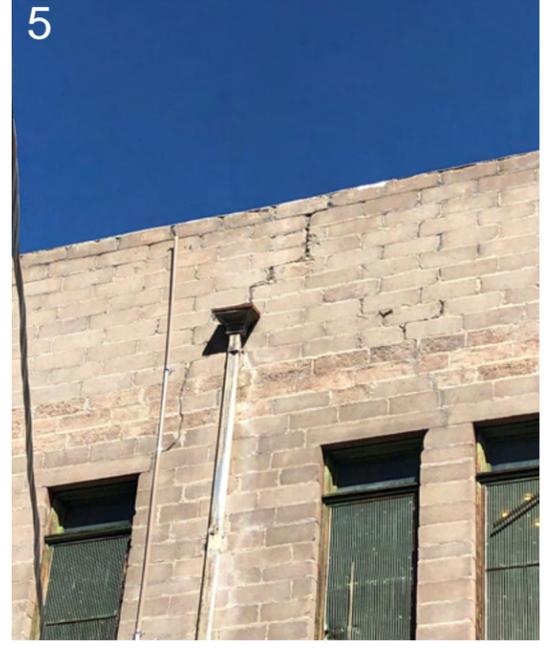
The exterior walls are CMU for the entire height of the building. It is unknown if it is reinforced or unreinforced masonry. It was common practice for the masonry to be unreinforced for this construction era. At various locations on the south wall, some cracking was observed. Most cracks propagate from wall openings and are the result of minor foundation settlement and lack of crack control joints in the wall. The cracks do not appear to pose significant risk to the structural integrity of the walls but should be repaired. Control joints in the wall

Photos 3, 4, and 5 show cracking observed on the south facing exterior CMU wall. See elevation view for photo locations.

1. The south masonry wall that has experienced cracking should be repaired. It appears there have been attempts at patching some of the cracks, but do not appear to have been performed by an experienced masonry repair contractor. The cracks should be cleaned out and filled with a cement base mortar by an experienced masonry repair contractor.

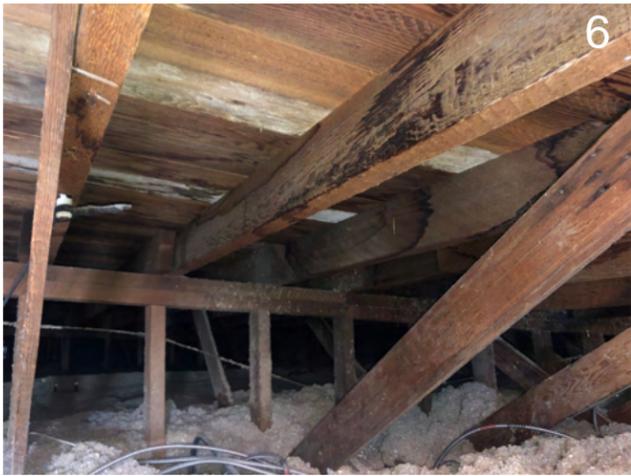
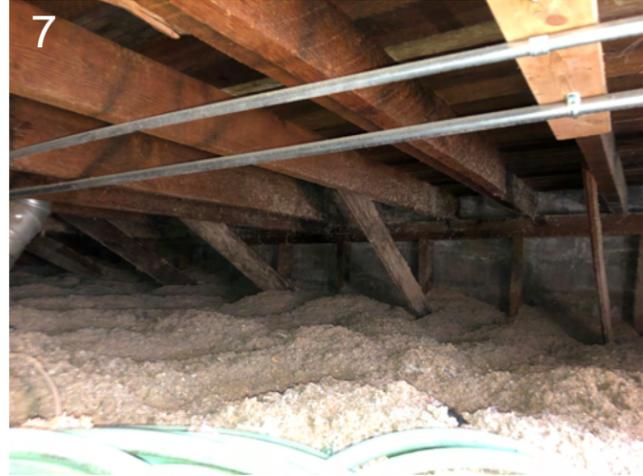
Photos 6 and 7 show what can be seen of the wood roof framing from the roof access hatch.
