# **COPPER QUEEN LIBRARY BISBEE, ARIZONA**

*BUILDING CONDITION ASSESSMENT*

*May 20, 2021*

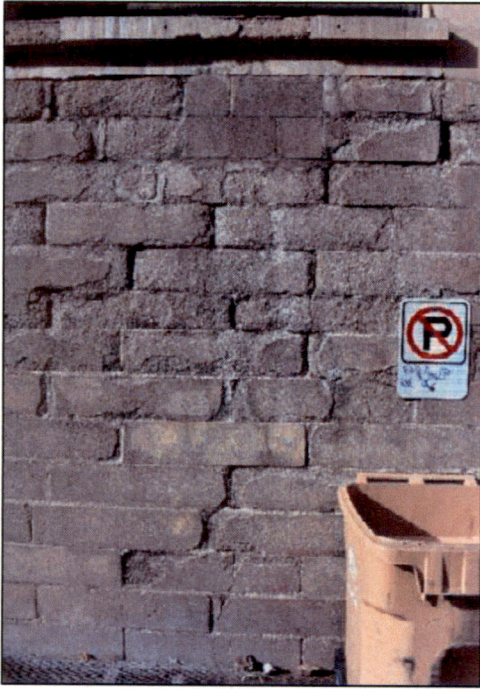
Figure 4. Damaged/undamaged gray smooth-faced blocks at ground story of south elevation. March 2021.

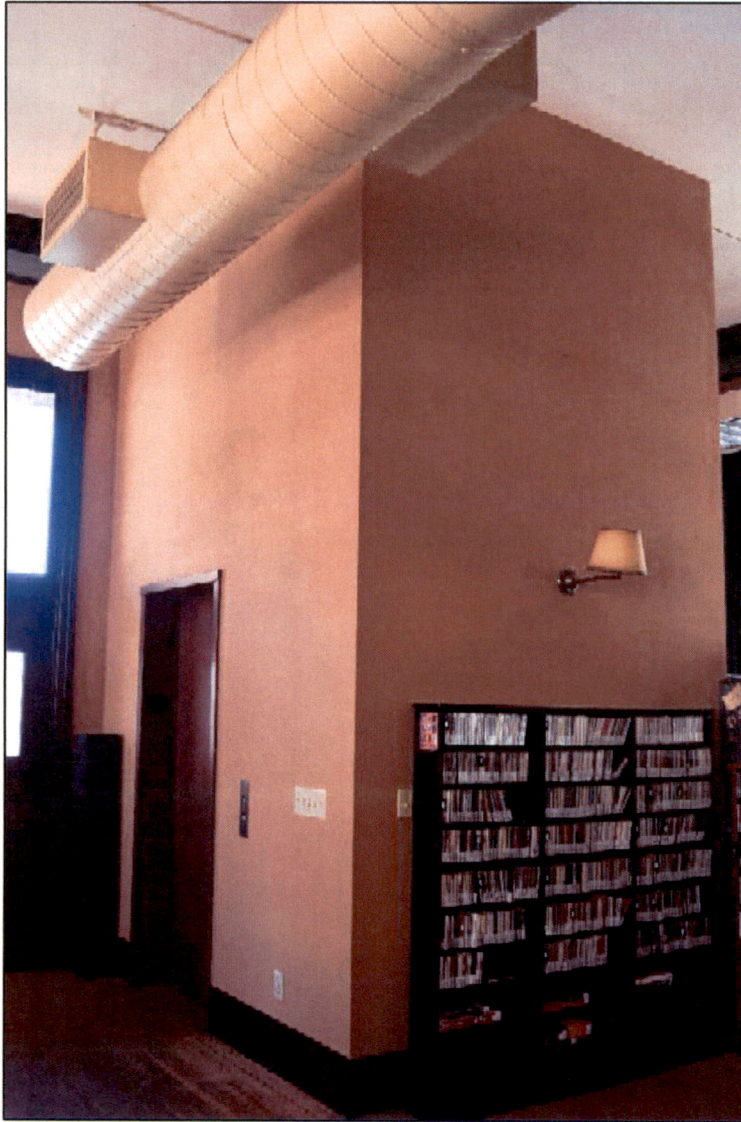
The second story of the library has undergone few changes since its construction. The most obvious of these changes include the diminishment of the story's open floorplan to accommodate an elevator and shaft; the construction of the new rear bathrooms, and changes to various building systems including new light fixtures and HVAC ducts (Figure 37). Smaller-scale changes include the addition of new light fixtures such as hanging fluorescent box lights and, more recently, hanging brass chandeliers, new ceiling fans, light switches, and other utility features.

*Figure 37. Modern elevator shaft and air duct, looking southeast. March 2021.*

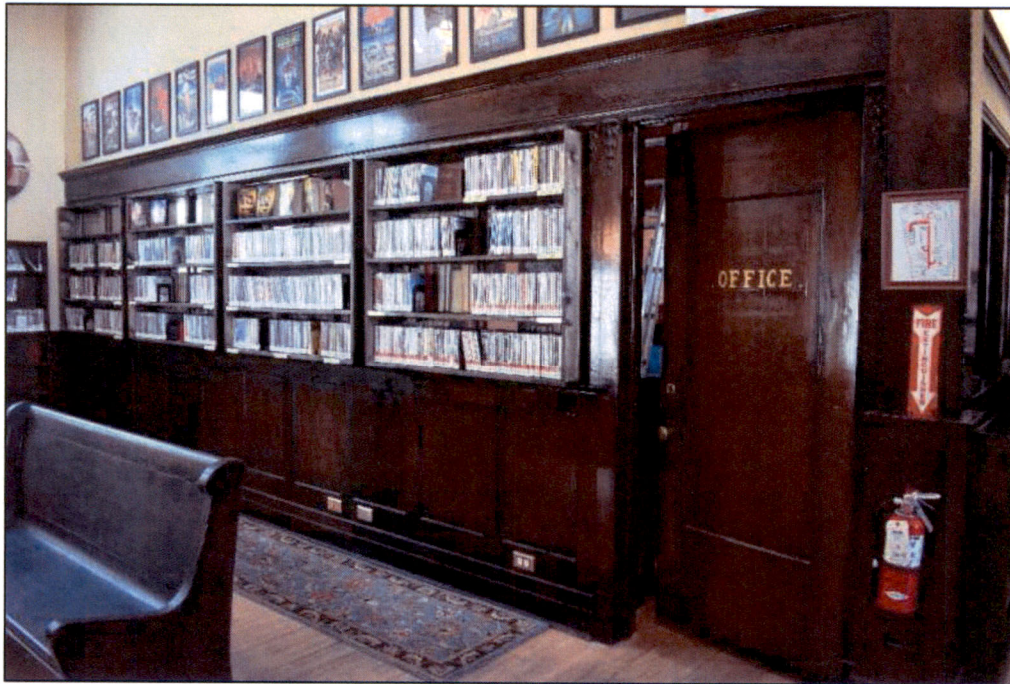
Figure 38. View of office-cum-reading room with shelves inserted over original intact glazing. March 2021.

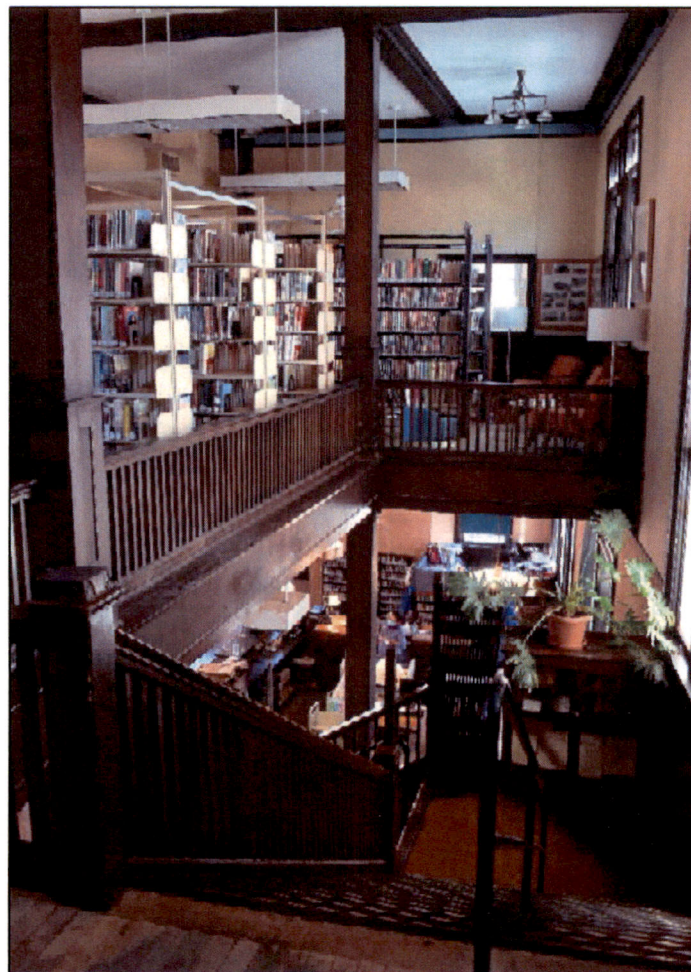
*Figure 46. View of main stairway looking down from third story. The L-shaped circulation pattern of this stairway including its banister, woodwork, and lower gate should be preserved. Later elements including the metal hand rail or particle board flooring are not character-defining and may be removed or altered. Note that although these features are not representative of the building's original architecture, they are illustrative of its history and age and could be retained as a testament to the library's long-standing use. Library Bureau issued tables and chairs are original to building and should be preserved and retained. View looking east. March 2021.*

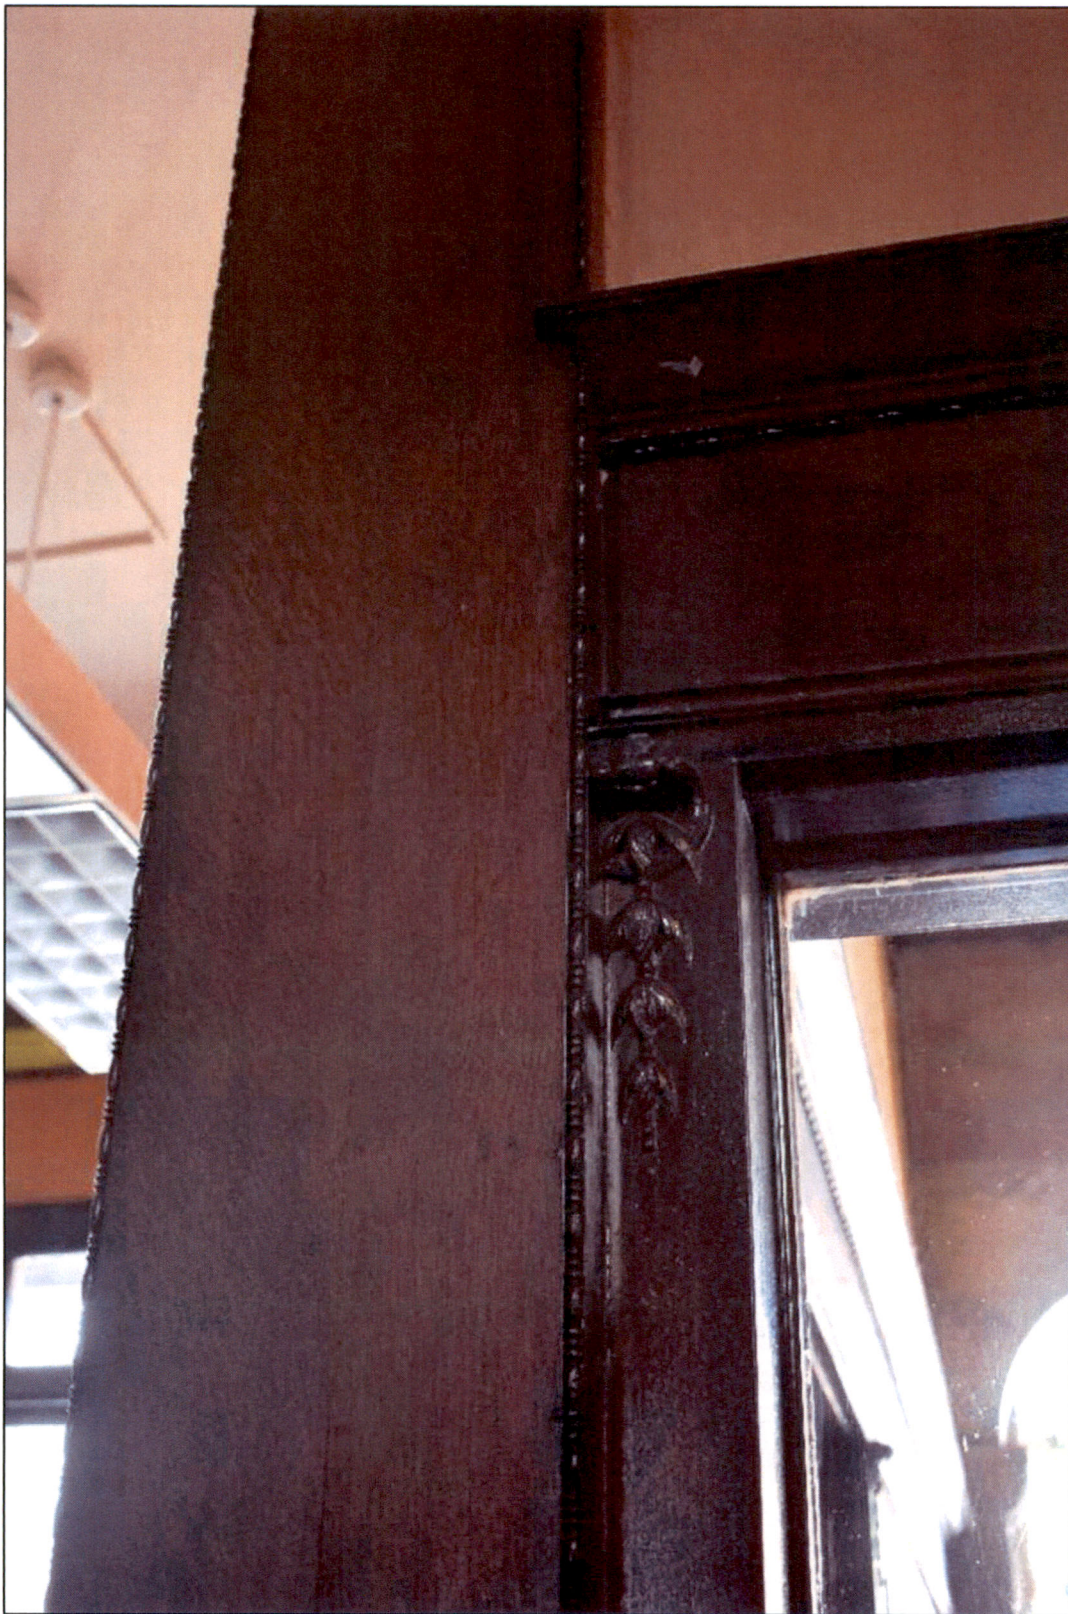
*Figure 47. Character-defining molding along second story entry vestibule. Note bead and reel string course and dropped drops of husks, with view looking north. These elements are character-defining and should be preserved or restored. They should not be painted or otherwise altered. March 2021.*

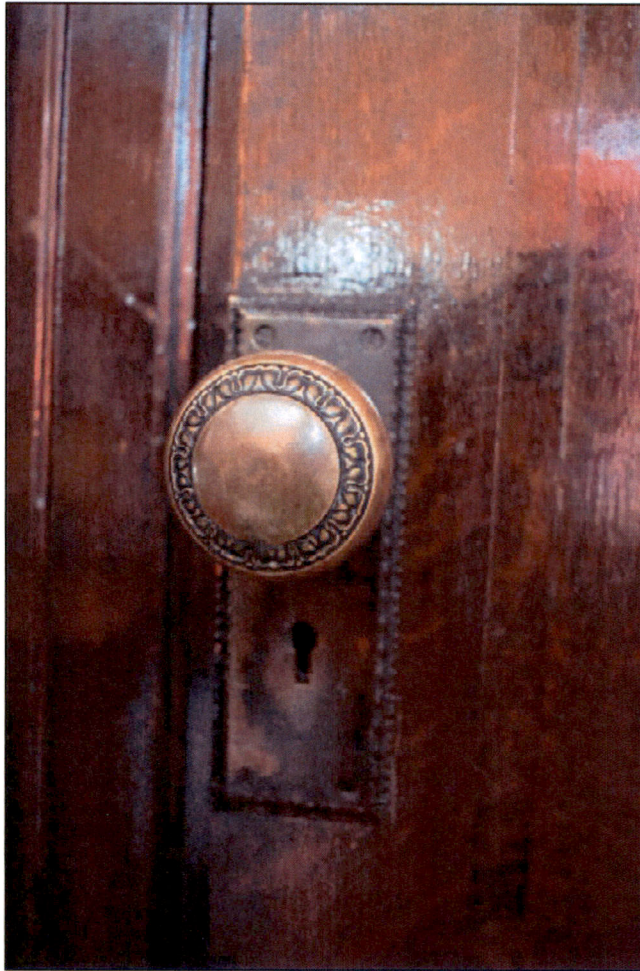
*Figure 48. Doorknob on second story door beneath stairway. Small-scale features such as door hardware should, where possible, be retained and preserved. March 2021.*

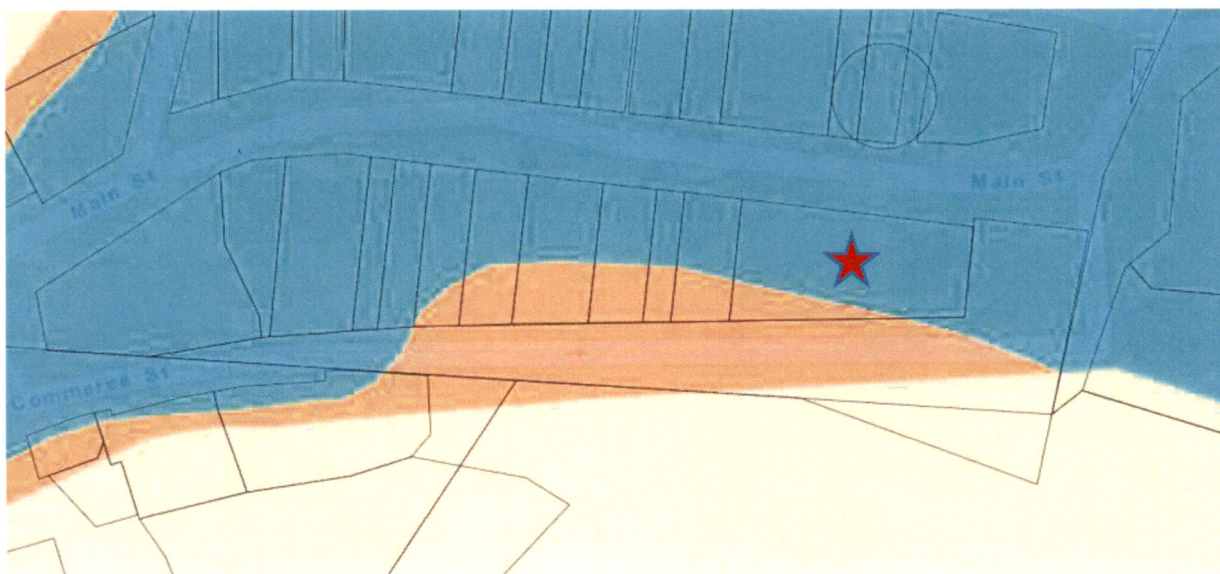
The Library is bisected by two Flood Hazard Zones. In blue is the **AE Flood Zone**. This is in essence the 100 year storm flood zone with an Annual Chance of Flood Hazard. In buff color is the **X Flood Zone**, the 5000 year storm flood zone with a .2% Annual Chance of Flood Hazard. The Library has a small basement, so the two flood zones may present a significant hazard. The first floor is occupied by the US Post Office, but a visual inspection indicates the first level Finish Floor level is probably above the Flood Zones.

Cochise County GIS Flood zones

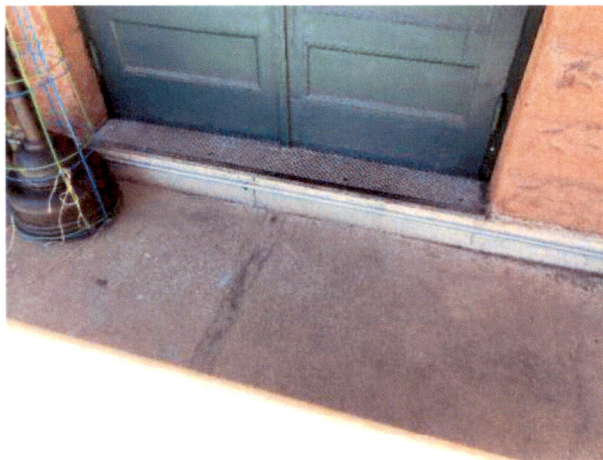
ADA access to the *veranda* from the Library on the upper two floors is not available because of 2.5" steps at all doors leading from the Library to the outer porch. The front doors of the library do exit at grade to a portion of the porch, but that area is ADA isolated from the remainder of the *veranda* with the same grade change. We recommend a platform at the eastern doors of the Library on the 2<sup>nd</sup> and 3<sup>rd</sup> floors with a 1:20 sloping sidewalk heading north from that western door platform of the Library.

*Library to veranda at east Library exit*

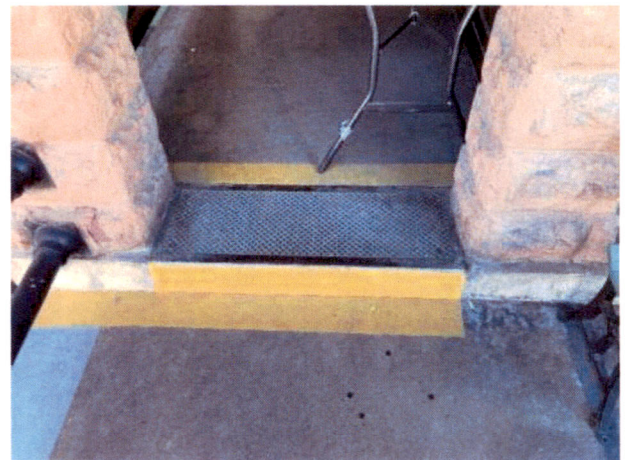
*Grade change from entry veranda to wrapping verandah.*

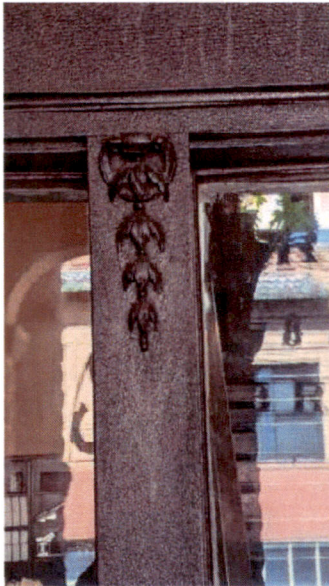
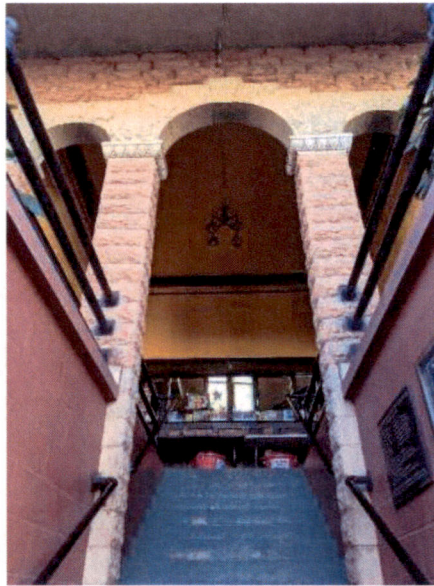
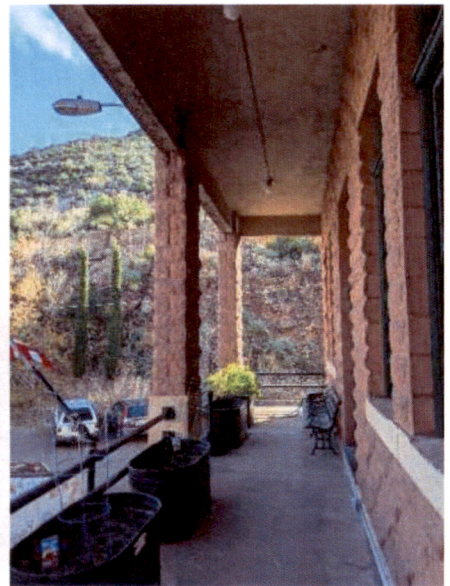
Because three of the four sides of the upper two levels of the Library have been protected by the veranda, the exterior walls of the Library inside the veranda are in generally very good condition, including the wood panel areas.

*Protected exterior walls*

- walls protected by the veranda need minor cleaning and repair
- walls on the north, east and west exterior walls need substantial cleaning, repair, and especially repair of delamination of exterior plaster coats
- the south wall needs major improvements, starting with removal of obsolete piping and conduit, panels, meter bases, etc.

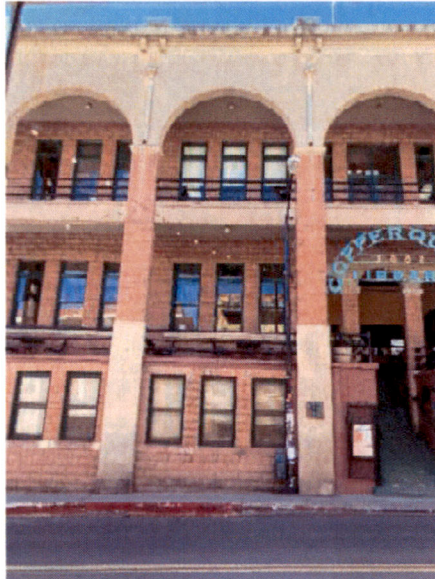
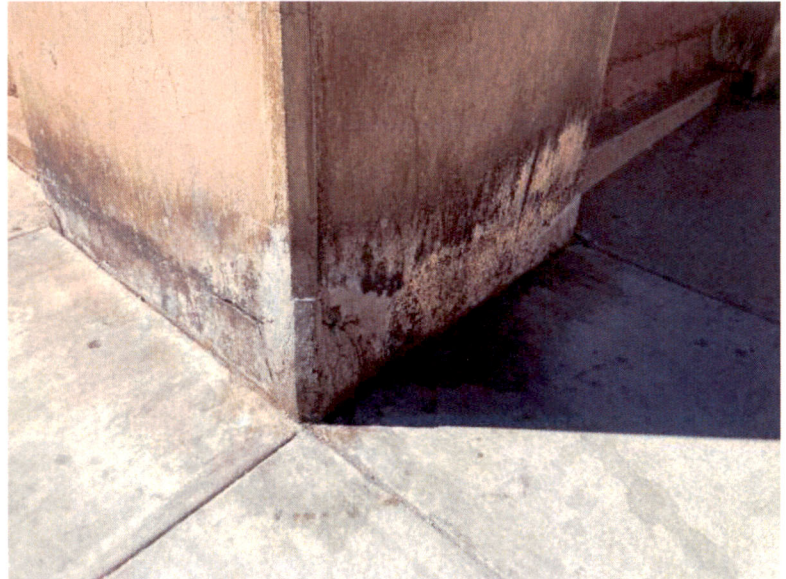
By contrast the portions of the three sides not protected by the veranda has some minor damage, and the south wall facing Commerce, unprotected by the veranda, has significant damage

*Unprotected exterior walls*

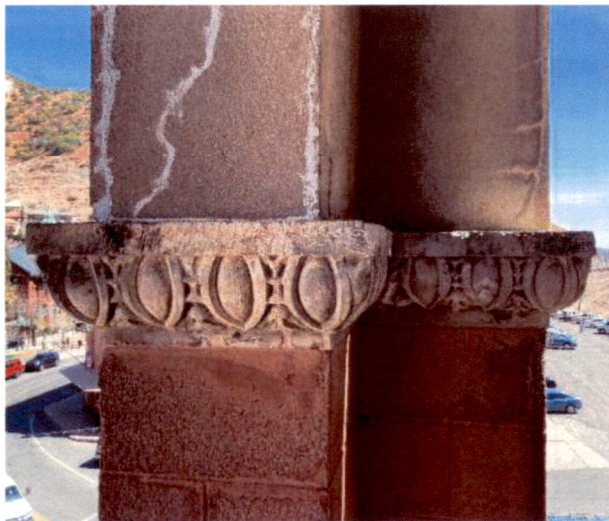
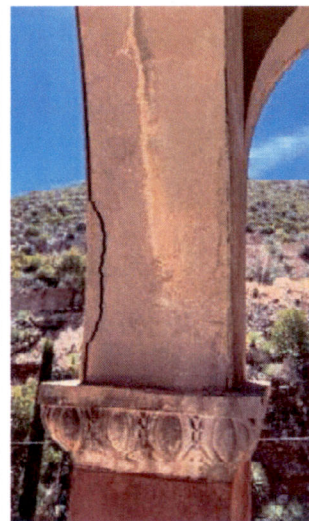
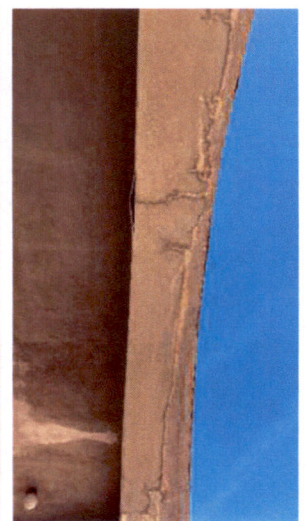
*Delamination of unprotected exterior walls*

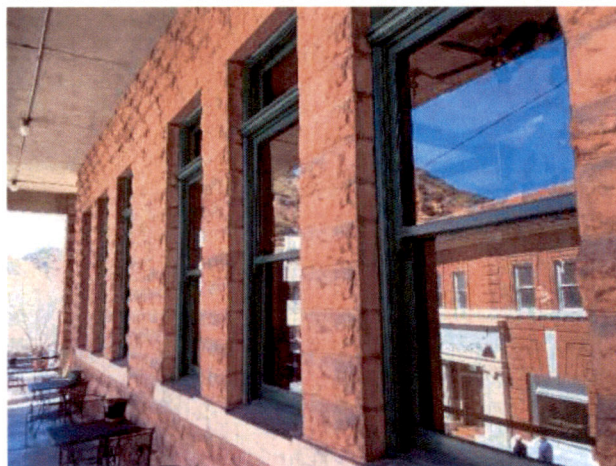
The windows in the Copper Queen Library follow the pattern of the walls described above. The windows protected by the veranda are in extraordinarily excellent condition. The windows on the east and north at the lower level (not protected by the veranda) are in good condition, and the windows on the south wall are in fair condition with several of the windows covered with security screens at the lower level.

*Windows covered by veranda*

- the windows that face onto the veranda need light sanding (check for lead-based paint content) and repainting, inside and out.
- the windows on the north side that face onto Main Street and the four windows on the east side need some repair, more substantial sanding (check for lead-based paint content), and repainting inside and out.

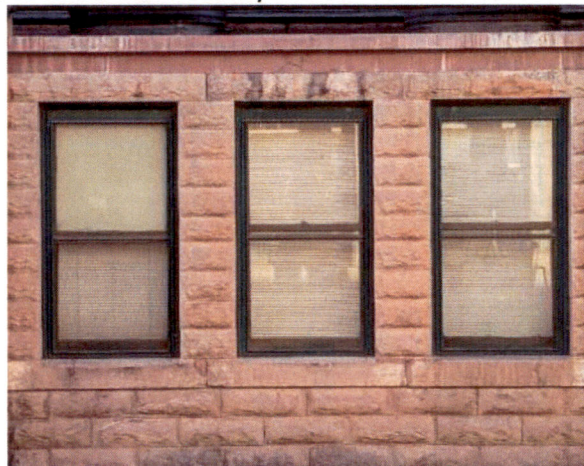
*North windows facing Main*

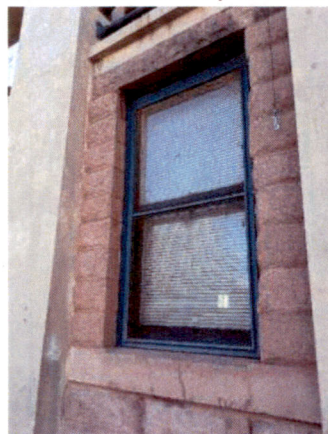
*East window at Post Office*

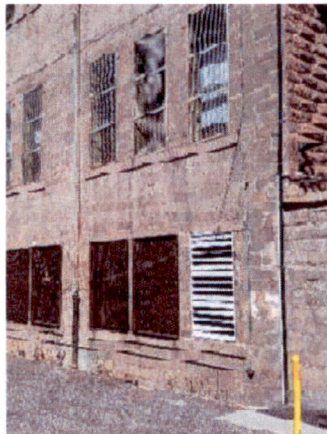
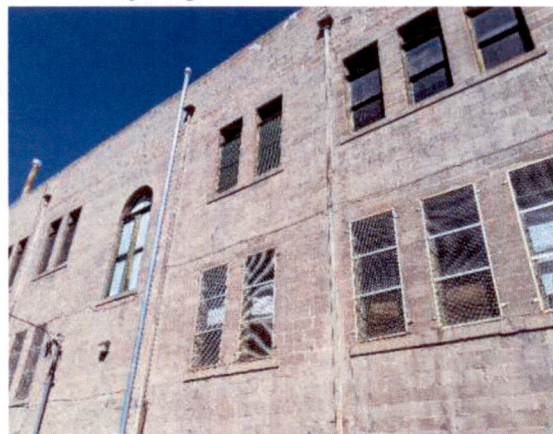
*South windows facing Commerce (1<sup>st</sup> floor, 2<sup>nd</sup> floor and 3<sup>rd</sup> floor)*

- the windows on the south wall should receive the following treatment: lower level windows into the Post Office should keep their steel expanded metal security screens (these should be repainted dark green.) The interior of these windows need sanding and repainting. The windows on the second level should have their tabbed security screens removed. The wood windows beneath the security screen, damaged by extensive exposure to south sun, should be repaired as necessary, scraped (check for lead-based paint content), and repainted, inside and out. The windows on the 3<sup>rd</sup> level are in poor conditions and will need extensive repair and repainting, inside and out.

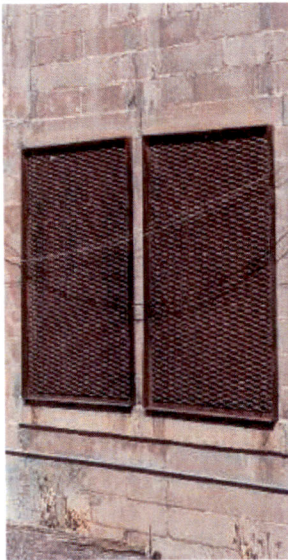
*1<sup>st</sup> level metal security*

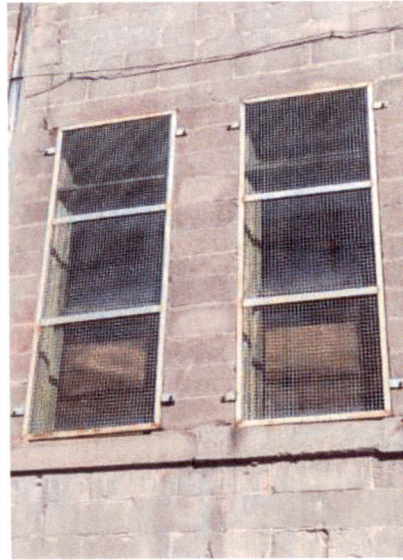
*2<sup>nd</sup> level metal security*

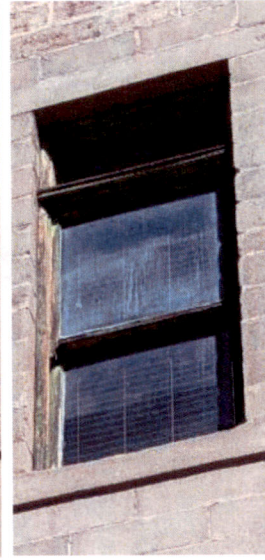
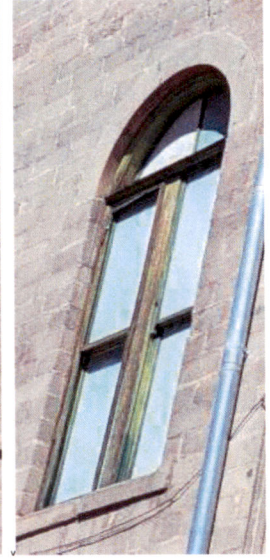
*3<sup>rd</sup> level wood windows in poor condition*

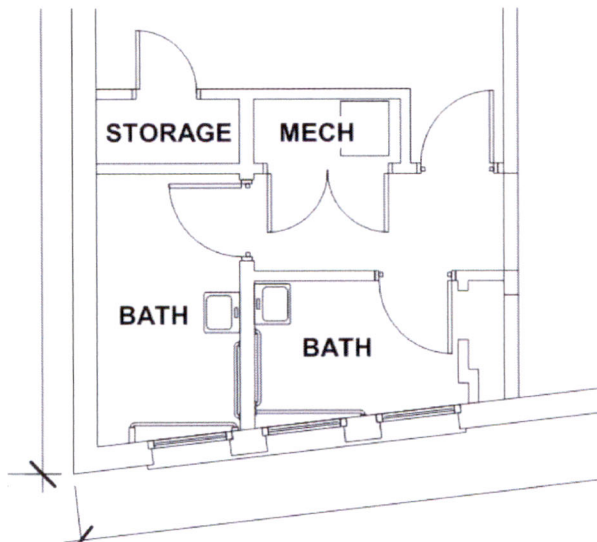
The bathrooms on the 2<sup>nd</sup> floor seem to be in good order and are both ADA accessible. The 3<sup>rd</sup> floor bathroom is not accessible.

*2<sup>nd</sup> floor accessible bathrooms (WC not shown)*

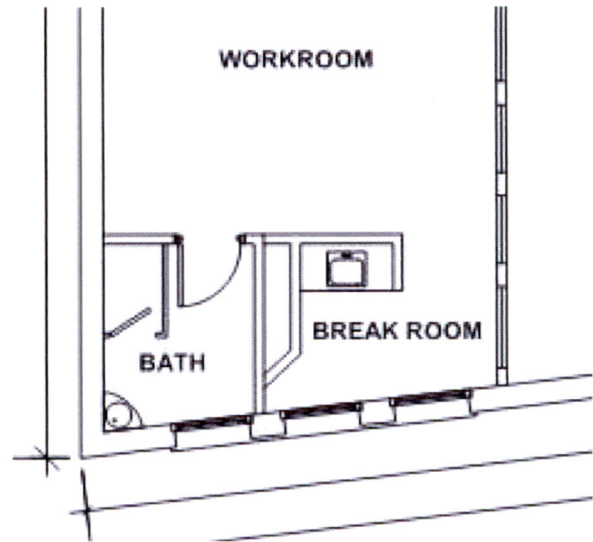
*3<sup>rd</sup> floor bathroom not accessible (WC not shown)*

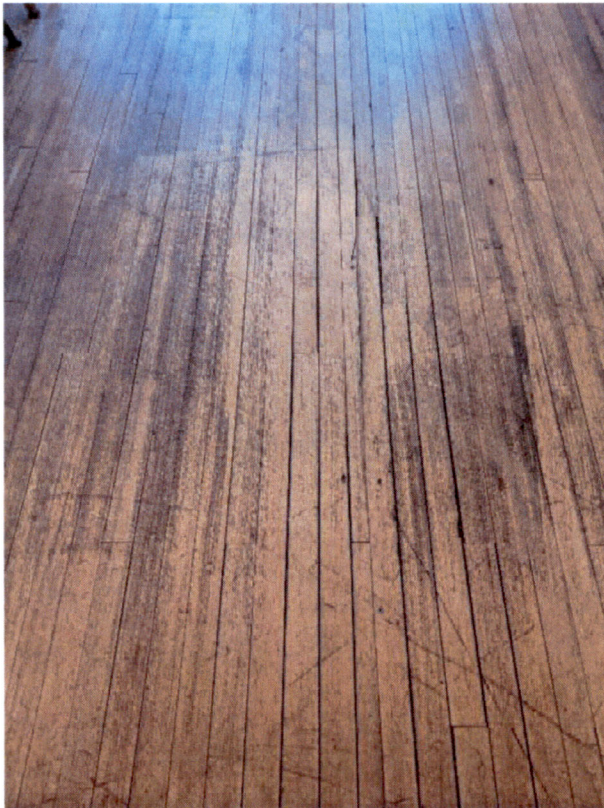
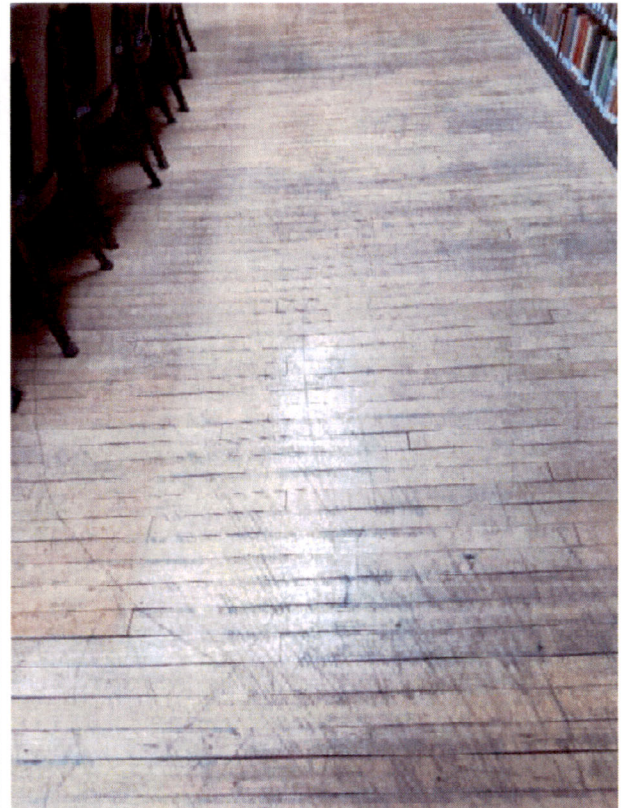
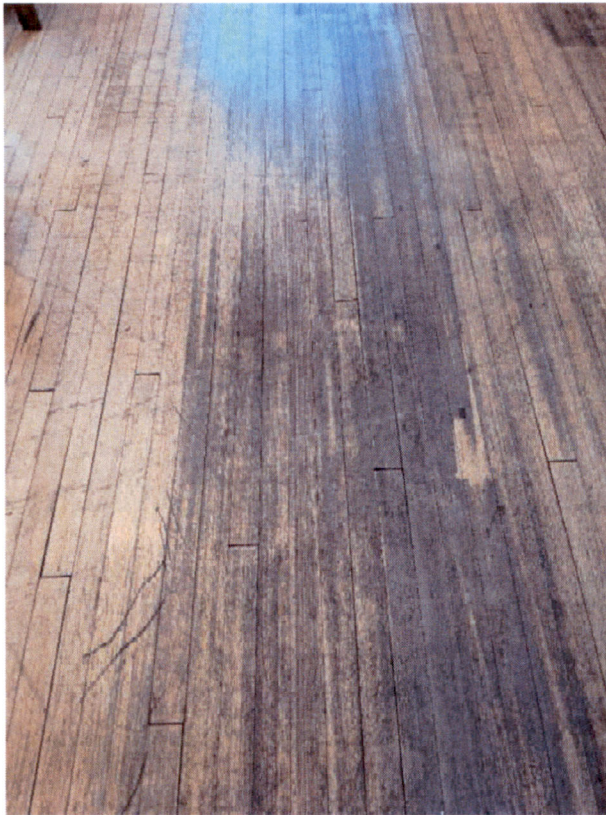
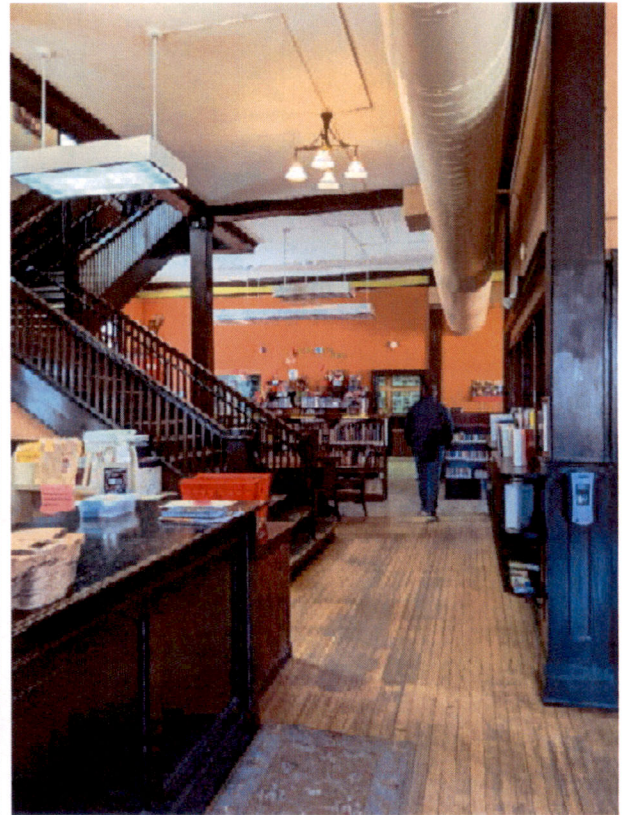
The flooring in the library is high quality wood flooring (maple?) that appears rough, but is simply in need of a machine re-sanding and refinishing. It looks as if it has not been refinished before, so it should easily handle the sanding without endangering the top tongue of the tongue and groove. It can be beautifully restored. The scuff marks and damage should be easily repaired. The open joints will close in wetter season and the floor will do better with a more stable HVAC system. Evaporative coolers are very rough on wood floors.

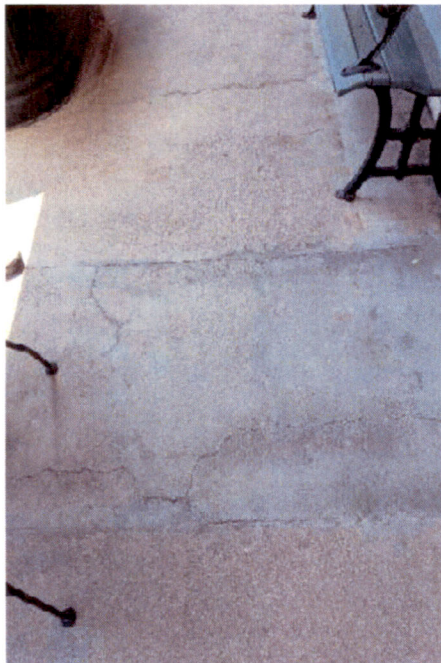
The exterior deck of the veranda has substantial cracking. It is recommended that a new 1/2" cementitious topping with appropriate score spacing be placed on top of the existing veranda surface. This will restore a good quality walking surface outdoors and provide waterproofing to prevent leakage to the ceiling below.

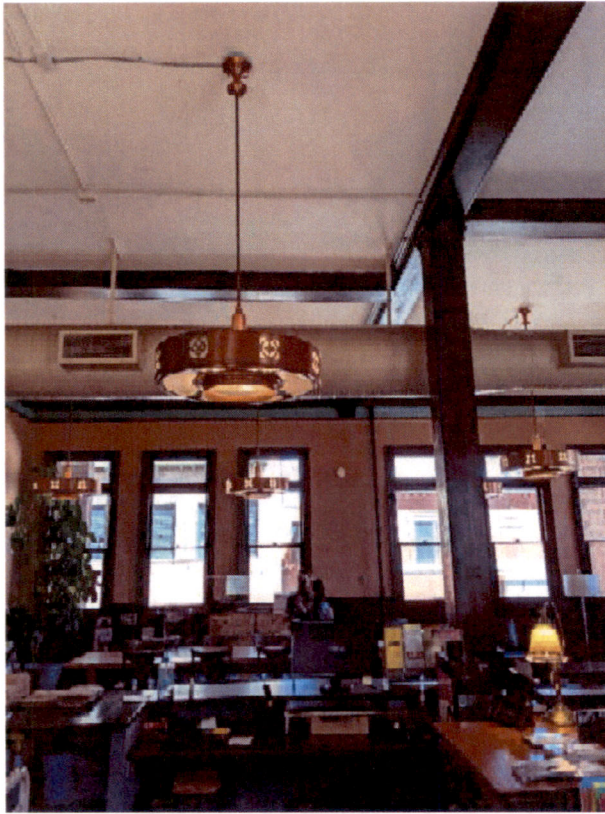
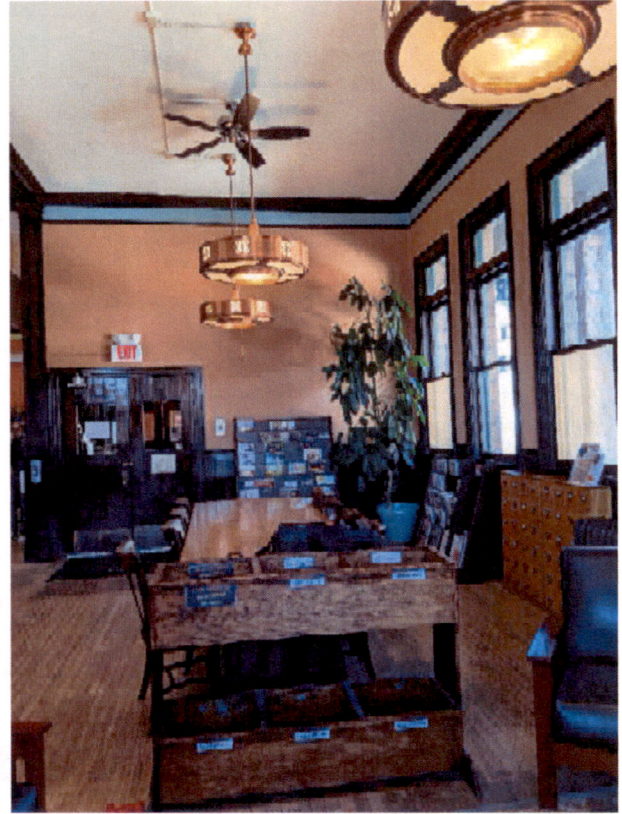
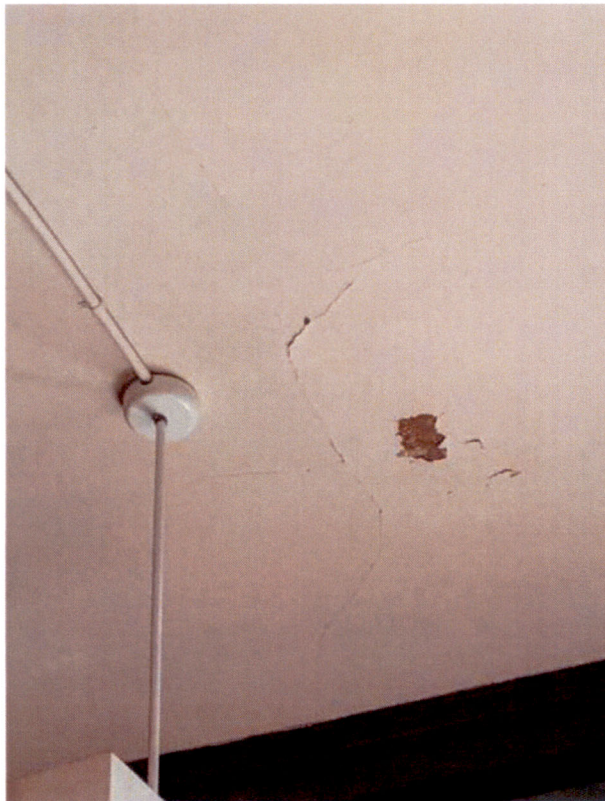
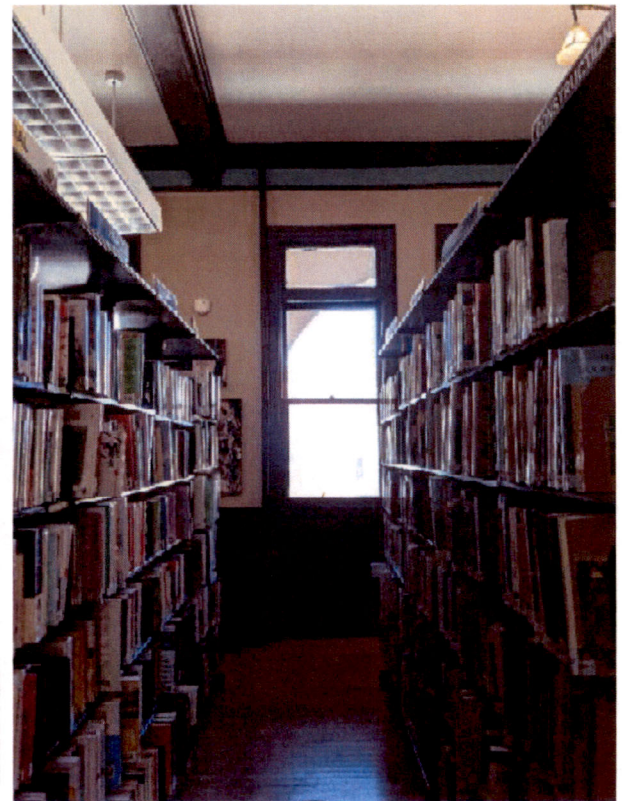
The ceilings in the Library interior are in generally very good conditions. They simply need to be cleared of electrical conduit and repainted.

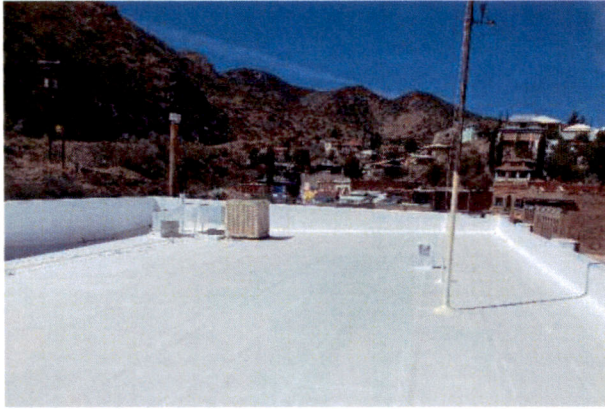
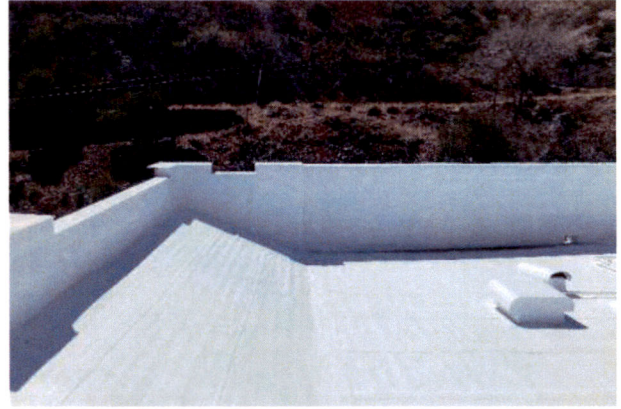
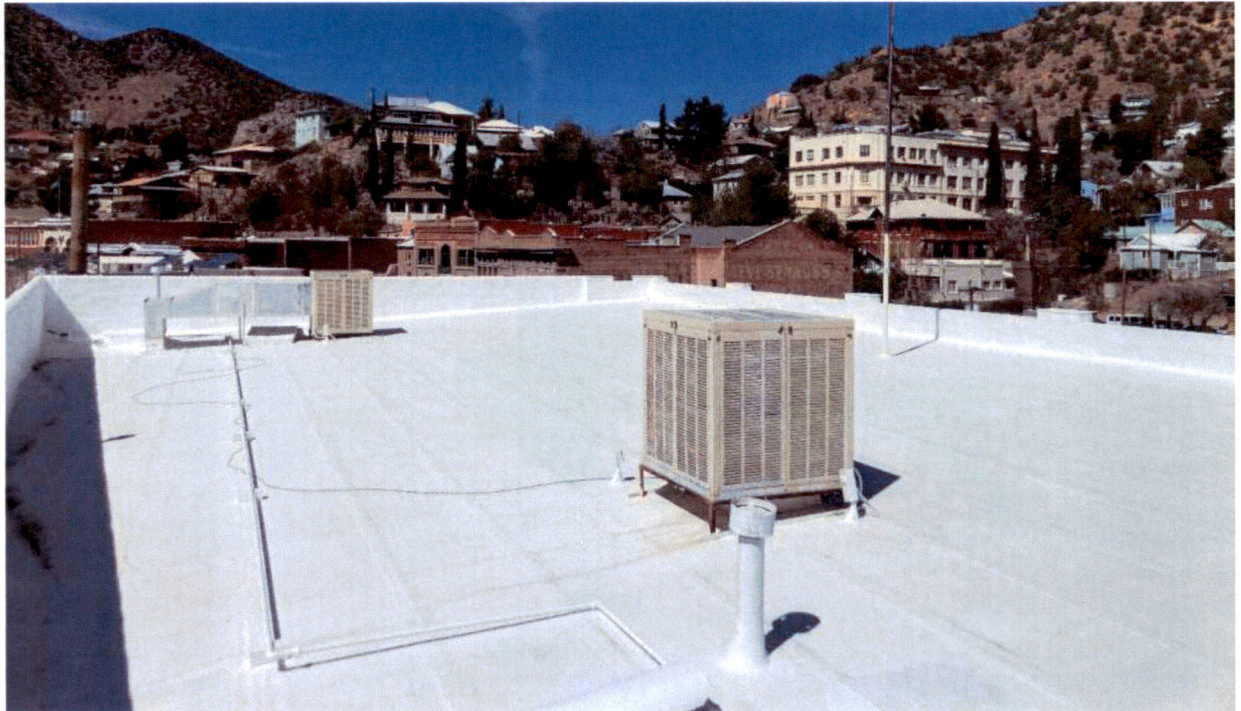
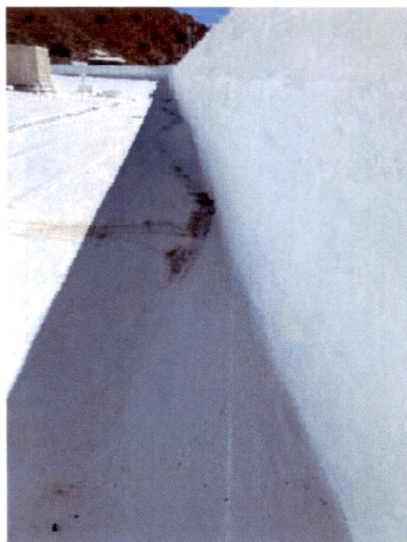
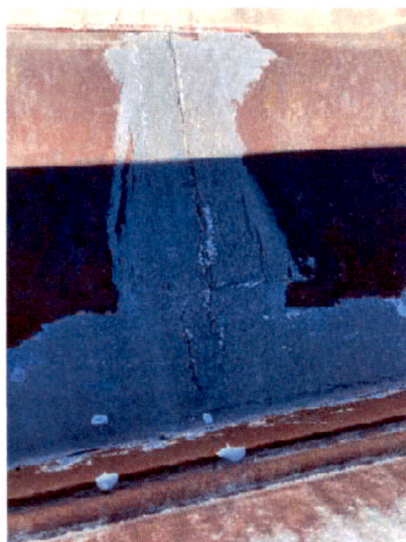
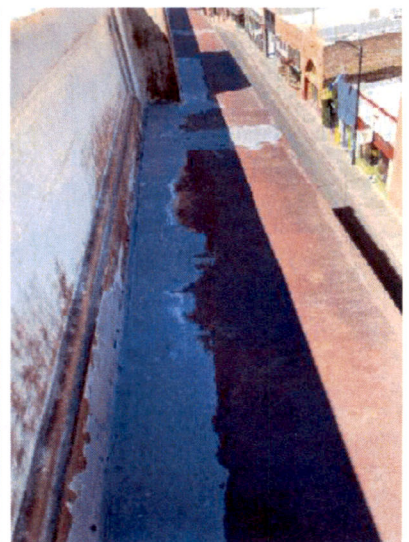
The roof is in excellent condition. Given the change in HVAC systems that will likely be roof mounted. The roof should be inspected for areas of repair and then recoated with a white acrylic coating.

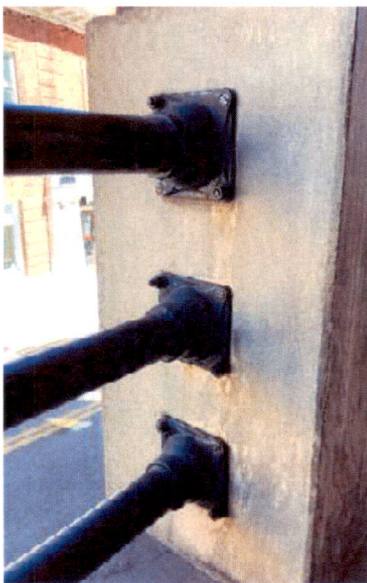
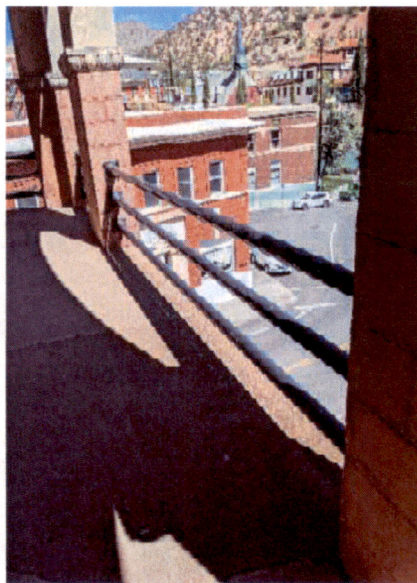
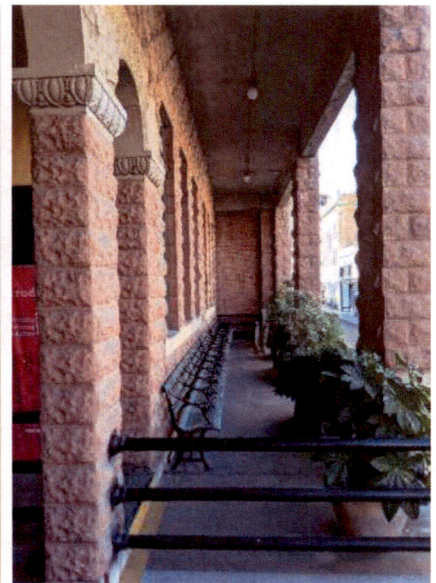
The railing of the veranda is the most significant code issue presenting a significant danger to users. It is recommended that the public not be allowed to access the veranda until this danger is eliminated. danger to users. The railing has two problems: it is 29" tall compared to the code required 42" tall. In addition, the code requires that a "4 inch ball shall not pass," meaning that no opening in the railing itself should be larger than 4". The current railing meets neither of these requirements for the full length of the veranda.

The solution is complicated by the fact that the pipe rails are a character-defining element of the exterior design of the veranda railing. From an historic preservation perspective, it would be best to maintain the material, scale, proportion, and character of the railing.

PMM had a similar challenge in our rehabilitation of Old Main on the University of Arizona campus. With the enthusiastic approval of Arizona SHPO, PMM created a nearly invisible free-standing rail inside the historic railing. Building users were clearly able to understand that the railing was contemporary and installed for safety. Yet from the exterior. The historic material, scale, proportion, and character of the railing are maintained.

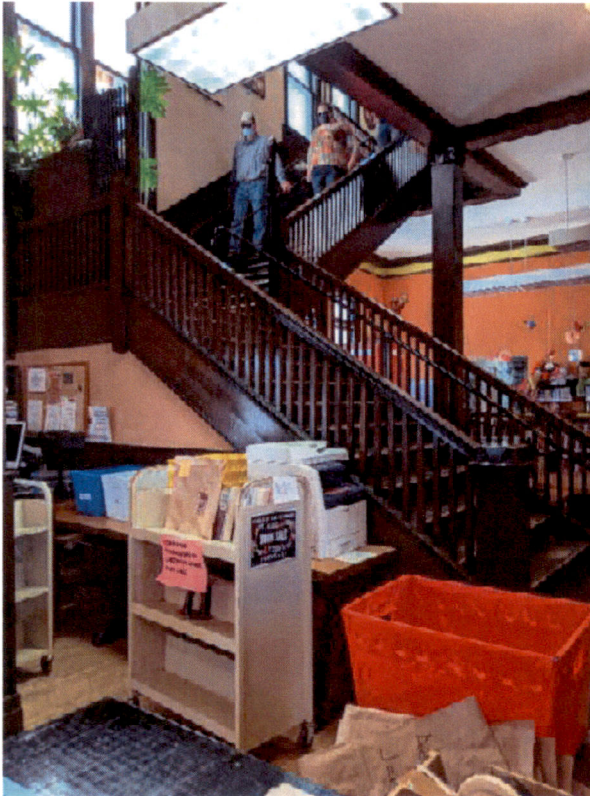
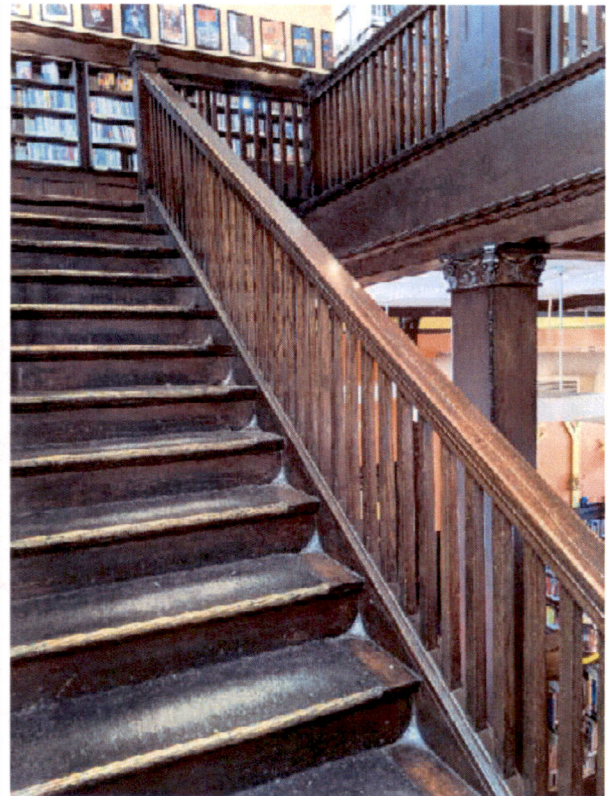
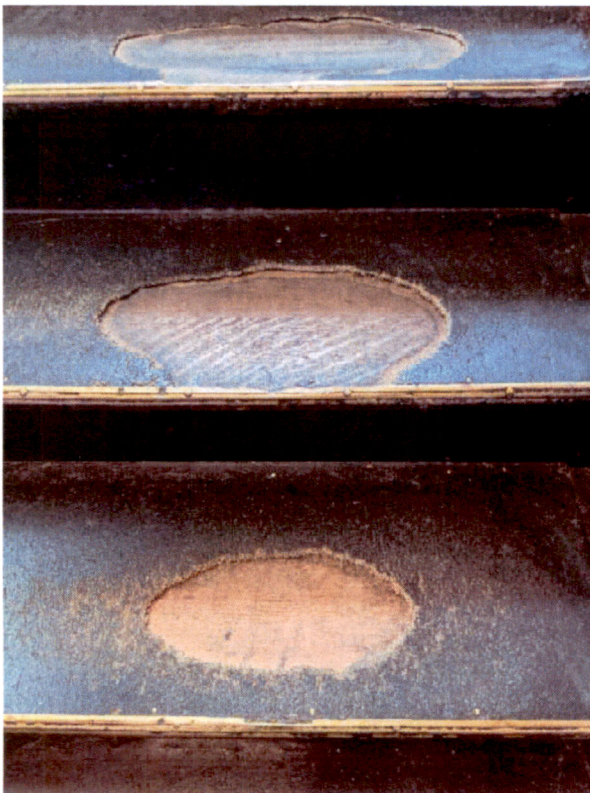
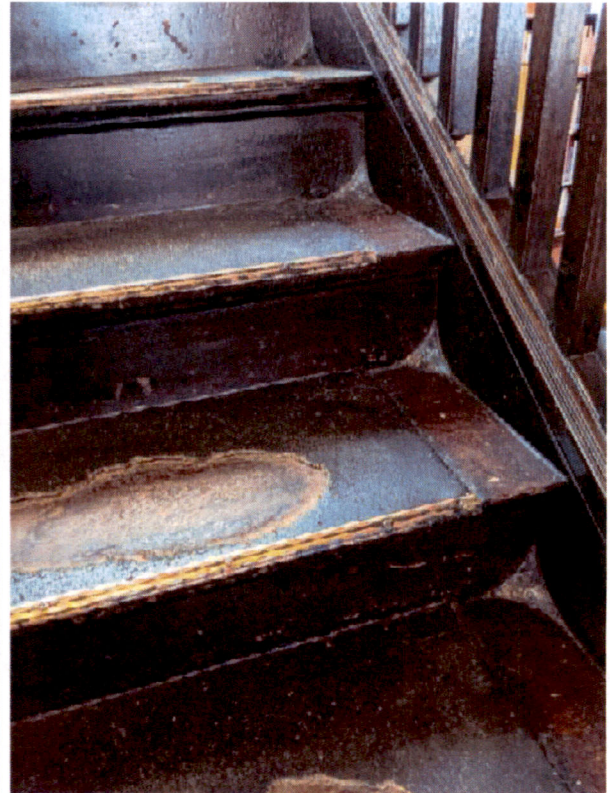
The interior staircase is generally in good condition except for two significant issues:

- The stair treads are seriously worn out and should be replaced for the entire staircase with a comparable composite material in thickness and color to match the original. Care should be taken to leave the exposed existing wooded tread for the last several inches. The brass nosing should be repaired or replaced as necessary to match existing. Care should also be taken to not compromise the unique “dust corner” inserts.

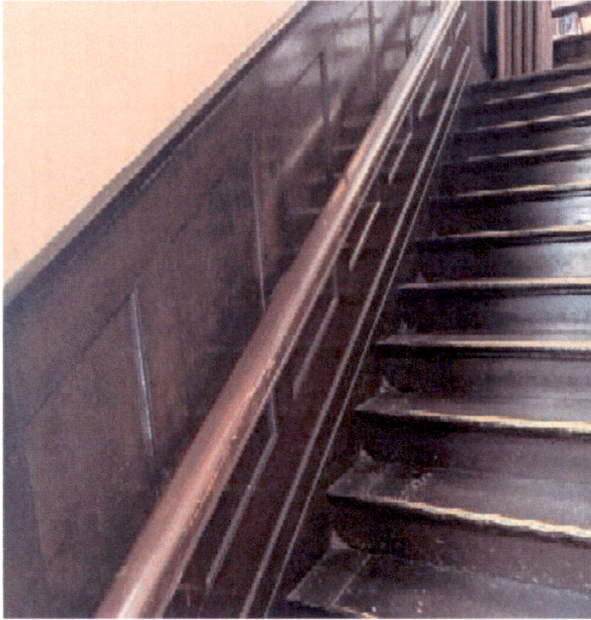
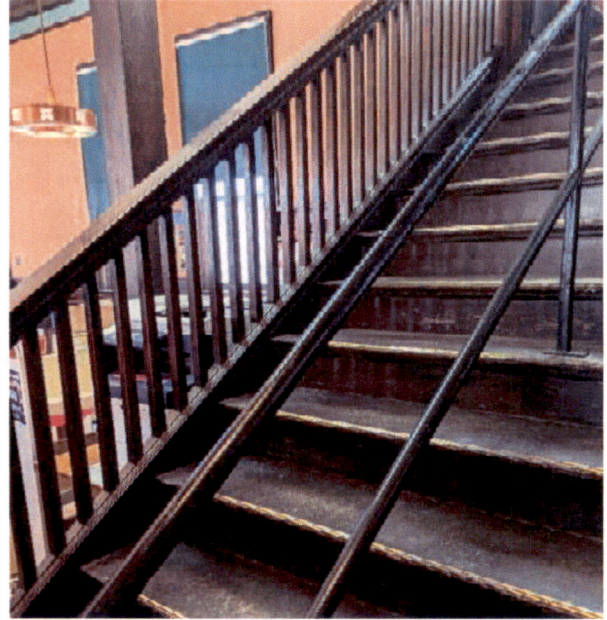
- The stair railing is also a significant code violation and presents a danger, particularly on the 3<sup>rd</sup> floor. The railing is 29" tall in most locations. The code requires a much higher railing at 42". On the upper half of the stair where the wainscoting sits behind the handrail, the handrail can simply be raised to the appropriate height using the existing hardware. At the other three location where there is a low slat rail, a simple pipe rail (similar to the center rail) can be added. This needs to be studied, by our initial recommendation is to "L"-shape a bracket and attach it to the side, not the top of the square top rail, at the appropriate height. The height of the center pipe rail may need to be raised as well. At the 3<sup>rd</sup> floor, a similar pipe rail needs to be added all around the stair opening. That top rail also needs to comply with the 4" ball shall not pass, although there may be some code leniency in this regard.
