# **COPPER QUEEN LIBRARY BISBEE, ARIZONA**

*BUILDING CONDITION ASSESSMENT*

*May 20, 2021*

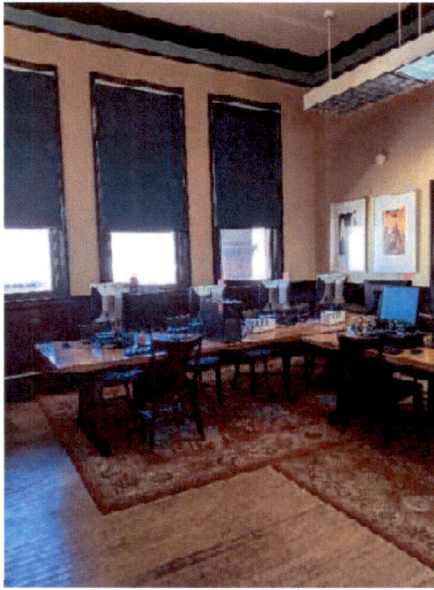
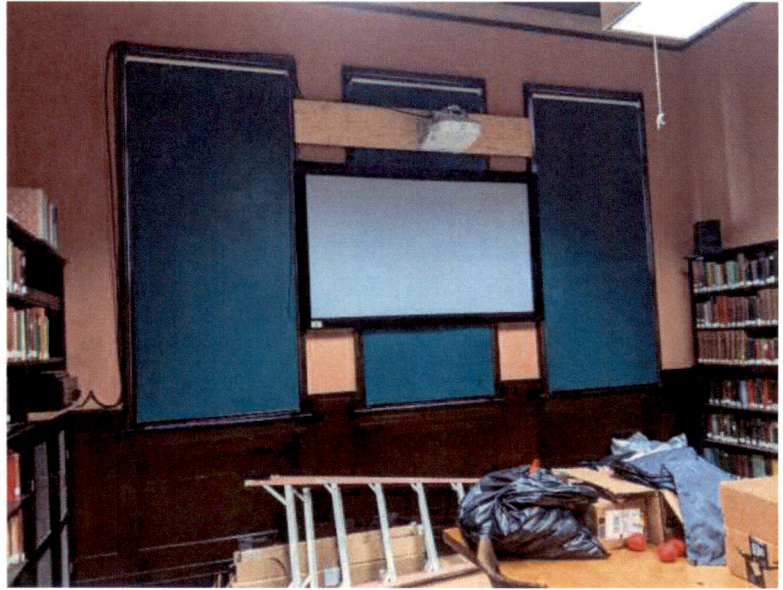
There are not window coverings on all windows. But where there are, they should be consistently installed. The roll-down, green, black-out shades seem to work well with the existing interior and it is recommended that they be installed as needed.

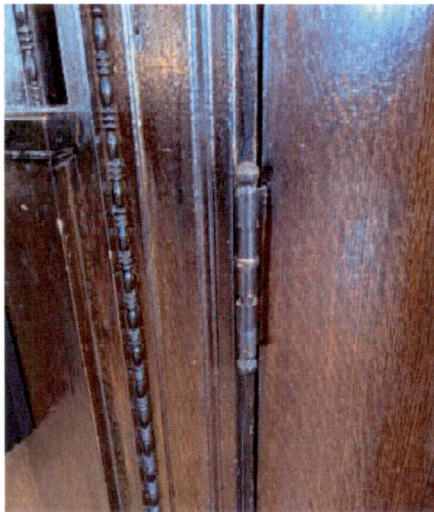
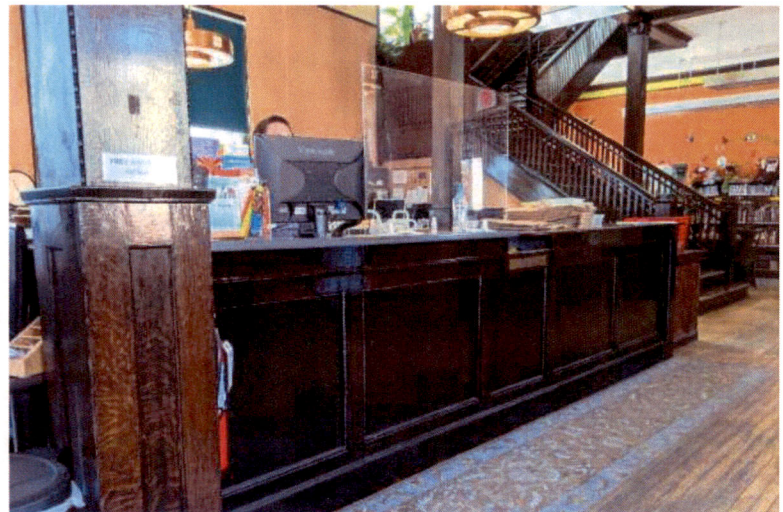
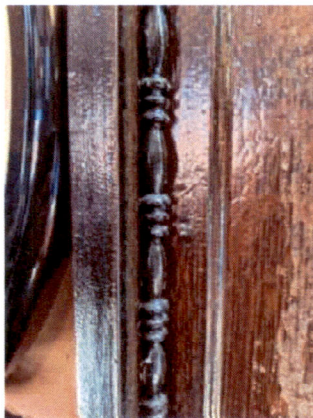
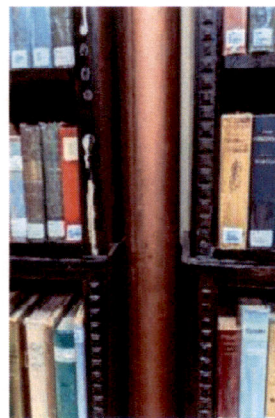
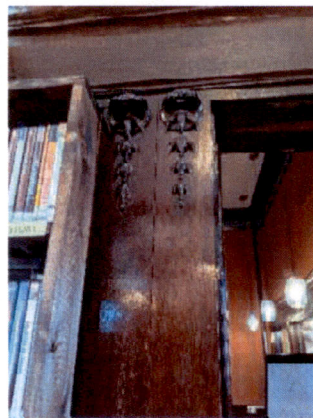
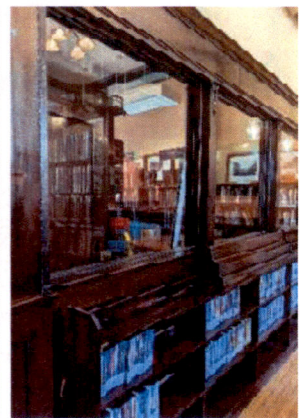
One of the most valuable aspects of the Copper Queen Library is the extraordinary woodwork and the high level of integrity in those materials. The same is true for much of the furniture, which is original and must be maintained and preserved. It is recommended that all of the cabinet work and furniture be repaired and restored to its original quality, including shelving, trim, window trim, and furniture, etc.

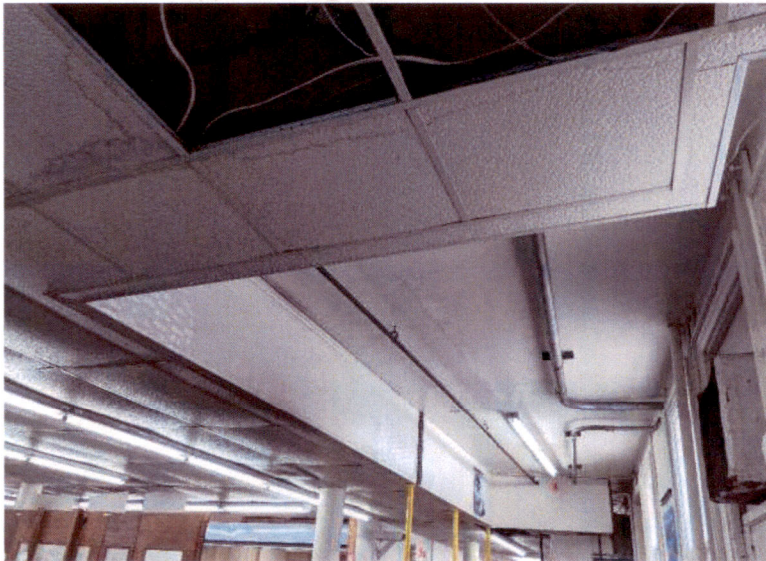
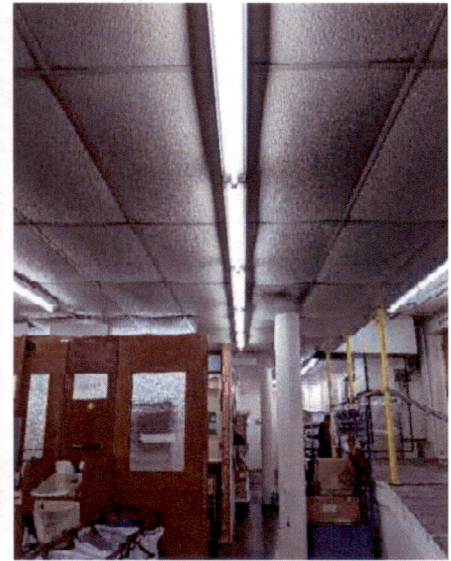
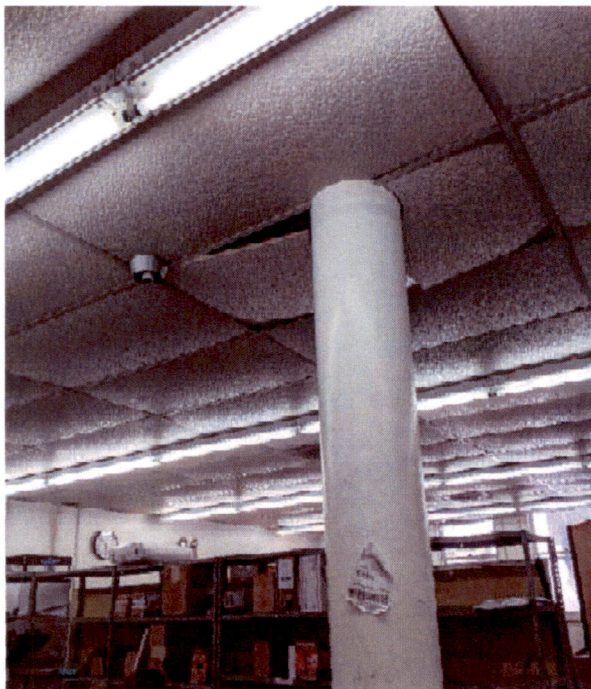
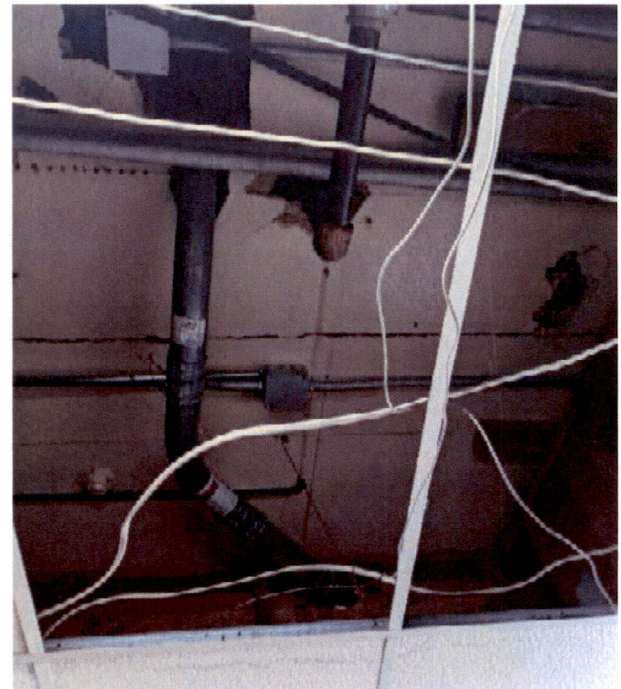
- The ceiling of the Post Office is in terrible condition and has dramatically reduced the spatial quality of the lower level space. There are additional recommendations in the lighting and mechanical sections of this report. There is currently a dropped ceiling at 24" below the original plaster ceiling. It is recommended that, to the extent allowable by the need of lighting and mechanical ductwork, the ceiling be raised by as much as 12". This will improve the spatial quality of the Post Office and the new dropped ceiling will reduce the shabbiness of the Post Office appearance.

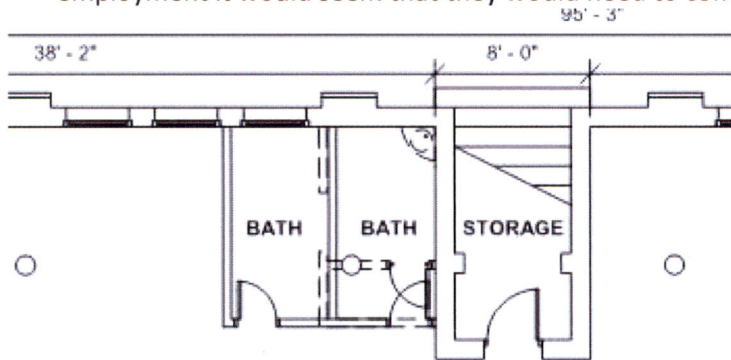
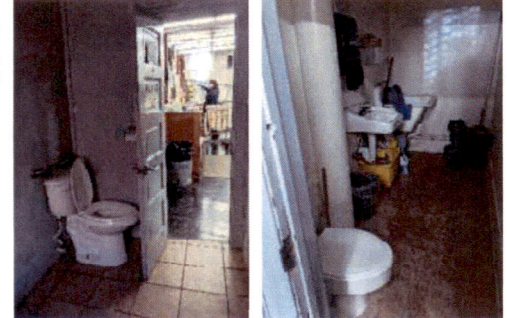
- The Post Office does not have an accessible bathroom on the first level. Given the varied population employment it would seem that they would need to comply. There is room to remodel for ADA.

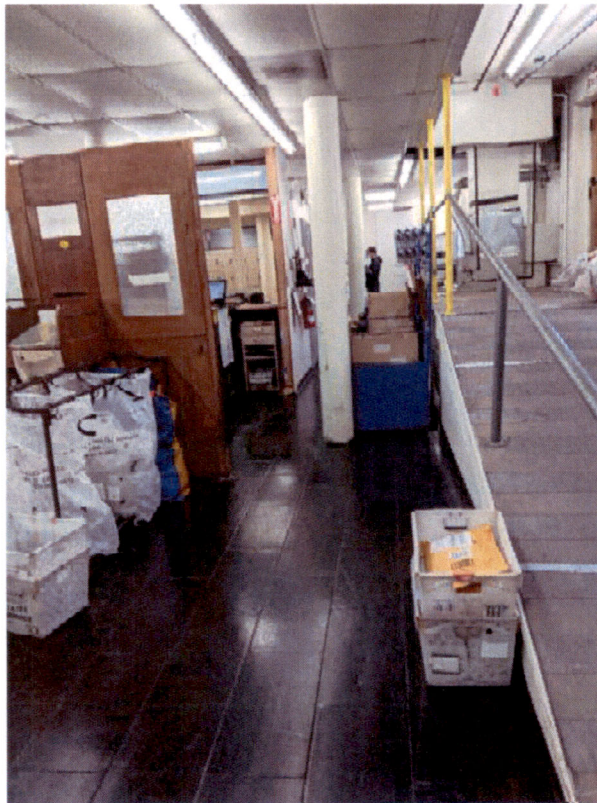
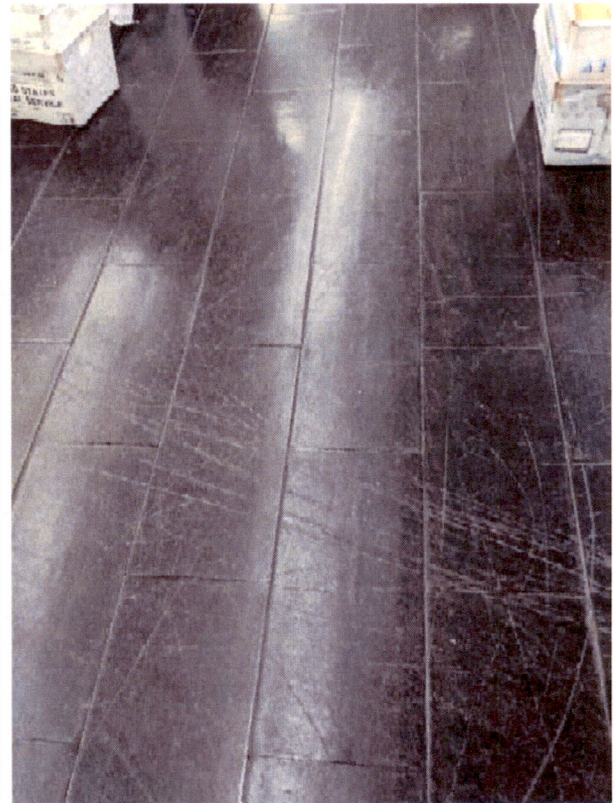
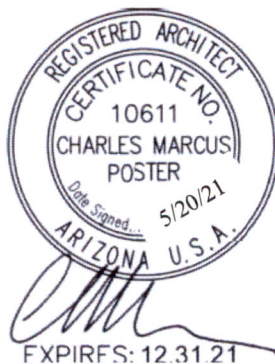
- The floor in the Post Office is an interesting composite running-bond material that is in poor shape. Amazingly there is a stash of extra flooring material in the deep basement accessible from Commerce Street. This extra material could be used to repair damaged areas. The entire floor could be repolished and brought back to an interesting finish.

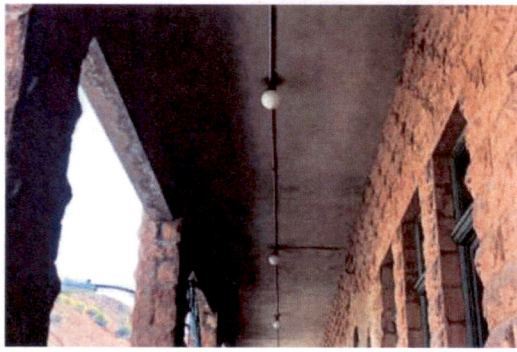
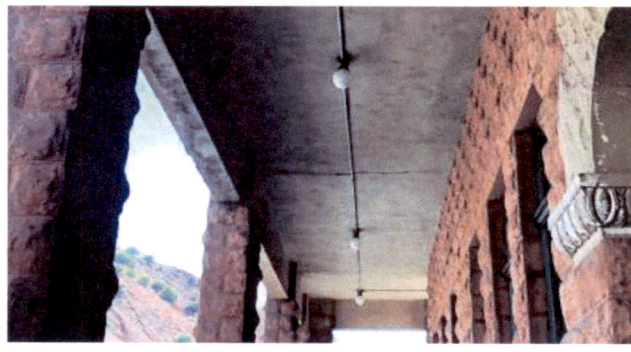
The level 3 deck was observed to have some cracks occurring on the underside in alignment with the exterior pillars. There is evidence of moisture seeping through the crack from exposure to rain on the top surface. A surface applied sealer over the top surface of the exposed decks would help mitigate moisture seepage through the deck that can promote corrosion of slab reinforcing.

1 and 2 above were taken from the level 2 porch looking up at the underside of the level 3 porch concrete deck. Cracking was observed spanning in the north/south direction from the CMU pillars to the CMU wall. See plan view for photo locations.

2. The exterior porch slabs appear to be allowing moisture from the weather to seep through and potentially causing corrosion of the reinforcing steel. It is advised to apply a surface sealant that will mitigate surface moisture from migrating through the slab.

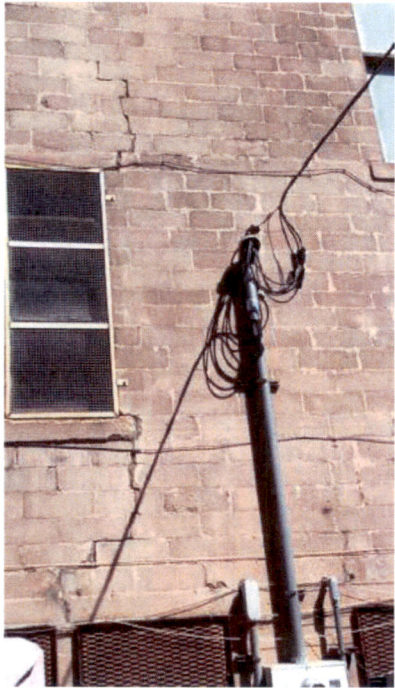
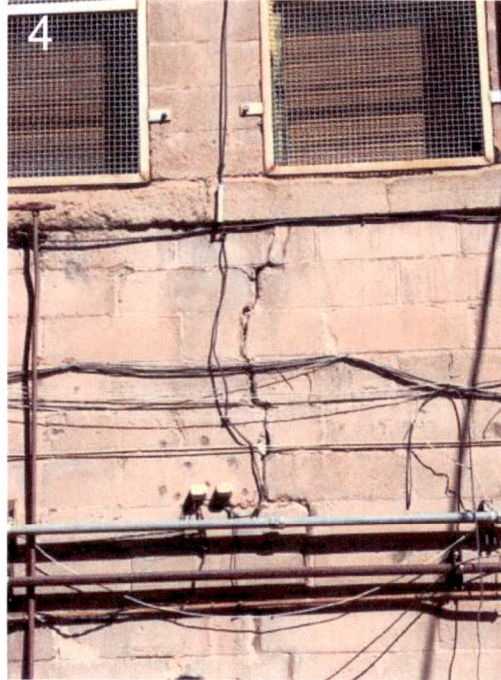
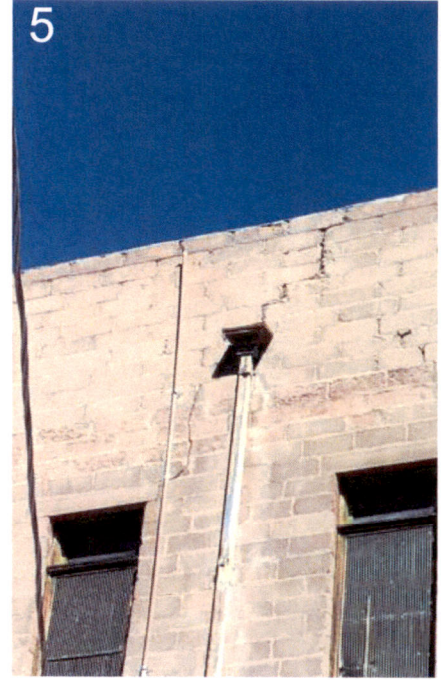
3, 4, and 5 show cracking observed on the south facing exterior CMU wall. See elevation view for photo locations.

1. The south masonry wall that has experienced cracking should be repaired. It appears there have been attempts at patching some of the cracks, but do not appear to have been performed by an experienced masonry repair contractor. The cracks should be cleaned out and filled with a cement base mortar by an experienced masonry repair contractor.

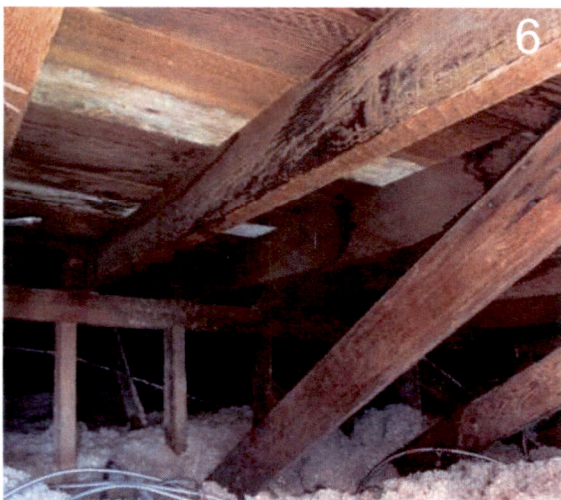
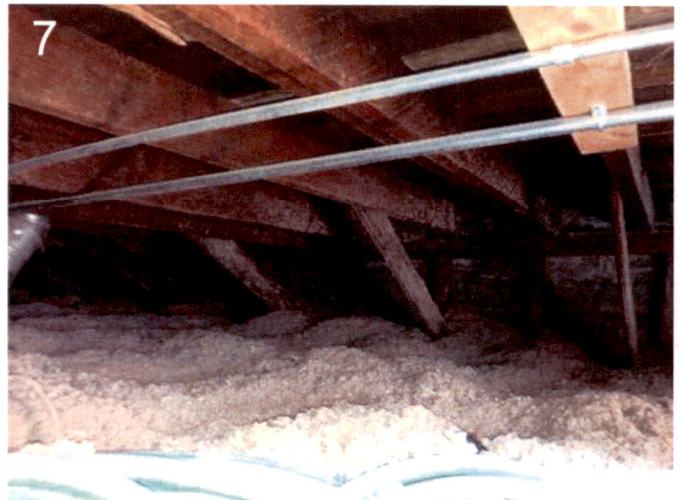
6 and 7 show what can be seen of the wood roof framing from the roof access hatch.
