Copper Queen library needs \$1.1 million for needed renovations

Shar Porier

July 25, 2021

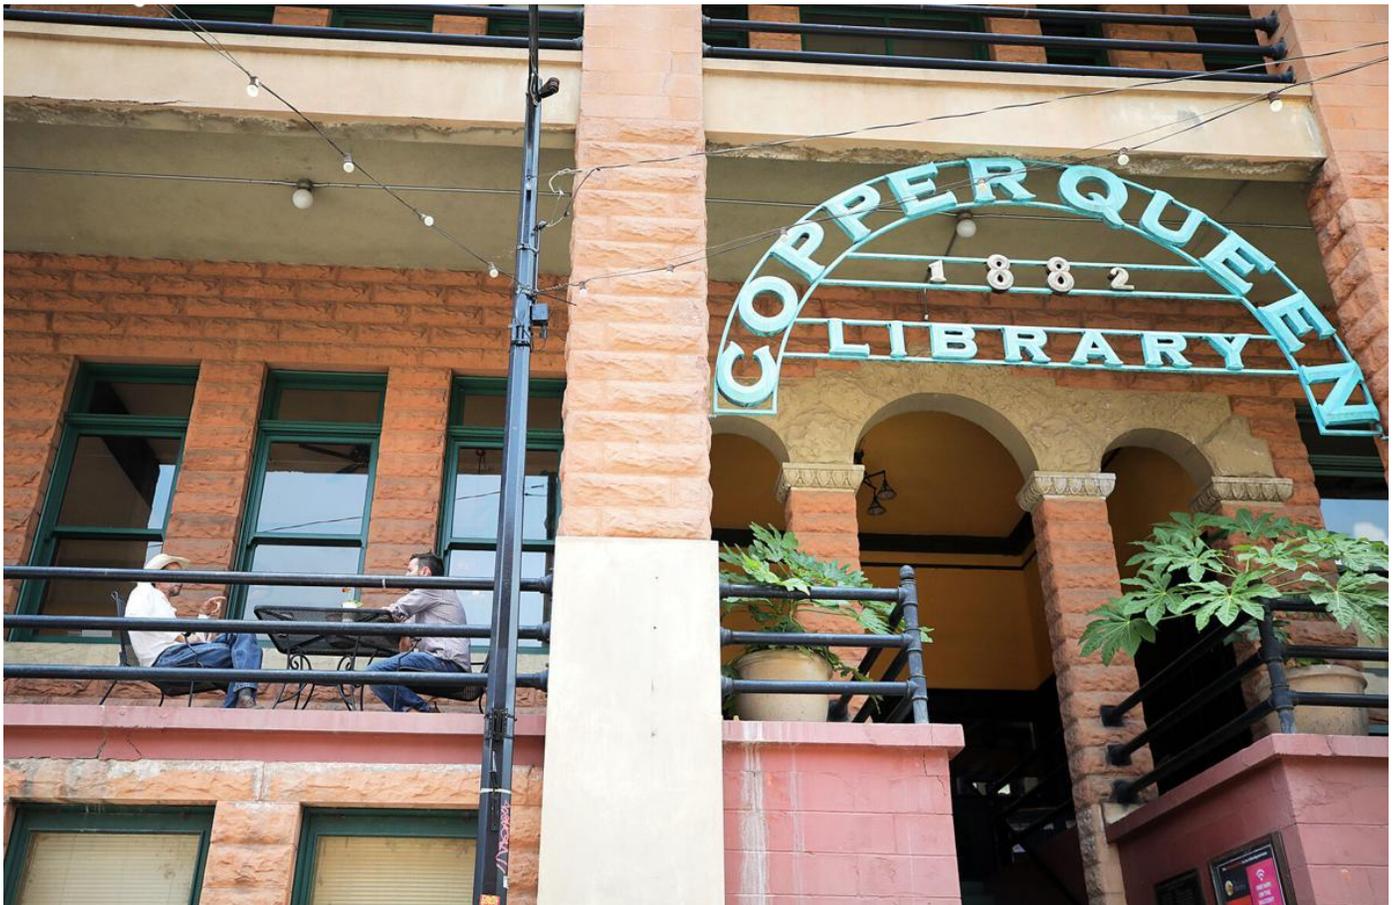
Bisbee's Copper Queen Library will be using funds provided through a building assessment grant from the State Historic Preservation Office of Arizona for various repairs. One of the items to be addressed will be adding "invisible balcony rails" along the existing rails.

The most important upgrade needed as quickly as possible are the railings along the stairs inside the library and the balcony which are lower than the current building code requires, he said.

There are possible additions to the railings to meet the height requirement and still retain the historical look.

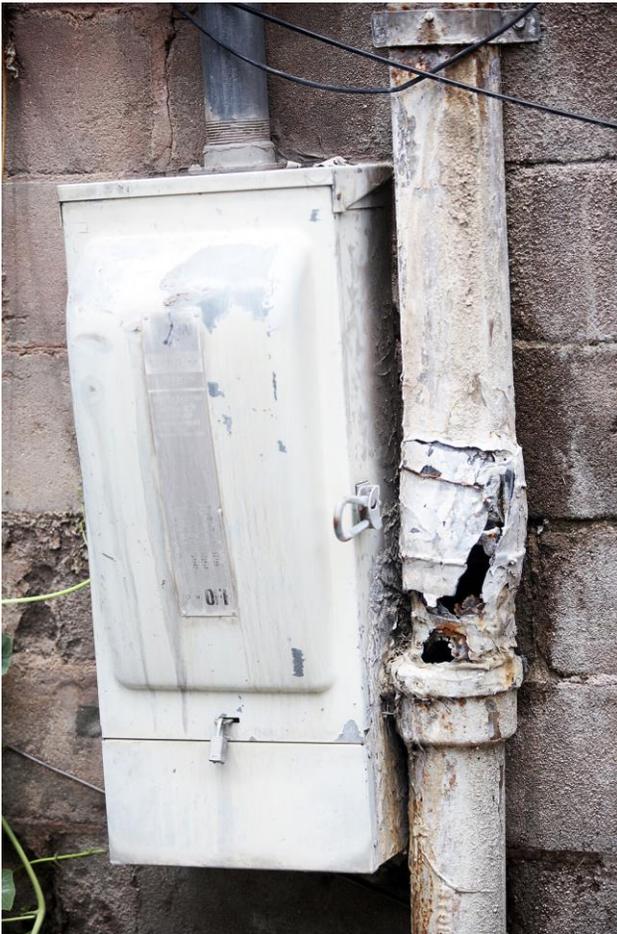
Two downspouts are broken which need significant repair so the storm water goes into the drainage channel underneath Commerce Street. One of the broken downspouts sits close to an electrical box creating a hazard.

A deteriorating downspout lies precariously next to the library's electrical panel box in the back of the 114-year-old historic structure.

“That probably needs repair immediately,” he noted.

Roof, downspouts improvements: \$55,000

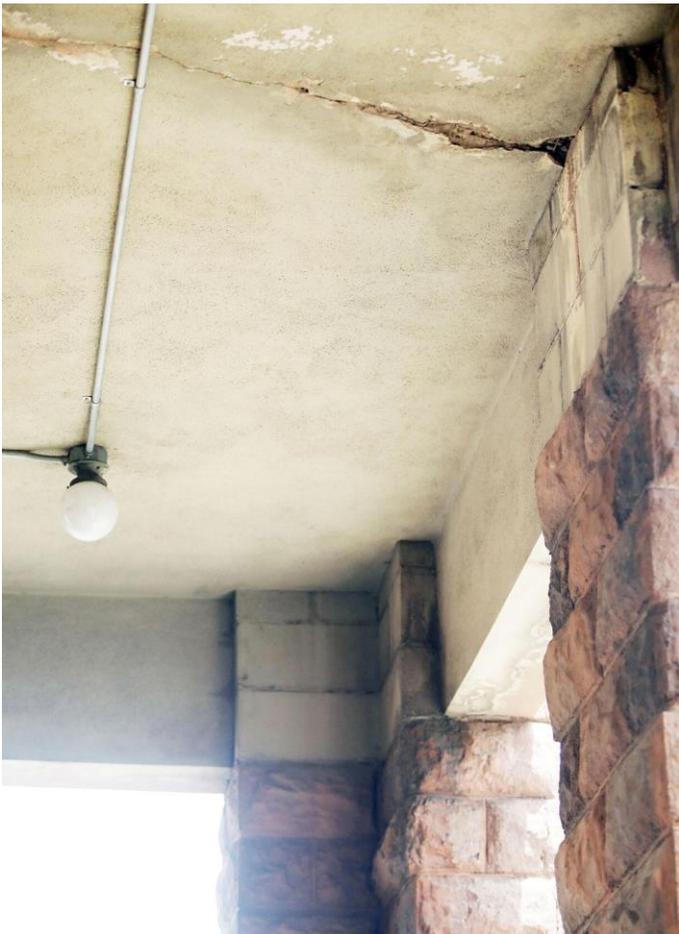
Cosmetic cracks and chipping around the facility are in need of repair.

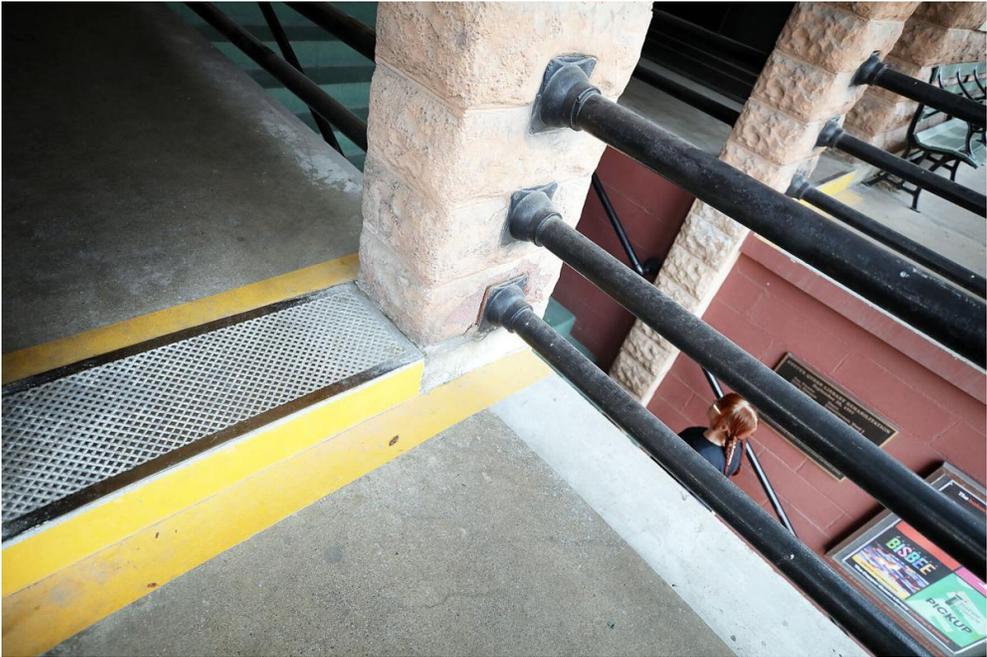
“The railings along the verandas are dangerous,” he continued. “In some places it is only 29 inches to 30 inches off the ground. And the space between the railings are too large. Code requires it to be 42 inches from the ground. The spacing between the rails must be just four inches wide, so that children cannot get their heads through it. You shouldn’t allow people out there,” Poster said.

He also pointed a possible danger to people in wheelchairs accessing the veranda as there is slight step down from the second and third library floors which needed to be remedied.

They also found cracks in the concrete on the verandas which could allow water to penetrate through the slabs if not repaired.

The library's balcony needs ADA approved ramps as well as new railing.

Outdoor verandas, railings: \$65,000

ADA access to veranda: \$16,000

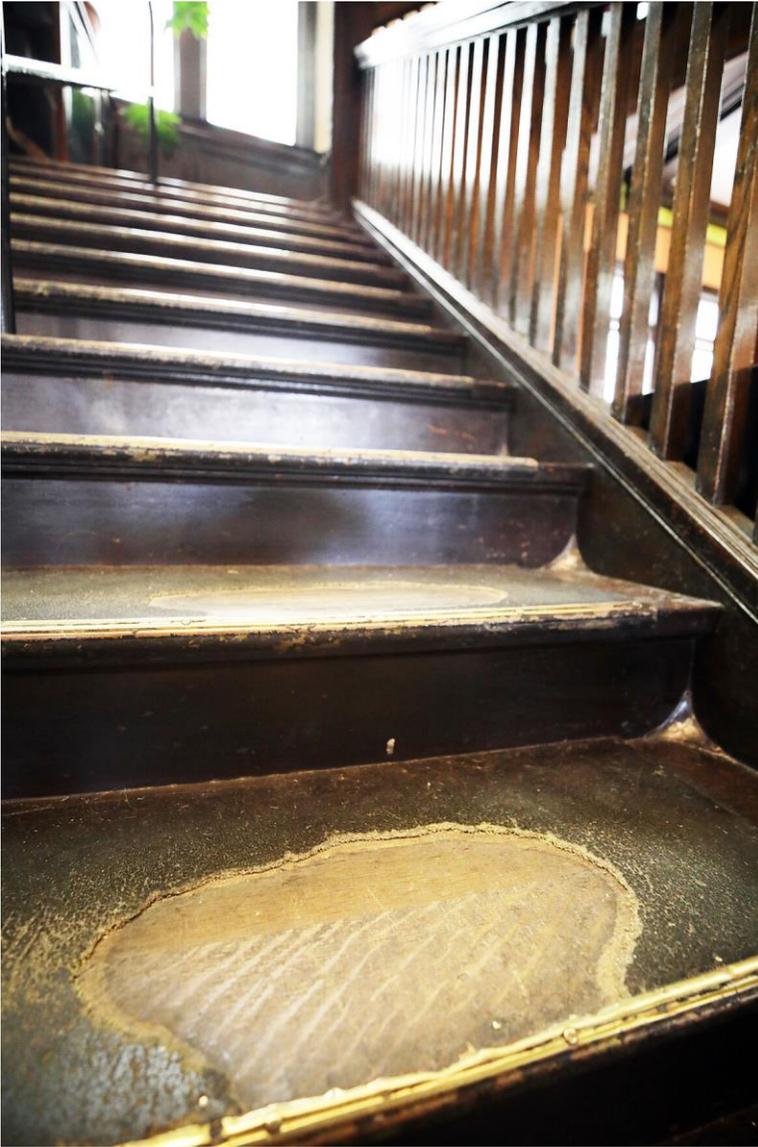
The railings going up to the third floor are also dangerously low and need to be raised to meet code, he continued. They are about 30 inches of the ground and need to be 42 inches to meet code.

The Copper Queen Library's inside main stairway is in need of renovations to the steps and railing.

Interior stair railings, safety improvements: \$55,000
